# Analysis and Solution of Flooding Water Problem for EV Passenger Compartment

Li Zhongkui\*, Xu Zebin, Shu Peichao

Dongfeng Motor Corporation Technical Center, Wuhan, China

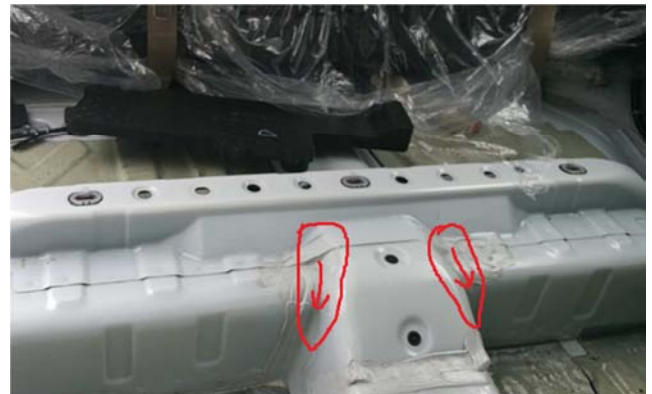
The water inlet point is located in the middle of the middle floor at the back end of the middle passage. At the position of the circle in figure 3, there is a large water flow.

Figure 3. Water inlet in the middle of the middle floor.

(1) To solve the problem of water inlet the car body middle floor, the temporary solution is to fill up the glue that is leaking. Permanent solution is to improve the local structure of body floor, to cancel the local strengthening structure on the

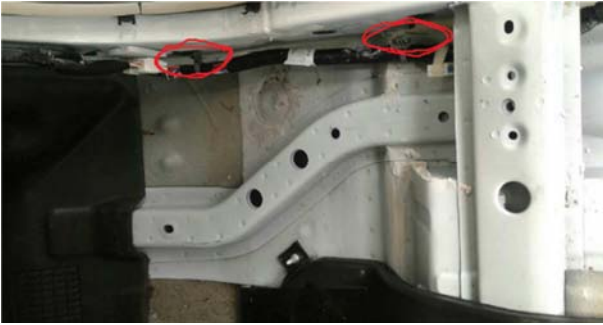
the left and right sides of the body, as shown in Figure 5. Water drops appear at the cable harness buckle installation on the right longitudinal girder of the car body.

**Figure 5.** The water inlet is at the wire harness buckle place, at the right longitudinal beam of the car body.

(3) In order to solve the problem of water inlet at the wire harness buckle on the inner plate of the body longitudinal beam, the solution is to change all the wire harness buckle holes into welded studs, as shown in figure 25.

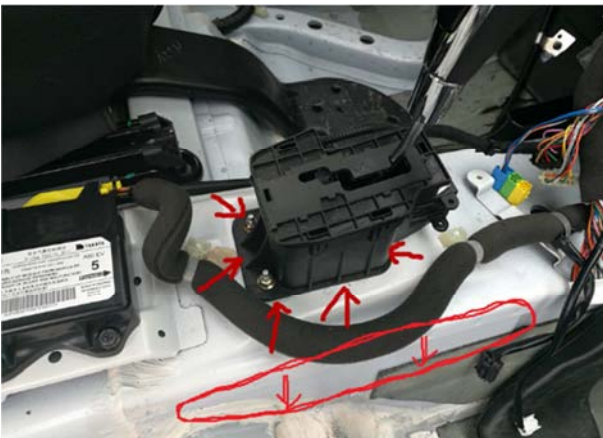
The water inlet point is located around the installation position of the gear shifter, as shown in figure 6. There are water drops flowing out along the periphery of the gear shifter and both sides of the middle channel strengthening plate.

**Figure 6.** Water inlet on position of gear shifter.

(4) To solve the problem of water inlet at the gear shifter installation, the temporary solution is to put a plug in the box with holes on both sides of the box under the gear shifter, as shown in figure 26. Permanent solution is to improve the structure of the box under the gear shifter, or use other types of gear shifter to solve the sealing problem.

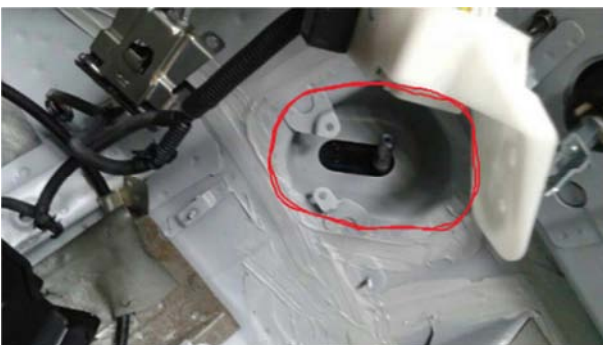
The water inlet point is located at the position of the steering column hole in the cowl panel, as shown in figure 7. There is a large amount of water in the sinking platform of the steering column hole cover.

**Figure 7.** Water inlet at the through-hole position of the steering column.

(5) To solve the problem of water inlet at the through-hole of the steering column on the dash panel, solutions are within the steering column sheath set card hook structure, will cover the collection on car body, as shown in figure 27 and figure 28, through the card hook card tight sheath, keep sheet metal sheath and body moment in the compression state.

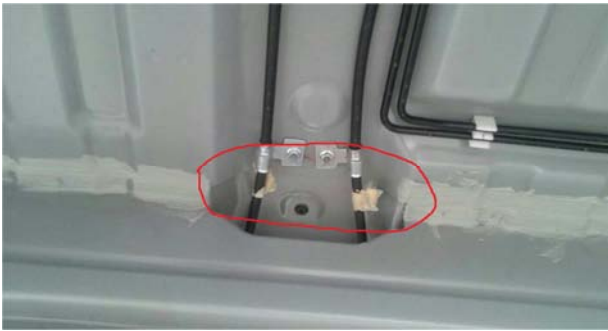
Check the car and found that the original mathematical model defined on coating line, as shown in figure 9, the local not besmear in real vehicle is shown in figure 10, and it is located in the sheet metal pieces of the corner, considering the manufacturing technology level, set aside a large gap, as shown in figure 11. Therefore, if the place is not covered with glue, when the vehicle wanders into the water, there will be a large water flow into the vehicle.

Figure 10. Leaking glue under the floor.

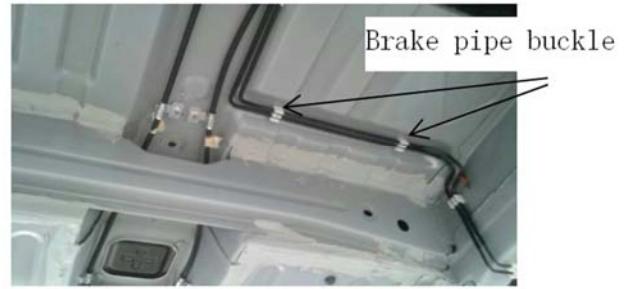
Figure 12. Brake installation line.

In comparison, there is no water drop on the left side of the floor, and there is water drop on the right side. Check the real car and the number model, and confirm that the water drop is from the installation of the brake pipe lug, as shown in figure 12. It is caused by the failure of complete sealing between the buckle and the hole of the brake tube. Refer to figure 13(a) the buckle structure and figure 13(b) the gap between the buckle and the hole.

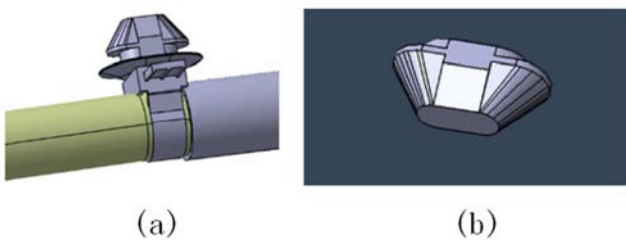
Figure 15. The mounting structure of wire harness buckle.

The wire harness buckle is also a common clasp, and it is difficult to ensure complete sealing between the mounting hole and the wire harness buckle, as shown in figure 15.

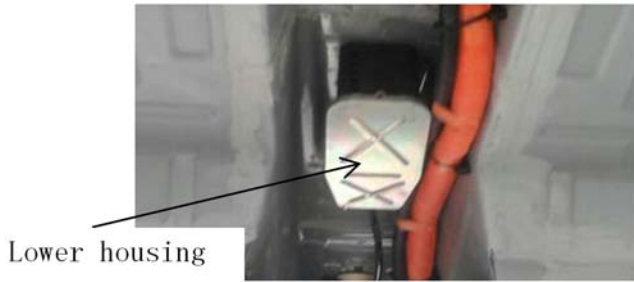
Figure 16. The shifter structure below the middle channel.

Check the real car. There is a gearshift box below the middle channel, as shown in figure 16. Further inspection of the mathematical model reveals that there are holes on both sides of the under gear shifter box. Refer to figure 17(a) left side of the under gear shifter box and figure 17(b) right side of the under gear shifter box. The hole corresponds to the shaft line of the shift handle, and the seal is not considered in the design. When the vehicle waded into the water, it was easy to get water from the hole into the inside of the gear shifter, which then flowed up and into the car cabin.

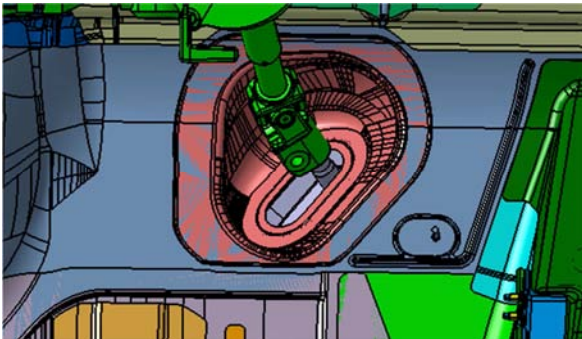
Figure 18. The structure of the steering column through the hole.

As the steering shaft sleeve is connected to the body only by elastic extrusion, it is easy to be deformed with the wheel beating and steering, resulting in a large amount of water entering the cabin and flowing to the driver's foot place.

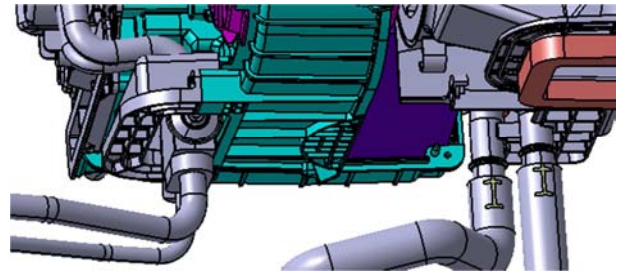
Figure 20. Air conditioning piping structure.

When the air conditioning pipeline passes through the front fender, it does not effectively seal the through-hole, resulting in a small amount of water from the air conditioning pipe passing through the through-hole into the cabin. Figure 20 shows the air conditioning inlet and outlet pipeline structure. Figure 21 shows the hole in the enclosure spacer, only one hole is added with the cushion block, but it is a sponge cushion, which has no waterproof effect.
