Diagnostic Investigation of Hydro Electric Project Made Easy with Remote Operated Vehicle

3.1. Underwater Scanning of Hirakud Dam Using ROV

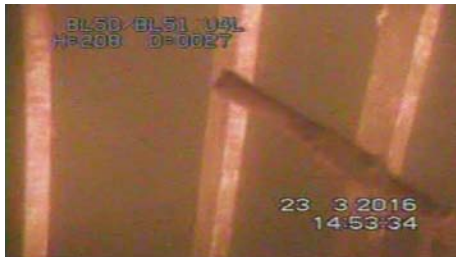
Figure 3. Wooden debris obstructing the downward movement of ROV at EL 528ft.

Operated Vehicle (ROV) proved to be useful. The recorded image can be used for remedial measures of the distressed portion. Scanning of upstream surface must be carried out at regular intervals. Since the debris were found up to the elevation of 530ft it is recommended to clean the trash racks.

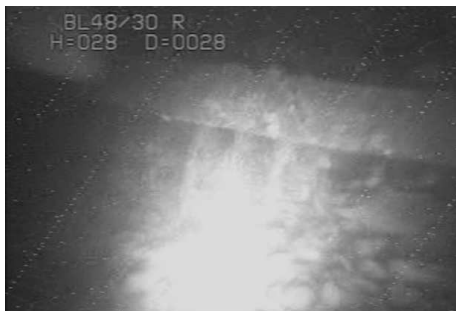
Figure 4. Boulders and pebbles found at EL 522 inside the trash rack of Unit 6.

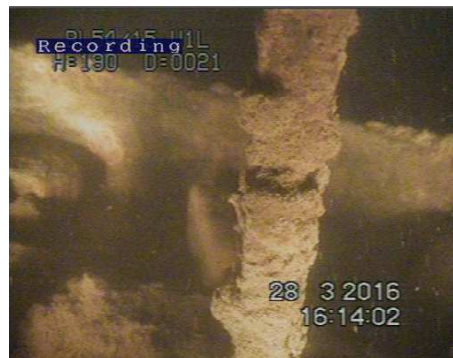
depths. Signs of deterioration/ defect could be seen at few locations. In masonry, the pointing is intact on all over the places where images were captured. The mortar in rubble masonry is not missing in the observed locations. Cracked mortar was not visible. Cavities could not be detected. Algae growth was visible in many places [9] [10]. The concrete portion of the trash racks, that is the slab and columns are generally intact at all depths. Grouting marks could not be observed in the masonry portions. ROV could not be piloted below 530ft elevation due to wooden debris or other obstructions (Figure 3 & 4). In front of the trash racks and at the bottom of masonry portion, wooden branches as debris were visible in many places (Figure 3). Heap of stones were found at EL 522 ft inside the trash racks (Figure 4), which is above the invert level of the inlet of the penstock. No other defects were seen in trash racks. The cross section of the horizontal member of the trash rack looks like I section and the vertical member rectangular. In this I section, stones were found lying at many places in the horizontal members (Figure 5) [10].

Figure 5. Stones found on horizontal members of left trash racks in Unit 1 at EL547ft.

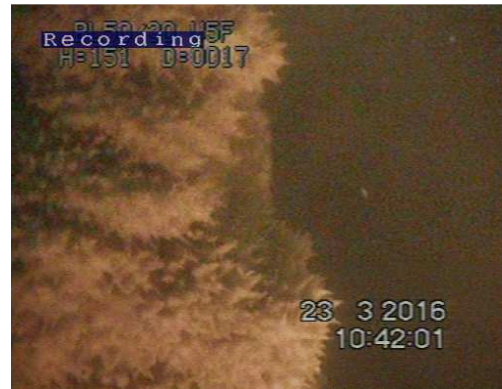
Due to dense algae growth in all the trash racks except unit 3 and 4, identification of cross section of the vertical members was difficult (Figure 5 & 6). In the trash rack of unit 3 and 4, mild growth of algae was observed as these were installed recently. Some trash racks of the Unit 4 were almost free of algae growth. Honey combing in concrete was observed at some locations on both banks (Figure 7 & 8). The observation of the gate grooves revealed anomaly on all gate guides (Figure 9) on the surfaces which are not coming in contact with the rubber seal. From the above images (Figure 7 & 8), the aggregates used in concrete were found to be rounded indicating the use of river bed material.

Figure 6. Heavy growth of algae on the vertical members of trash racks of Unit 5 at EL 561ft.

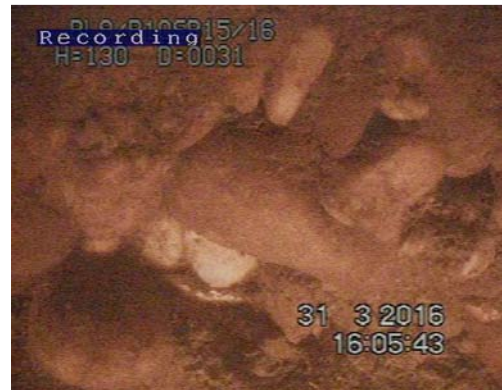
Figure 7. Honey combing in concrete between SB15 and SB16 at EL 513ft.

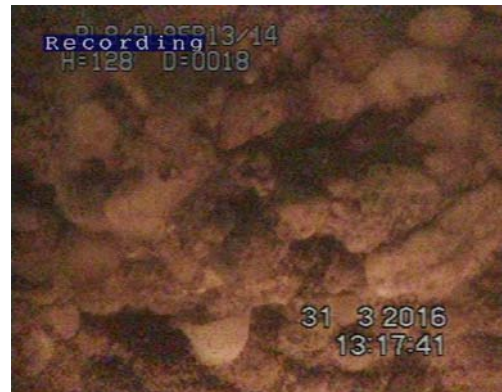
Figure 8. Honey combing in concrete between SB13 and SB14 at EL 556ft.

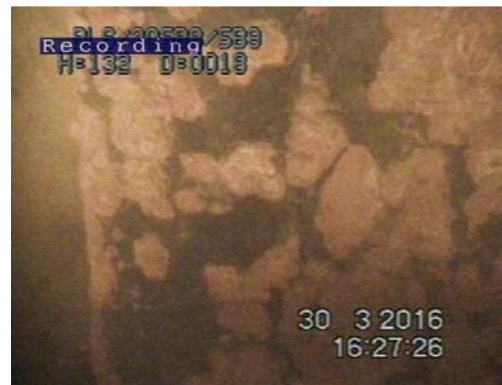
Figure 9. Anomaly on the left gate guide of SB9 at EL 556ft.

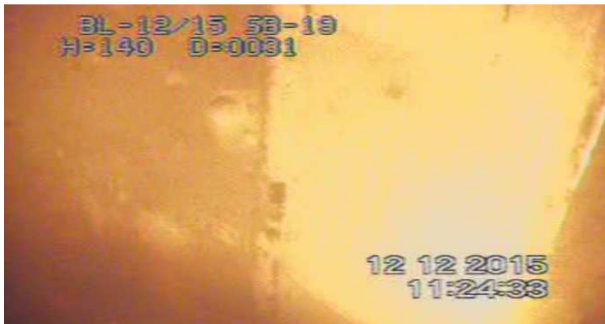
No anomaly can be seen on the locations on the gate groove where it comes in contact (Figure 10) with the rubber seal as the portion where the seal is coming in contact with rubber seal of gate groove is always clean and getting good reflections of light (Figure 10). Good concrete could be observed at many locations even at the deepest as well as at the shallowest levels (Figure 12). Previous intact grouting marks could be observed in many locations (Figure 11).

Figure 10. Reflecting portion in gate groove of SB19 at EL523ft.

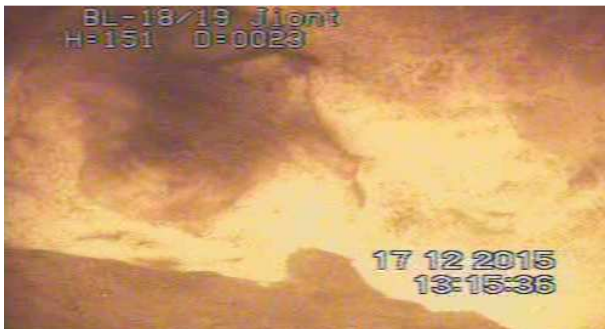
Figure 11. Grouting marks seen at EL549ft. On Block 18/Block 19 Joint.

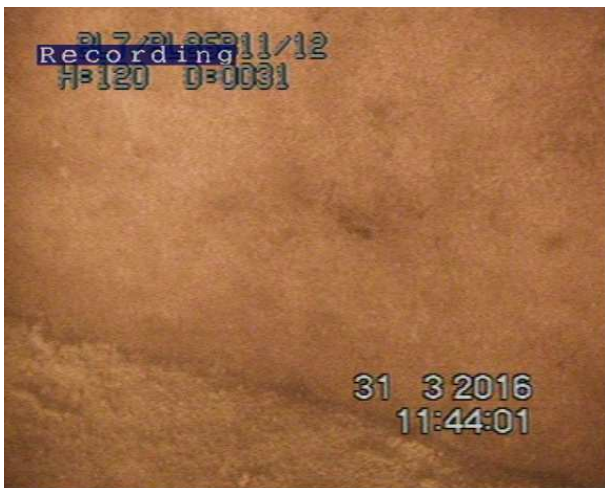
Figure 12. Good concrete at bottom of gate groove of SB 11 at EL513ft.
