# The Investigation of Negative Effects of Salt Dome on the Quality of Water in Gotvand Olya Dam and the Use of Cut-off Wall as Treatment

Mahmood Mansournejad, Behzad Kalantari, Mehdi Mahdavi Adeli. The Investigation of Negative Effects of Salt Dome on the Quality of Water in Gotvand Olya Dam and the Use of Cut-off Wall as Treatment. *American Journal of Civil Engineering*. Special Issue: Research and Practices of Civil Engineering in Developing Countries. Vol. 3, No. 2-2, 2015, pp. 53-56. doi: 10.11648/j.ajce.s.2015030202.20

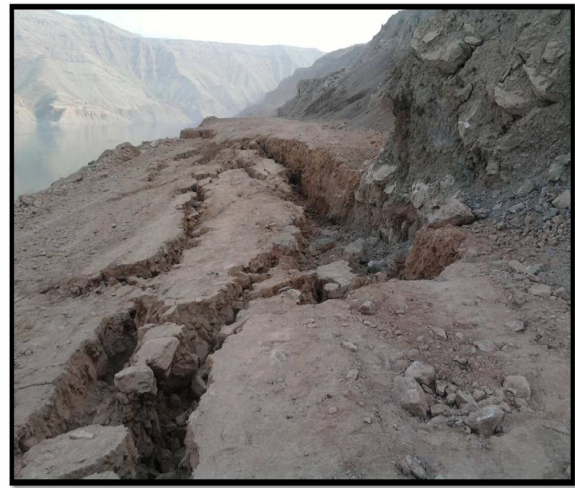
After the first step in Gotvand Olya dam impounding, due to rapid impounding of the reservoir, some tracks and holes were created in embankment area, so based on the design consultant some changes were applied in the implementation method of the band, the most important of which are as follow:

- Cancelling the transition later implementation: due to sinking of the only mine of these materials SB
- Change in the implementation method of materials: after impounding, for stability and filling of the hole, clay and riprap materials were evacuated in form of damp on the band and the contraction of material was done by the traffic of road construction machineries (figure3).
- After impounding, due to safety concerns, the consultant

of this project began amending the tranches of zone 3 [5].

Concerning the results obtained, reviewing the prepared photos and according to the opinion of experts engaged in the project, the quality of soil was evaluated as somehow mid to low.

Fig. 3. cracking in the embankment after dam impounding.

of clay wall is salty clay with shrinkage limit of 18%. For reaching the maximum density and weight, it is require contracting the soil with 18% moisture while for determining the moisture percentage, the design consultant used TM1556 modified proctor test. Concerning the laboratorial information and experiences obtained for clay soil in modified proctor density test, the moisture is almost 16% which is less than shrinkage limit, this indicates that in this soil test method, not enough moisture is provided for contraction.

2. Concerning the applied energy by the rollers, also distribution of load in the soil, if the thickness of embankment layers increases, enough energy is not supplied and provided for contraction of the below layers so just the upper layers of the soil will be contracted. Due to this, according to executive bylaws and instruction the thickness of embankment layers should not exceed 30 cm before pummelling while in the first step in executing and building clay wall, the thickness of layers is three times more (80-90 cm) which leads to proper contraction of the soil.

3. In embankment process, after impounding of the dam, embankment is done by traffic contraction. Concerning the fact that the applied force by the road-construction machineries is low and the width of their tier is at most 50 cm, also due to high height of embank and its low width, the possibility of this machineries for manoeuvring will reduce and there is just the possibility of partial and incomplete contraction under the wheels.
