The Major Causes of Flexible Pavement Deterioration and Propose Its Remedial Measures: A Case Study Bako to Gedo Road, Oromia Region, Ethiopia

Shiferaw Garoma Wayessa, Dessalegn Geleta Abuye. The Major Causes of Flexible Pavement Deterioration and Propose Its Remedial Measures: A Case Study Bako to Gedo Road, Oromia Region, Ethiopia. *American Journal of Engineering and Technology Management*. Vol. 4, No. 1, 2019, pp. 10-24. doi: 10.11648/j.ajetm.20190401.13

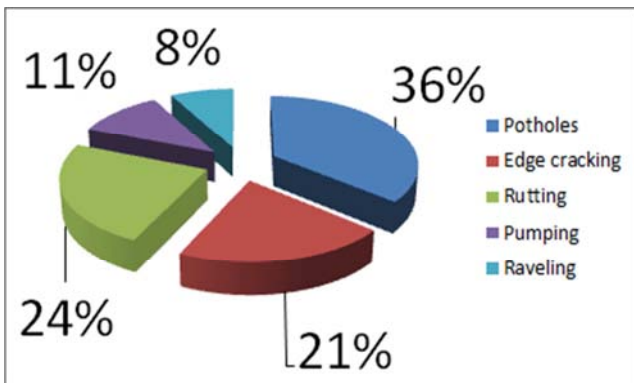
Figure 1. The percentage of common deterioration types and their severity.

The major types of deterioration observed along the study area of Bako-Gedo rehabilitation Road Project. Relative to this, the researcher had organized the possible deterioration types based on existing condition of the pavement surface together with the extent of damage and had been ranked accordingly. The following Figures show the different photos taken from the field observation of the different types of deterioration along Bako-Gedo road project.

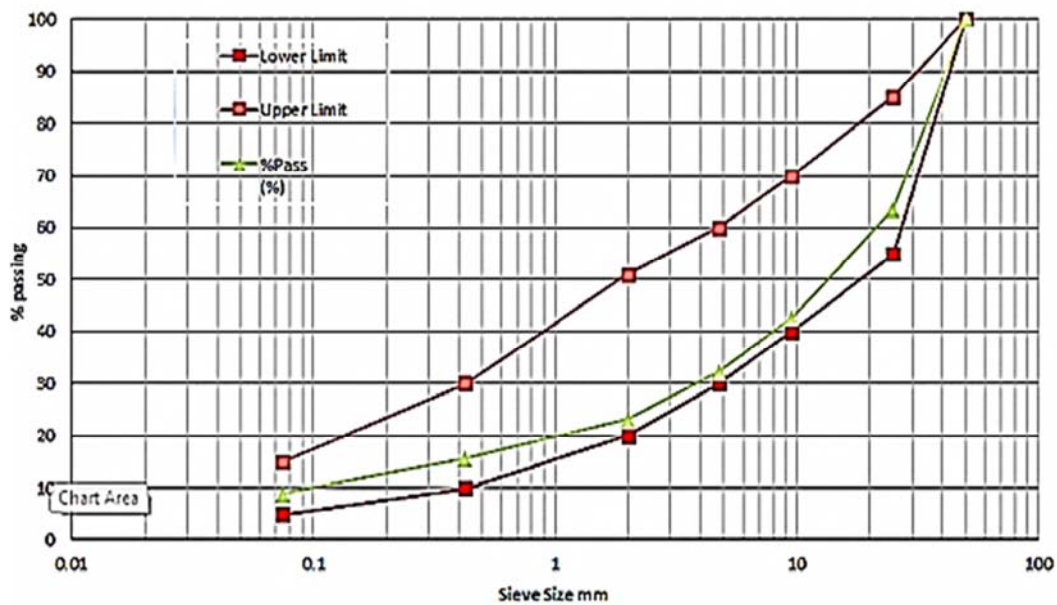
It can be observed that the gradation of the base course at all the three sections, the gradation is within the recommended range. However, this recommended range will come to invalid if there is a possibility of moisture fluctuation because of poor drainage condition. Since this moisture fluctuation can be affected or washed out the fine ingredients of the base course

Figure 10. Comparison of base course material at section (1) with GBI.

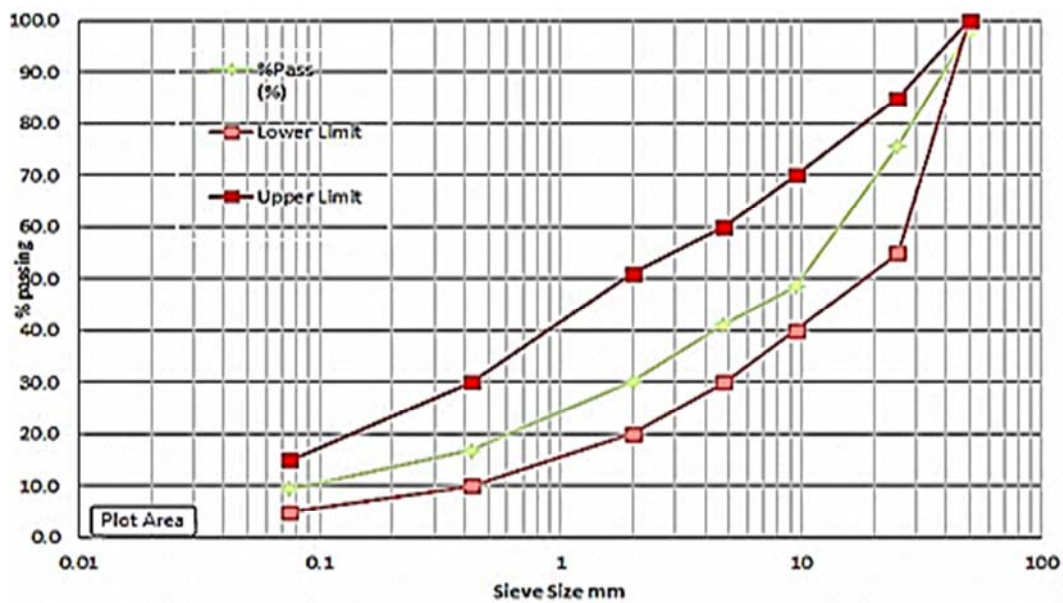
Figure 11. Comparison of base course material at section (2) with GBI.

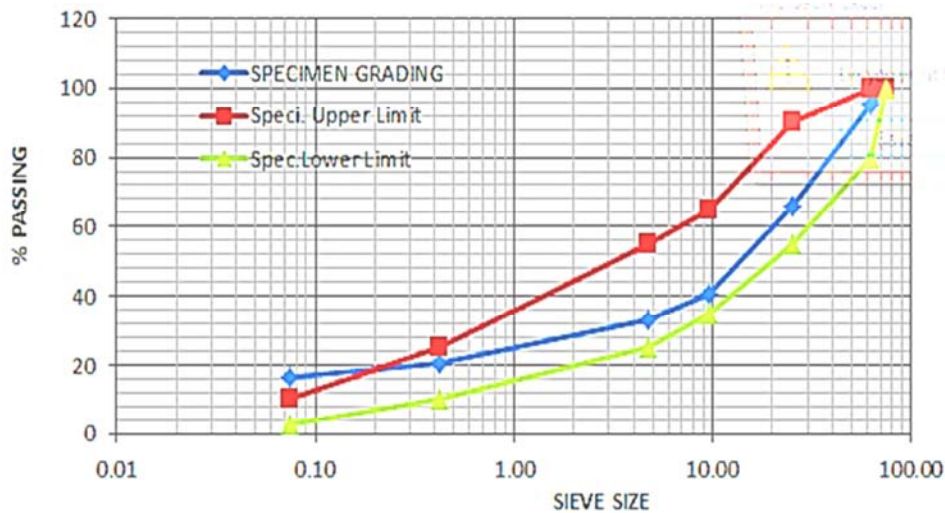
Figure 12. Comparison of base course material at section (3) with GB1.

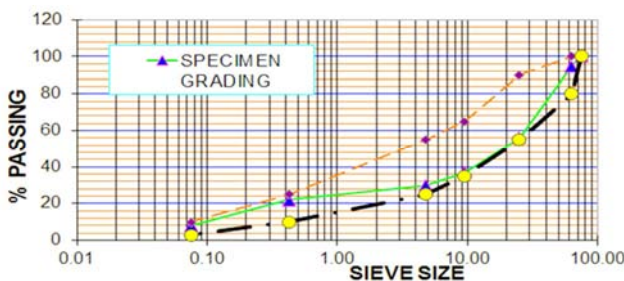
From above figures, be observed that the gradation of the natural sub base at all the three sections. Gradation analysis was made for this layer at all sections and have different gradation curve with the section. However, it could be noted that section (1) and (2) lie within the recommended range

Figure 13. Comparison of natural sub base course material at section (1) with GS2.

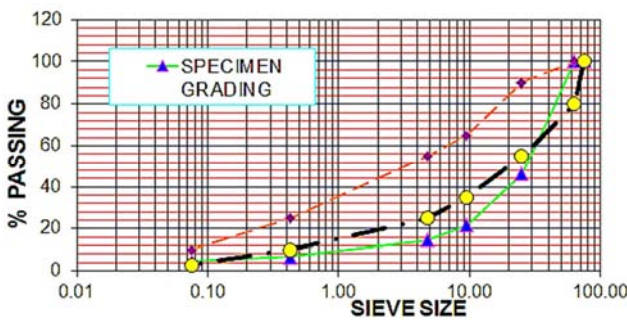
Figure 14. Comparison of natural sub base course material at section (2) with GS2.
