Analysis of Partial Discharge Patterns for Generator Stator Windings

Korea Electric Power Corporation (KEPCO) Research Institute, Daejeon, South Korea

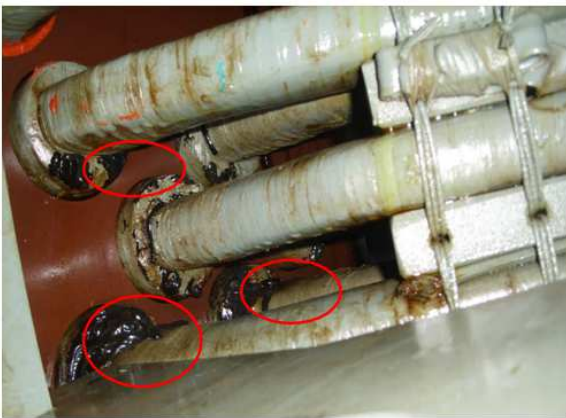
This is a case where a large-scale water cooling steam turbine generator was tripped because of the destruction of the main insulation of the stator winding caused by cooling water supply discontinuance. The generator, which was manufactured with thermal class B insulation material with a maximum allowable temperature of 130 °C, experienced a discontinuance of the cooling water supply. The discontinuance was caused by an error in the coolant supply system for approximately 10 min during normal operation, and the temperature of the stator windings increased rapidly to approximately 200 °C. This caused the main insulation of the stator winding to fail, and a ground fault eventually tripped the generator. The melted compound of the connecting joint between the cooling water box and the stator winding caused by overheating is shown in Figure 1, and the failed insulation of the stator winding is shown in Figure 2.

Figure 1. Compound melting due to overheating.

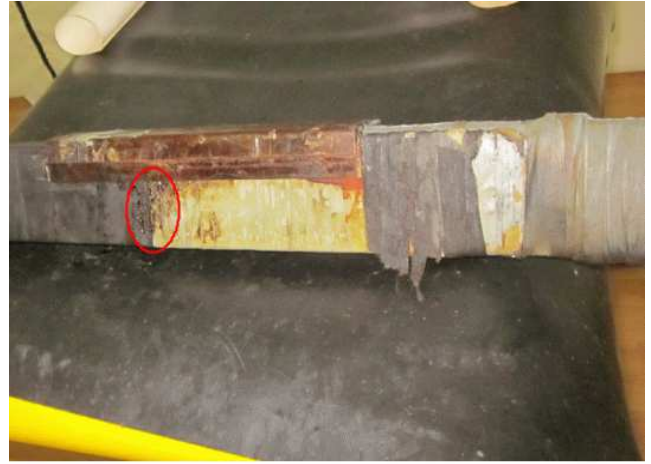
Figure 2. Stator winding insulation failure.

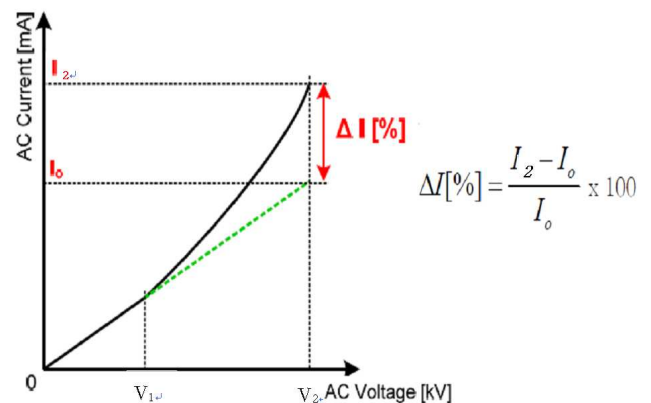
Figure 3. Voltage vs. AC current.

The AC current and DF measurement results at 15kV (phase voltage) were measured in two years prior to the failure. The same voltage of 15 kV was applied to measure the values of ΔI and $\Delta \tan \delta$ in order to compare the test results. The results show that both ΔI and $\Delta \tan \delta$ increased after the failure, as shown in Table 1. This implies that PD started to occur more than two years prior to the failure, and also implies that the number of voids, which cause discharging within the insulation system, increased because of stator winding thermal overheating.

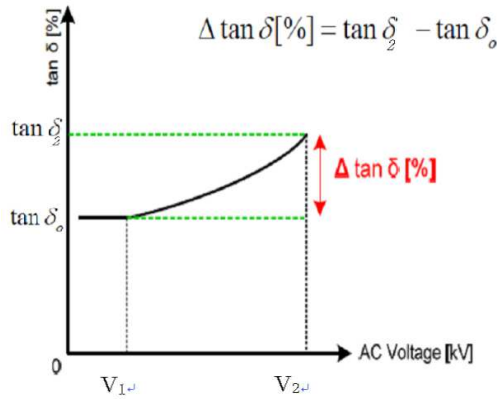
Figure 4. Voltage vs. Dissipation factor.

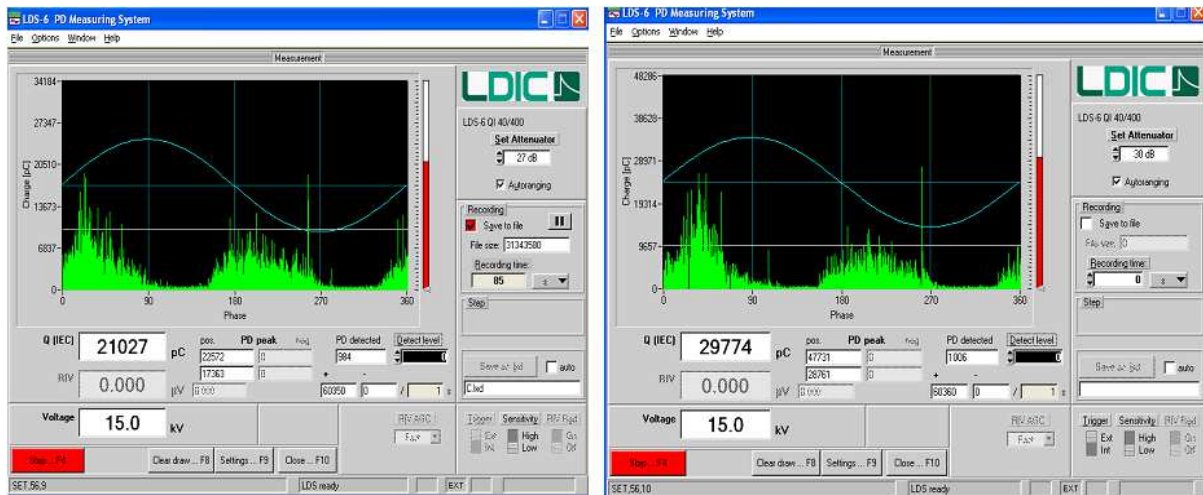
Figure 5. PD pattern for copper conductor overheating.

results show that the level of PD increased significantly after the failure and that there was also a change in the discharge pattern. Before the failure, the size and number of the negative discharge pulses, which appeared when the test voltage is positive, were similar to those of the positive discharge pulses, which appeared when the test voltage is negative. However, negative pulses were larger than the

positive pulses after the failure due to thermal overheating, as shown in Figure 5. This pattern appears mainly in the gap between the copper conductor and strand insulation [10]. Furthermore, it was found that the insulation was not in good condition because the PD size was close to 30,000 pC or greater [11].

This pattern is produced because of delamination between the copper conductor and the insulation because of the differential thermal expansion between the copper conductor and stator winding insulation as a result of rapid thermal overheating.

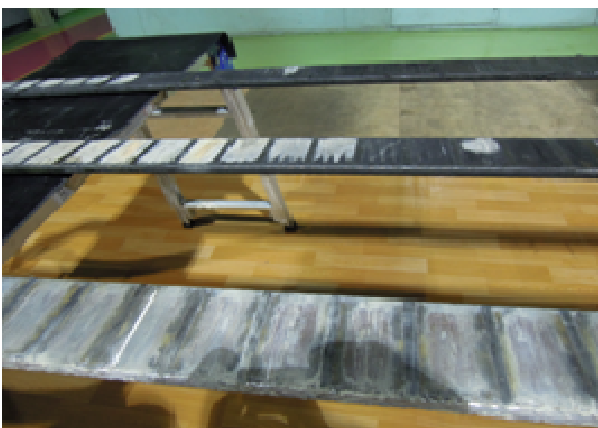
However, when the generator is started and stopped, the winding insulation is subject to thermal expansion and contraction because of Joule heating, and the resin that holds the stator winding in its position within the slots is separated. This creates a gap between the winding and the slot, and the stator winding starts to vibrate at 120 Hz because of the electromagnetic force of the rotor, further reducing the thickness of the insulation. This increases the length subject to vibration, accelerating the wear process and eventually causing dielectric breakdown. In Figure 6, it can be observed how the semiconducting layer is almost eliminated because of the slot vibration-induced wear on the surface of the stator winding. The semi-conductive layer is used to reduce the partial discharge between the stator winding and the slot [12].

Figure 6. Wear in stator winding surface.

Insulation diagnosis tests were performed on the remaining stator windings except for those that experienced dielectric breakdown. The PD measurement was carried out at rated phase voltage, and the measured PD magnitude and phase pattern is shown in Figure 7. The results show that the PD value was relatively high (38,000 pC), and the PD pattern showed that the positive discharge pulses, which occurred at a test voltage phase angle of 225 °, were produced more than negative discharge pulses, which occurred at 45 °, forming a slot discharge pattern [8, 9]. Most PDs are considered to occur at a gap between the stator winding and the slot, and it was also confirmed that the surface of the stator winding drawn from the slot was also significantly worn, as shown in Figure 6.

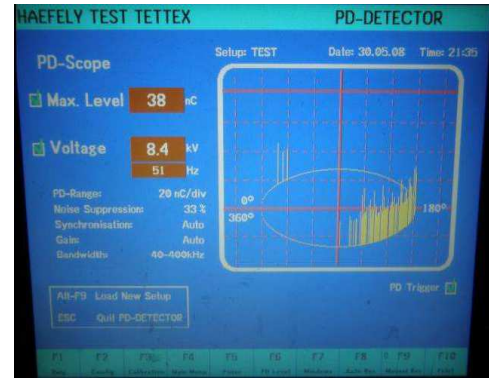
Figure 7. PD pattern for slot discharge.

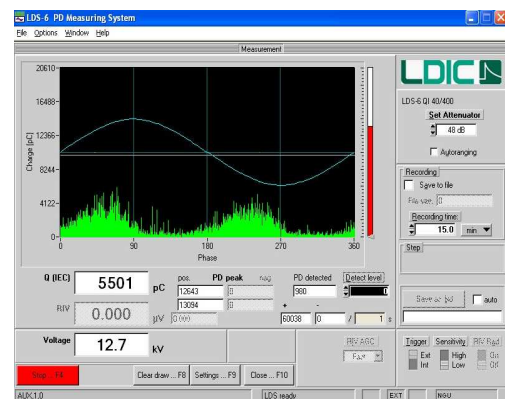
Figure 8 shows the PD measurements on a 22 kV steam turbine generator, which has been operating for approximately 20 years. According to the test results, the location of the main discharge is considered to be in the void inside the ground-wall insulation because the positive and negative PDs occur almost similarly. This is because the voids within the ground-wall insulation were not completely removed during the vacuum pressure impregnation process of the winding manufacturing or because voids were created inside the ground-wall insulation as a result of thermal deterioration. This discharge pattern due to the internal voids of the insulation material occurs during normal deterioration and is a frequent form of partial discharge pattern.

Figure 8. PD pattern for internal discharge.

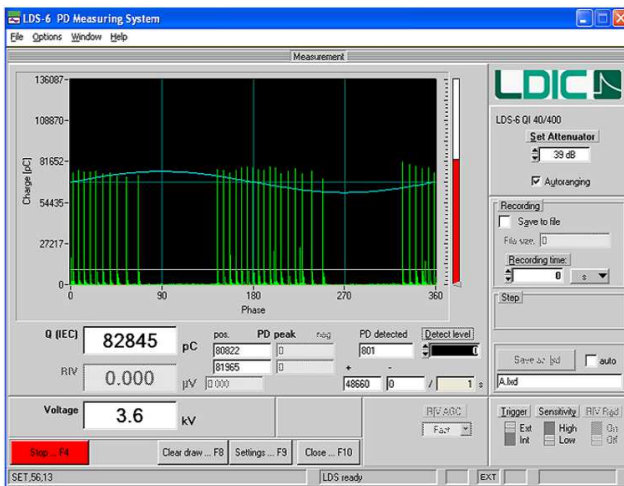
The screen of the PD measurement during a PD test on a generator that failed because of overheating in the copper conductor is shown in Figure 9. The location of the preliminary pulses are near 0° and 180° , and the size of the discharged pulses are almost identical. This pulse had a completely different shape with respect to the discharge pattern on insulation systems. This discharge pulse sizes being similar implies that the pulses occurred between particular electrodes. Because external noise pulses were detected in addition to the PD occurring at the electrical insulation, a visual inspection was performed to check the location that produced the noise. As a result, it was found that the contact between two isolated phase bus (IPB) bars, through which the generator output flowed for each phase, and the clip, which connected the two IPB bars to the common plate, was defective resulting in a discharge. This problem was rectified, and a test was conducted.

Figure 9. PD pattern for gap discharge noise.

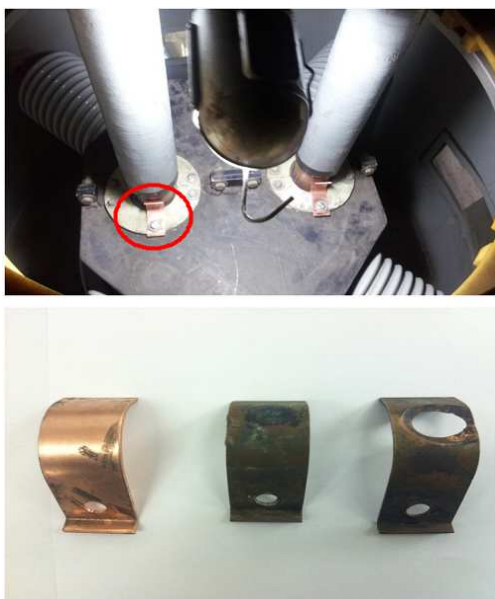
Figure 10. Gap discharge location.
