# Assessment of the Effect of Urban Road Surface Drainage: A Case Study at Ginjo Guduru Kebele of Jimma Town

Getachew Kebede Warati, Tamene Adugna Demissie. Assessment of the Effect of Urban Road Surface Drainage: A Case Study at Ginjo Guduru Kebele of Jimma Town. *International Journal of Science, Technology and Society*. Vol. 3, No. 4, 2015, pp. 164-173.

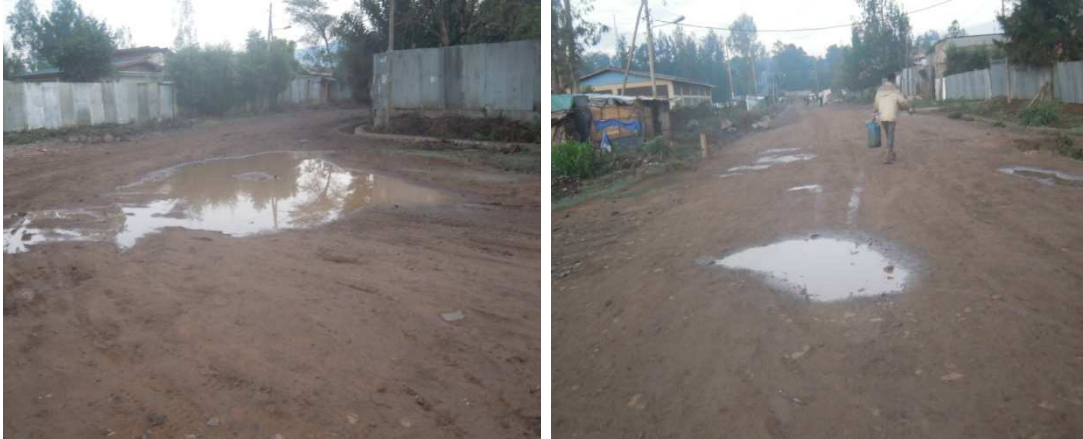
*Figure 1. Ponding of water on gravel road in Ginjo Guduru Kebele in front of Jehovah's Witness hall.*

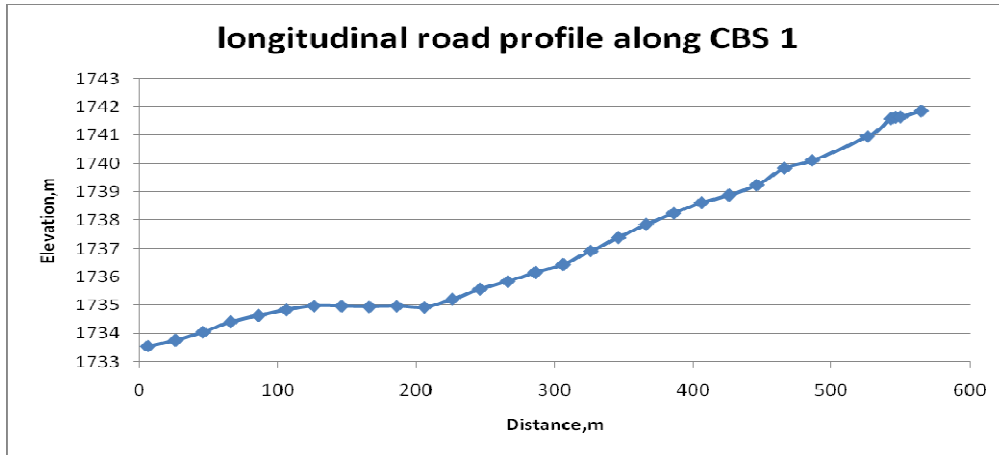
Figure 3. CBS1 road profile.

As it can be seen from table 2, about 15% of the road length have less than 0.5 percent longitudinal slope and

62.97 % of cross fall slope being less than 2.5 %, which is below the required minimum slope for adequate drainage.

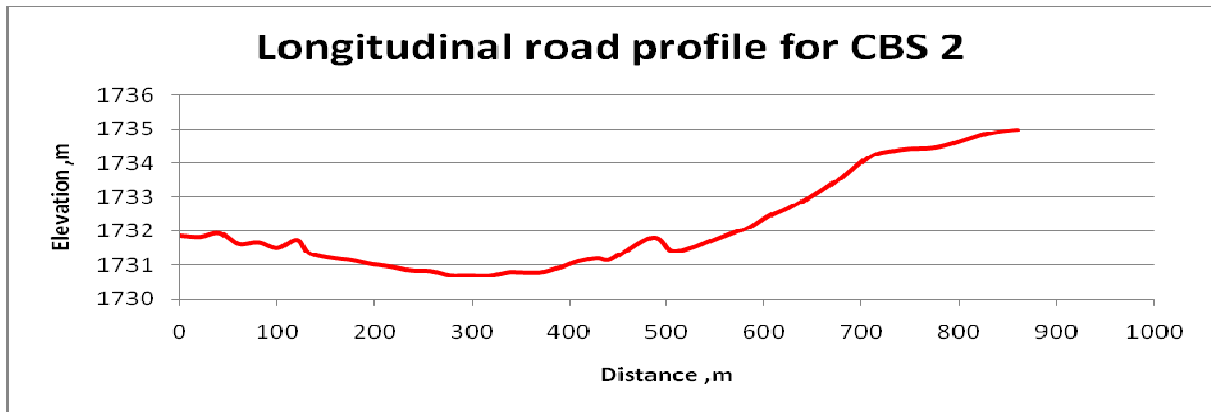
Figure 4. Profile of CBS2 road.

In this part of road segment of 0.9 km, about 48.93 % of the road likely to have less than 0.5 percent longitudinal slope and 51.07 % of the road have less than 2.5 % cross slope. The distribution of the longitudinal as well as cross fall slope between stations of the road is also not uniform and

this retards the safely disposal of water from the road.

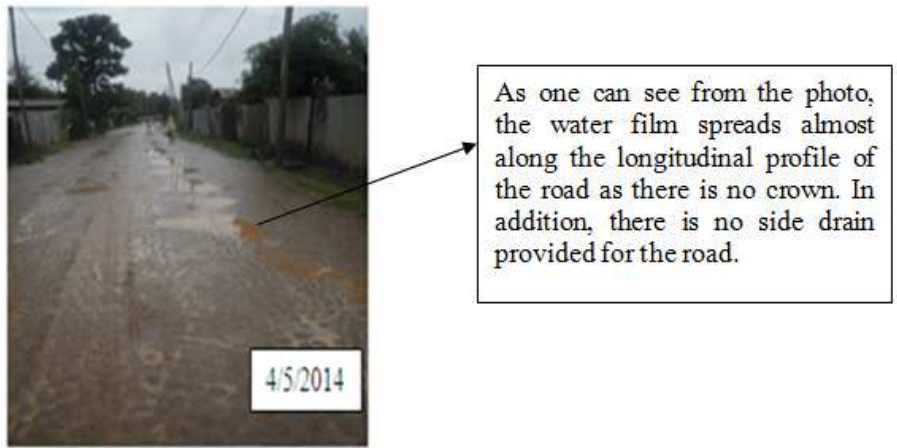
Figure 5. Photo of CBS 3 road.

In this cobble stone road, the cross fall is totally less than 1.0 percent and there is no uniform longitudinal slope as it can be seen from the table which gives favorable condition

for accumulation of water on the road.

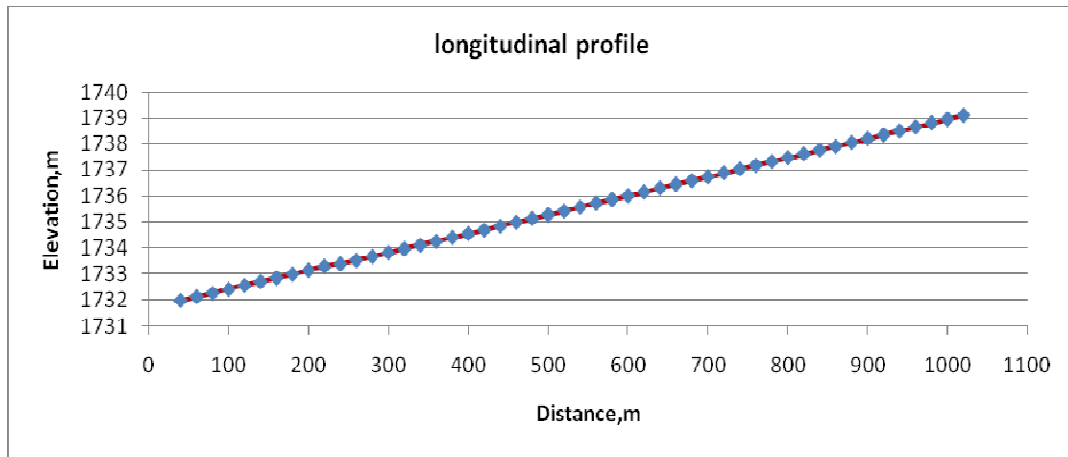
Figure 6. Longitudinal Profile of Asphalt road.

The profile of the asphalt road shown in Figure 6 indicates a uniform longitudinal slope of about 0.86 percent and a cross fall of 3.98 % respectively, which provides rapid removal of storm water from the carriage way of the road to the side drain ditch. The width of shoulder provided for this road ranges from 1.8 m to 2.4 m but the shoulder material is not sealed and subjected to erosion. The erosion of this shoulder is one of the main sources of material that fills the side ditch and results clogging. No manhole provided for the drain ditch of the road to regulate the flow of runoff water.

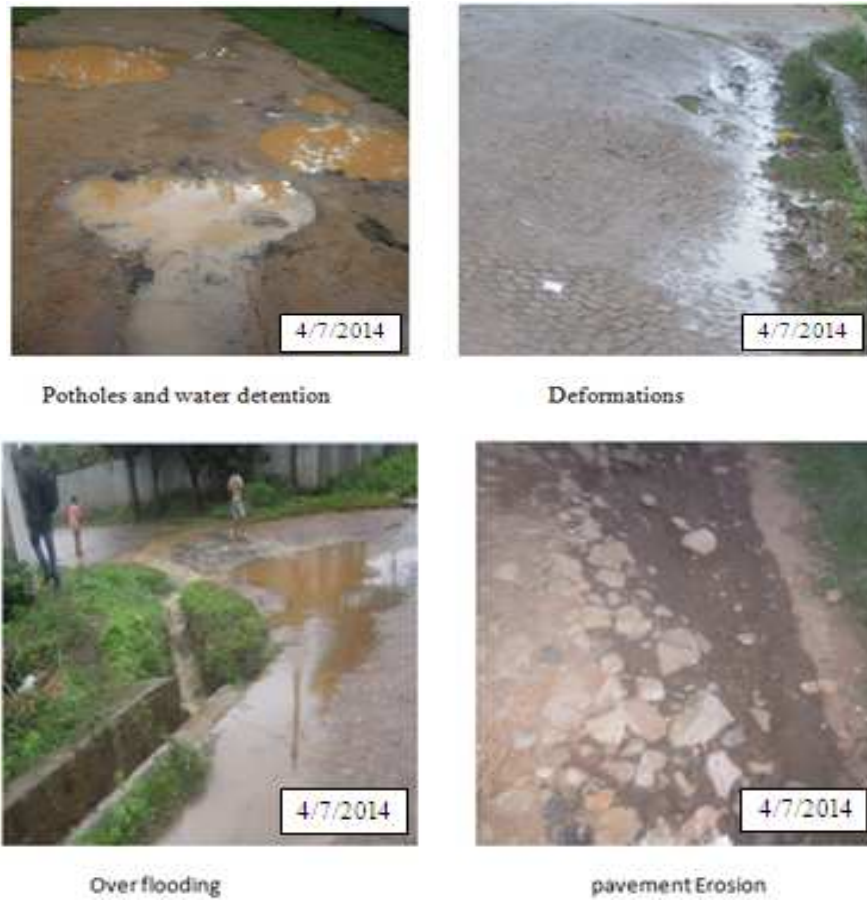
Different types of damages to the roads in the Kebele were observed during the study. These are potholes, washing and

deformations of the road pavements. About 5 cm to 30 cm deformation were observed on cobble stone and gravel road respectively while washing of asphalt road shoulder in the

order 5 to 7 cm also observed due to improper slope. Figure 7 shows different damages occurred to roads in the study area as it was observed in the field investigation.

Figure 7. Photo showing Road damages of the study area.

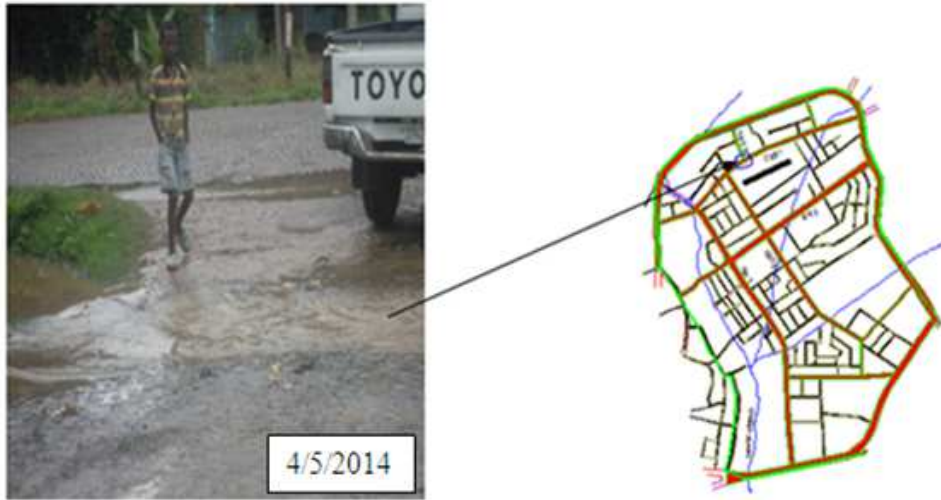
In the junction of CBS1 to CBS3, improper (under- sized) pipe culvert was provided and this create an obstruction to convey the water along the ditch and thus over flooding of water occurs at road crossing junction after every rainfall event. Figure 8 shows flooding due to improper connections or integrations at this location.

Figure 8. Over flooding of water from side drain ditch at road crossing.

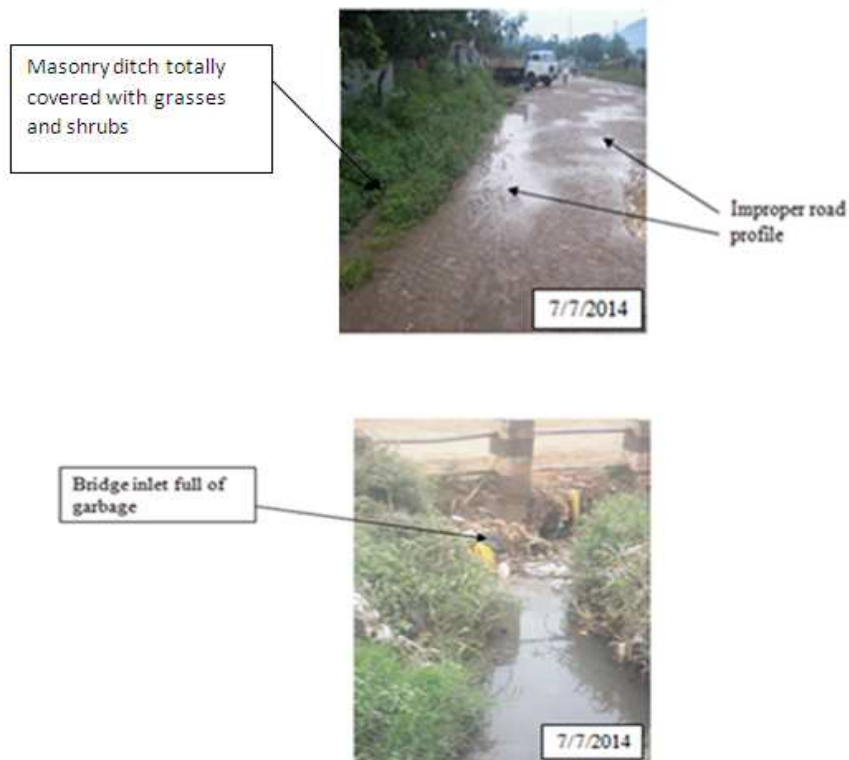
There is no regular maintenance of road and drainage structures as it was investigated during the study. Most of the side drain ditch is full of garbage and sediment at many places which obstruct the normal flow of water in the channel. Some drain ditches are also covered totally with grasses and shrubs and thus not giving the desired function for which it was constructed.

Figure 9. Poor maintenance of drainage ditch, bridge and road surface.

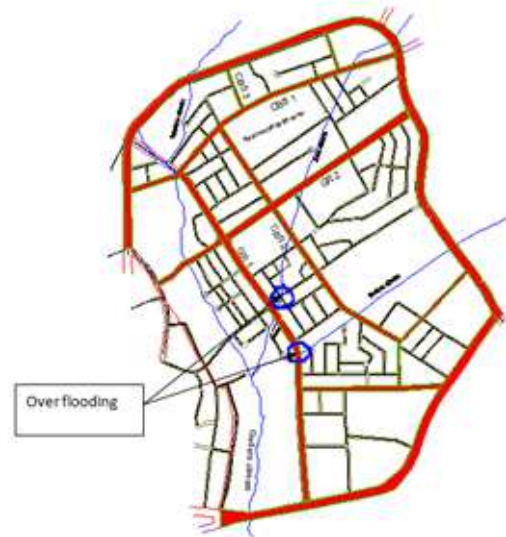
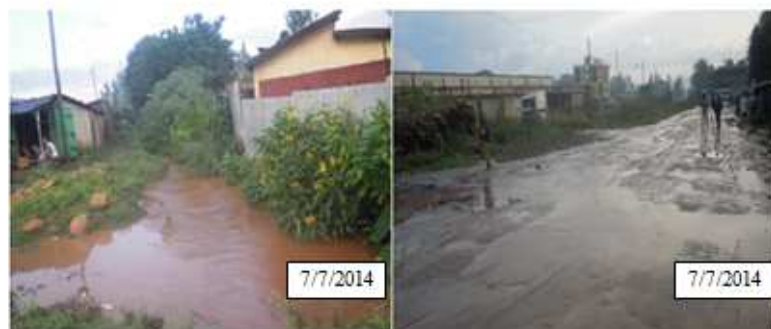
The result of the study shows that though the drainage problem is common in the area, the hazard of the flooding problem is dominant for about 38.6 % of the area and this flooded prone area is located at downstream reach of the Guduru sub-catchment along the streams. Two small bridges over flooded with runoff water in July 2013 due to blockage by debris and the flooding extended to the surrounding residential buildings causing damages or loss to their property. In 2014 rainy season, over flooding of runoff water also occurred to the bridge three times in a season.

Figure 10. Over flooding of road due to bridge and pipe culvert blockage by debris.
