Alkali-Aggregate Reaction: Definition, Influence and Control

Abstract: The alkali-aggregate reaction is a pathological manifestation due from chemical processes of interaction of reactive minerals that are present in some aggregates, and alkali hydroxides from Portland cement, water kneading and external agents dissolved in the solution present in the pores of concrete. It is a reaction that occurs slowly, but may cause irreparable damage, for example with cracks that impair the mechanical strength and durability of the affected structure. The main objective of this work is to expand the existing knowledge about the evolution of this pathological manifestation in order to contribute to eradicate this problem in the construction works. The methodology used in the article includes a literature review that addresses a history of occurrence of alkali-aggregate reaction in Brazil and around the world, its definition, the types of reaction, the factors that influence it, control methods and some cases in Metropolitan region of Recife that had this pathological manifestation during the construction process and during its lifetime. The article here presented is intended to contribute to s

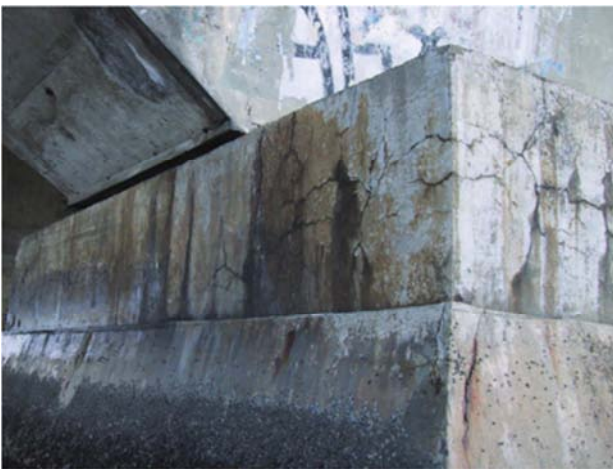
According to a case study carried out, all the support blocks of the main beams of the bridge presented pathologies worthy of attention, mainly cracks. The fissure frame varied from block to block, usually in "spider web" or "map" format, some with large openings.

The fissures were predominantly in the blocks themselves, but they could also be seen in the calyxes and the pre-welded plates that cover the calyxes and their bases (Figure 2). This framework of cracking in concrete pieces is characteristic of the occurrence of alkali-aggregate [25].

Figure 2. Signs of AAR in the central span support block of the Paulo Guerra Bridge [26].

Due to the local conditions and the advanced deterioration, the solution adopted for the recovery of the bridge was a structural project that chose to take advantage of the existing blocks, recovering them and reinforcing them through an encapsulation in reinforced concrete. This seemed to be the best alternative. As it is not possible to keep the concrete away from the water, it is expected that the AAR will continue in the foundation block. The designed confinement needed to withstand the forces of reaction expansion. For this purpose, it was decided to use a confinement force capable of withstanding tensile stresses of the order of 4 MPa (580 psi) [26].

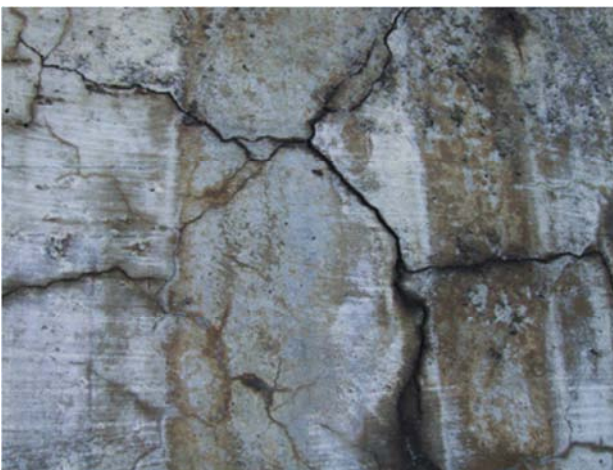
Figure 3. Crack in the shape of a map in the foundation block of the Paulo Guerra Bridge [26].

the tests, the occurrence of AAR in the alkali-silicate type was confirmed and it was observed through macroscopic analysis, several reaction characteristics, such as white material filling pores and defining edges at the interface, aggregate-mortar, later identified in the scanning electron microscope as an expansive gel.

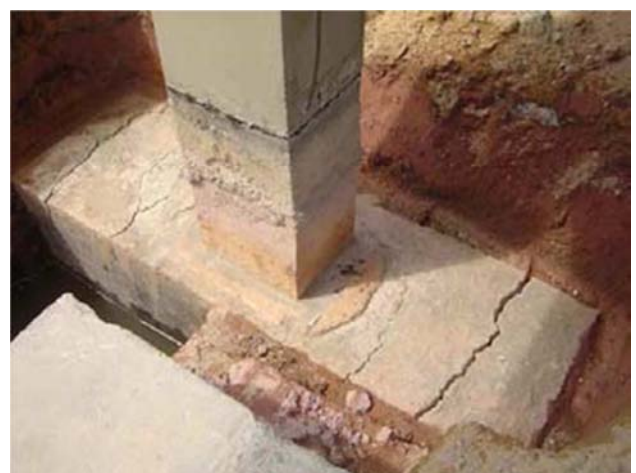
Figure 4. Fissure in block on two stakes, with dimensions 1 x 2,5m [25].

In the analyzes it was observed that in some cases, besides the vertical cracks in the blocks on two stakes have exceeded the connecting rods, in two cases, at the bottom of the building, the AAR weakened the blocks to such an extent that there were redistribution of loads to other blocks.

The company responsible for the recovery was JLC Project Engineering Ltda., from Rio de Janeiro and with the table presented, a mechanism was necessary to recompose the section of the block, introducing compression stresses in the block, through pretension (being in the larger blocks made in two directions), using Dywidag bars. In addition, it was necessary to seal the block to prevent the subsoil water from reaching the block by capillarity, thus re-feeding the alkali-aggregate reaction process.

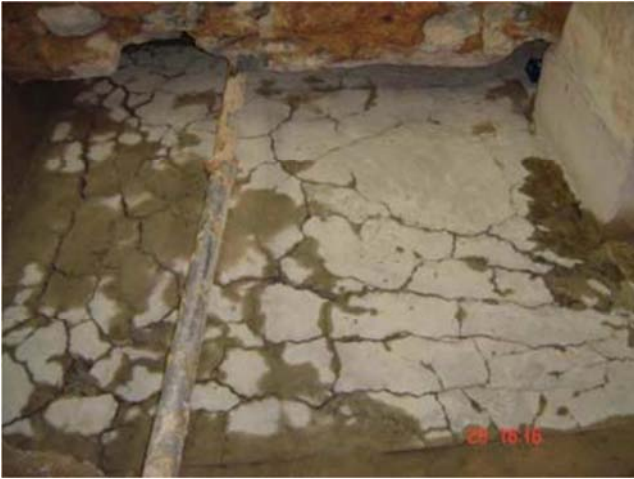
Figure 5. Block fissure with 18 stakes, with dimensions 8 x 6m [25].

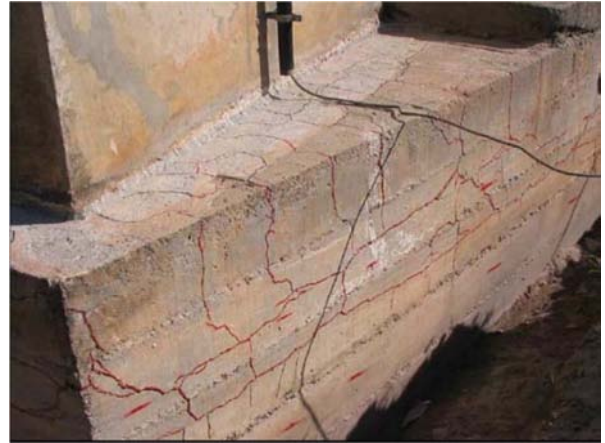
The foundation blocks presented a picture of cracks, with the largest blocks of the building (stakes 8 and 9), the blocks with more intense and variable cracks, while the secondary blocks (stake 1) were intact. Figures 5 and 6 show the cracks painted in color and the largest crack found in the work, respectively [25].

Considering the table presented and the analysis of the tests carried out, there is no doubt about the strong existence of AAR in the foundation blocks, being evidenced a high expansion in the blocks due to the favorable conditions to its development as the presence of reactive aggregate, alkalis and humidity.

Figure 6. Upper and lateral block faces with cracks painted [25].

With the confirmation of the occurrence of the AAR in the foundation blocks, the structural recovery actions were defined. The solution adopted was concentrated in two steps - the closing of the cracks and the intensification of the reinforcement. The closure of fissures and cracks with appropriate material had the main objective of protecting the blocks against the possible entry of deleterious product and humidity, factors that aggravate the alkali-aggregate reaction. The recovery of the blocks aimed at reconstituting the rigidity of the same and intensificate the reinforcement that combats the tensile stresses and in order to promote the sealing of the same ones with waterproofing material, to inhibit the continuation of the AAR process [25].

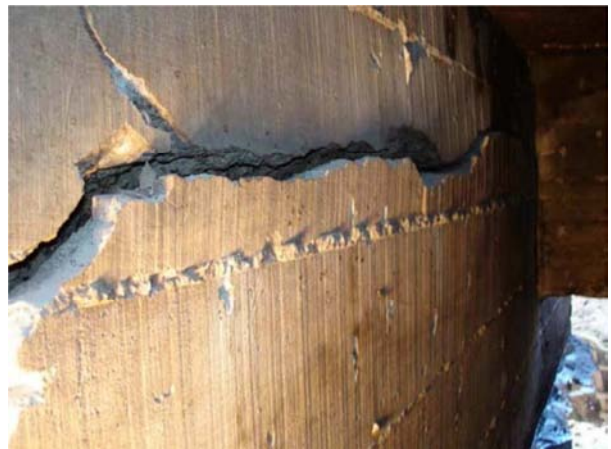
Figure 7. Horizontal crack with large opening and displacement [25].

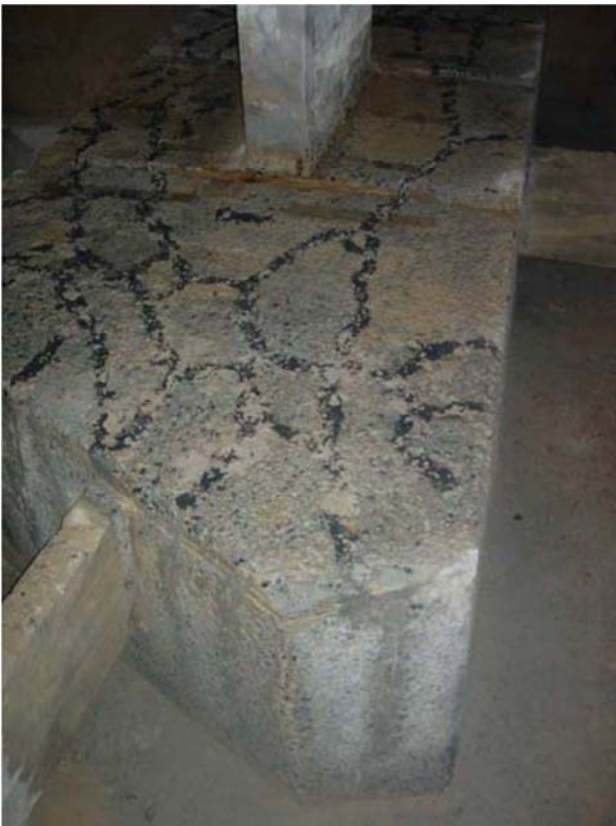
that in the year 1983, three years after its construction, the work had already presented fissures in some blocks, being reinforced the ones. However in 2008 it was found that some blocks which had not been reinforced in 1983, now presented many fissures in the lateral and upper faces, with similar aspect to those of several buildings in which the existence of AAR was already established in the metropolitan area of Recife. Figure 7 shows the cracks in the foundation block already filled with microcement [25].

Figure 8. Foundation block with cracks already filled [25].

Confirming the existence of AAR in the blocks and considering the advanced age of the building - 30 years, it was suggested that most of the expansion of the reaction had already occurred. Thus, it was recommended to solve the problem the filling of the fissure with microcement and subsequent encapsulation of the block with concrete layer in the lateral and upper faces, being recommended concrete with $f_{ck} \geq 40$ MPa with metakaolin addition, in order to inhibit the incidence of AAR in the new concrete.

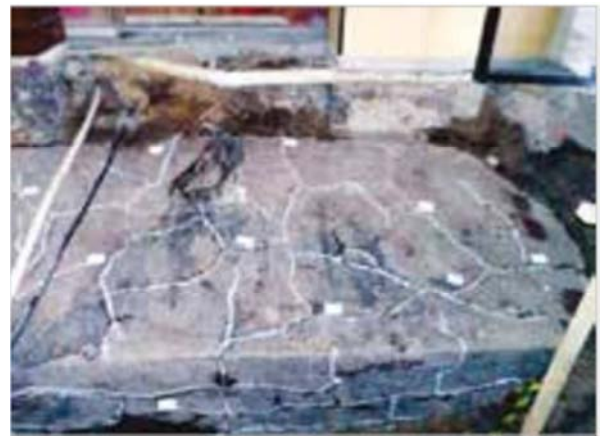
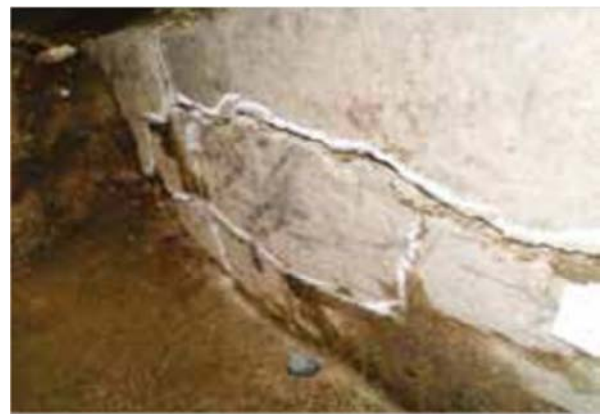
The construction of the building started in 1998 and ended in 2002. Fearful after the collapse of the Areia Branca building in 2004, the building's residents hired an inspection of the property in 2005, mainly due to the cracks found in the shoes. Although the appropriate tests for the diagnosis of the cracks had not been performed, the low shoes were recovered with the injection of rigid epoxy resin. In 2014, there was a new inspection to evaluate the state of the low shoes and it was verified that the ones inspected and recovered in the past have returned to many cracks and fissures (Figures 9 and 10). From this, the tests of resistance to compression of these shoes were made and, after studying the history of the foundation, the environmental factors and the characteristics of the building and in front of the realized tests, it was concluded that the foundation presented the picture of known pathological manifestation as an alkali-aggregate reaction [27].

Figure 9. Low shoes with cracks in maps marked with chalk [27].

The excavation was carried out around the shoes that were buried. After the faces of the shoes were excavated, the cleaning procedure was carried out with the washing of the structure, using a high pressure jet equipment for better visualization of the areas affected by cracks and fissures,

followed by the removal of specimens to verify in the laboratory if the fissure was caused by AAR. The next stage consisted in removing the epoxy from the previously received area, then performing the bore, blowing and cleaning procedures of the cracks and fissures, placing traps (a kind of plastic hose with a diameter of 10 mm) that were spaced apart approximately 250 mm apart and penetrated 90 mm (Figure 11) for injection and a micro-slurry. For cracks greater than 10 mm, it was preferable to use the grating. Already, for the surface clogging, which avoids the exit of the material inserted inside the structure, a mixture of epoxy and kaolin was used. Finally, it was chose the encapsulation for the structural reinforcement of the shoes, in order to restrict the expansion as much as possible, to have a good capacity to prevent the passage of water.

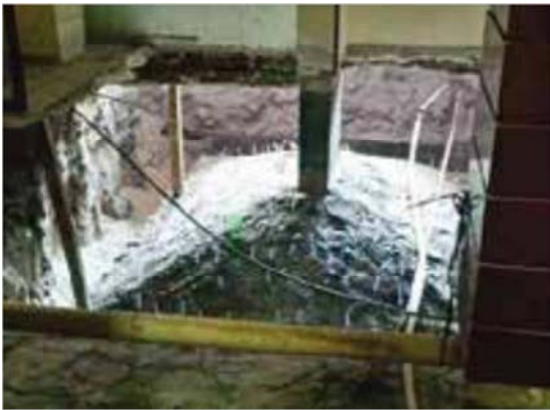
Figure 10. Low shoe bleeders [27].

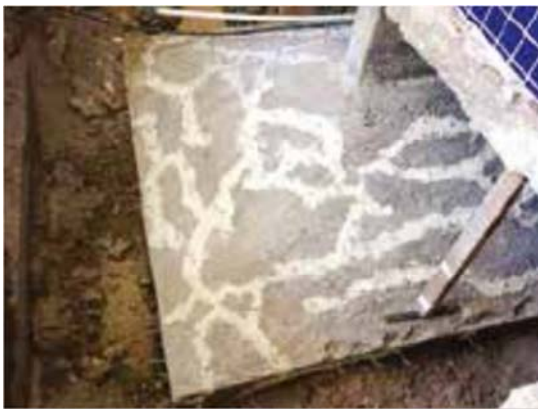
Figure 11. Cracks and fissures clogging [27].

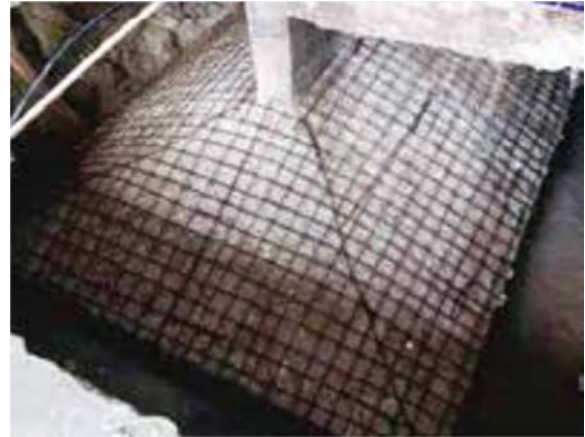
Figure 12. Steel mesh for shoe encapsulation [27].

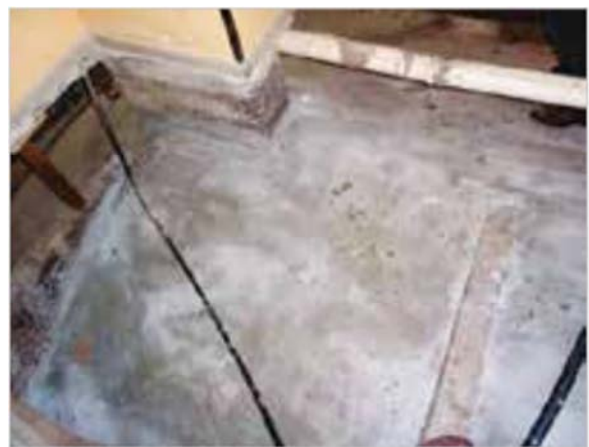
The recovery service was incomplete because, at the end of the shoe encapsulation, these were not waterproofed, which may facilitate the penetration of aggressive external agents and moisture. The method described in this work is the most widely used and known to the present moment for recovery of alkali-aggregate reaction, but it is not totally effective. The proof of this, is that some shoes that had already been recovered previously but, after a few years, returned to present the fissures [27].

Figure 13. Concreted shoe [27].
