# Analysis of the Power Plant Breakwater Failure Subjected to Typhoon Mangkhut Based on Model Experiment

**Abstract:** Growing social concern regarding the environmental and visual impacts associated with coastal structures due to climatic change is leading to a reduction in breakwater failures. After Typhoon Mangkhut passed through the southeastern coast of China on September 16 in 2018, the breakwater of a Power Plant was serious failure. As a case study based on model test, the failure process and causes of breakwater were explored in this paper. The wave height and water level were used as the wave parameters, which were accurately extracted by the GOHS system when the typhoon transits, and the breakwater failure process was reproduced based on the typhoon wave forces action at that time. By the experimental result investigating, it was found that the joint of the caisson breakwater and the mound breakwater was firstly failure, then the armor blocks and stones near the seawalls became to be unstable, the seawall was collapsed finally. Based on the analysis of the experiment, the distribution in time and space of the damage of the protective blocks are obtained and divided into

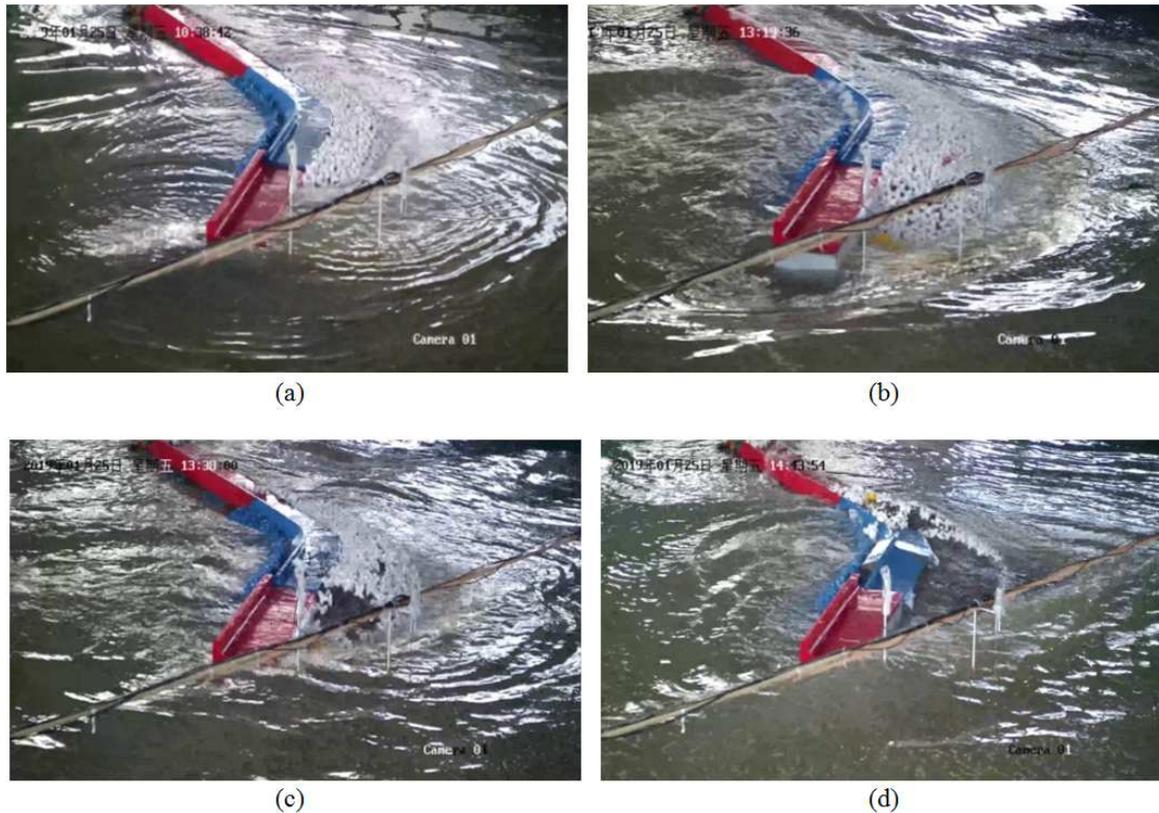
Figure 3. The test phenomenon of duplication test.

From 0:00 to 08:00, the breakwater remained stable at water levels from +2.31m to 2.61m, wave heights  $H_{13\%}$  from 4.02 m to 5.03m. (Figure 3(a)).

From 9:00 to 11:00, the 24t accropodes cover at the junction of the breakwater was began to be loose under the continuous action of the typhoon waves, which water level was +2.19m, wave height  $H_{13\%}$  was 5.91m (Figure 3(b)).

From 12:00 to 13:00, the gap width between the accropodes at the junction of the embankment was continued to increase under the influence of water level +2.13m wave height  $H_{13\%} = 6.91m$ , and the blocks were begun to unstable. During this period of continue wave action, the armor blocks were beginning to lose stability along the axis of the breast wall, and the core rocks under the armor were started to be scored and the failure area was increased (Figure 3(c)).

From 14:00 to 19:00, the armor blocks around the breast wall were continued to unstable, the connecting section of the breast wall was continued to collapse and core rocks were started underwashing, where the water level was +2.40m and  $H_{13\%}$  was 6.17m (Figure 3(d)).

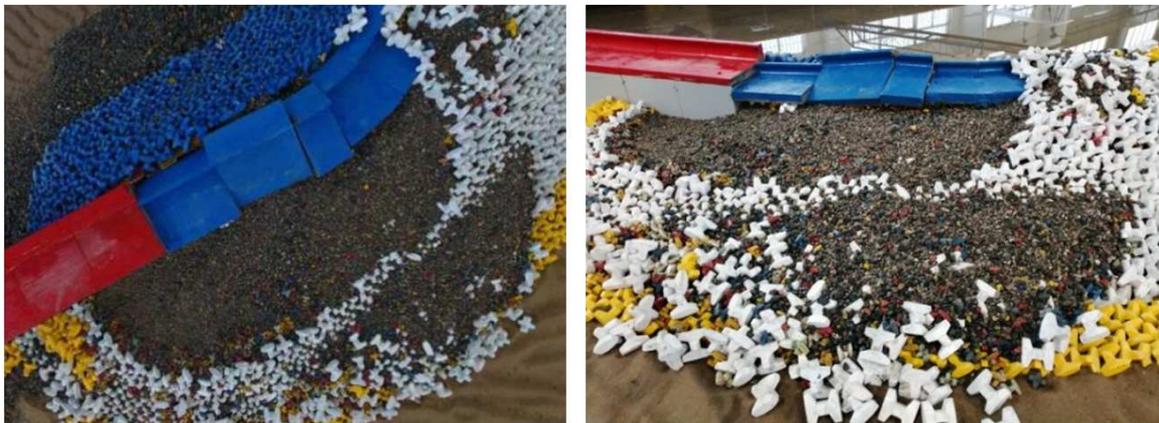
Figure 4. Failure layout of the breakwater.

Under the continuous action of subsequent water level and wave height, the damage of the armor blocks and the breast

wall were tended to steady state. After the experiment, the breakwater model was failure as shown in Figure 4:

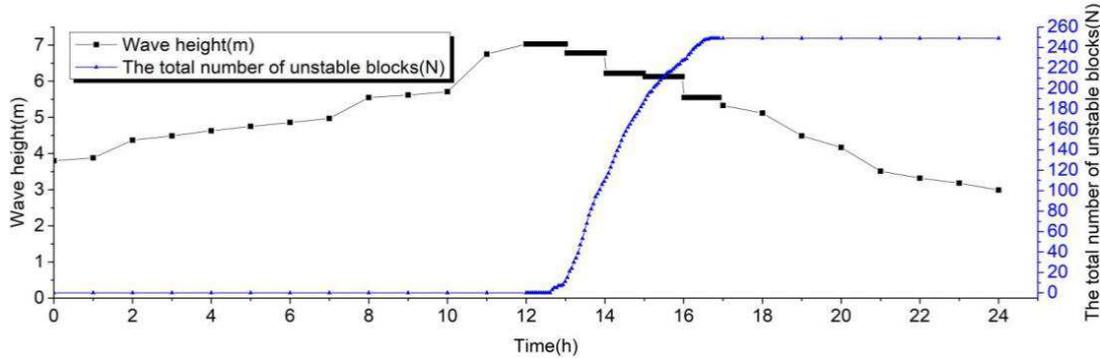
Figure 5. The variation of the wave height and the cumulative instability number of block during the test.

Figure 5 shows the variation curve of wave heights and the instability armor block number respect to action time. From

the figure, it can be clearly seen that the breakwater armor blocks remained stable until the maximum wave height coming, and the breakage time was concentrated between 12:00 to 17:00.

(1) From 12:30 to 13:45, the slope of the curve gradually increased, indicating that during this period the instability of the armor blocks were rapidly increased. The number of instability of the block at the same time interval was very different, and the destruction form was partial brittle failure. The brittle damage here means that a large number of armor

(2) From 13:45 to 16:00, the slope of the curve had a little change which indicated that the instability rate of the armor block was generally stable during this period. During the same time interval, the number of instability of the block was few different, and the damage form was ductile failure.

(3) After 16:00, the slope of the curve gradually becomes smaller and eventually becomes zero. At this time, the rate of increase in the number of instability of the shield block gradually decreases until the unstable block is no longer significantly increased, and the shield block is basically stable.

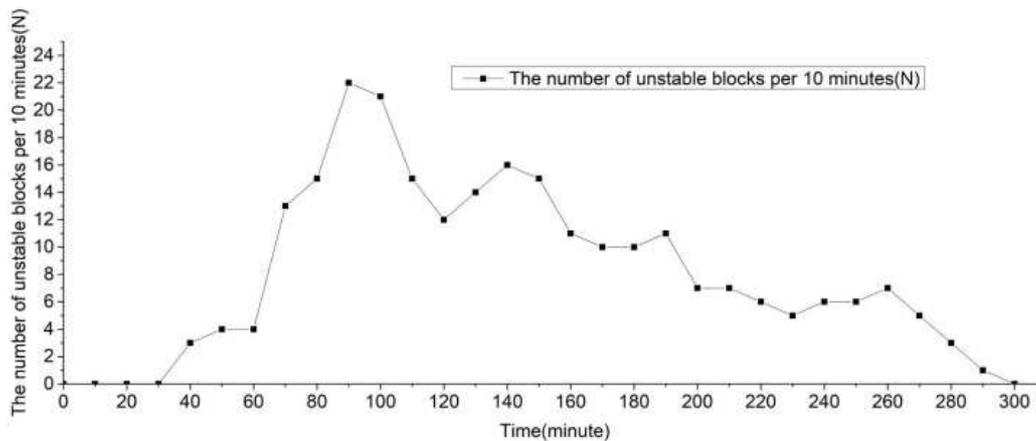
Figure 6. Number of block instability per 10 min during the destruction of the face.

(5) From 0 to 105 minute, the surface damage position was at the junction of the embankment head. During this period, the instability rate of the surface protection block sharply increased from 0 to a maximum of 22 blocks per 10 minutes, and the minimum was 3 blocks per 10 minutes, The damage speed of the armor surface changes significantly, so the junction of the head breakwater was a vulnerable area.

(6) In the period from 105min to 240min, the surface damage position is in area A near the breast wall. At this time, the surface protection block was mainly unstable due to the repeated climbing and falling effects of the wave cycle. The overall instability rate of the surface block was decrease. There are slight fluctuations in the period. The change in the damage speed of the surface is slightly eased, so area A near the wall is a sub-vulnerable area.

(7) In time from 240min to 300min, the surface damage position is in the area B. During this period, the rate of instability change of the surface block once again decreases to 0, so the B area near the wall is a non-vulnerable area.

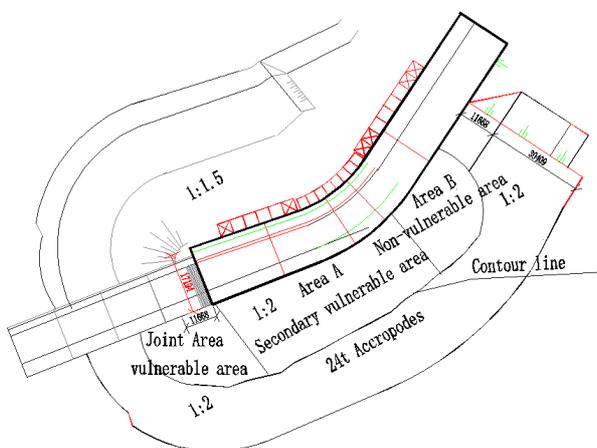
Figure 7. Distribution of destruction area division.

(4) Spatial distribution of slope breakage of breakwater was obtained. According to the experimental phenomenon, the surface protection block instability initially occurred at the junction of the head breakwater, and the next destruction position was developed along the axis of the breast wall toward the breakwater. Here, the damage rate of the surface is defined by the number of unstable blocks per 10 minutes and used as an evaluation index to determine the vulnerability of different positions of the slope breakwater. The damage rate of the surface is calculated from 12:00 to 17:00 (Figure 6). The surface damage location is divided into three areas: junction area at head breakwater, area A and area B as shown in Figure 7.

Based on the spatial distribution of the destruction of the breakwater surface, it can be judged that the protection surface at the junction of the head breakwater is not only the first destruction area but also at the maximum speed of destruction, which belongs to the vulnerable area. The destruction order of area A near the breast wall is only at the junction of the embankment head, and the damage speed of the shield gradually decreases, belonging to the sub-vulnerable area. In the area B near the wall, the destruction speed continued to decrease to 0, belonging to non-vulnerable areas.
