Influence of Manufacturing Processes in Deterioration of Ag-Cu Artefact Alloy

Abstract: Ancient silver with about 2% copper object is studied to determine manufacturing defects based on chemical and microscopic investigations. In this paper Bullion (silver-copper alloy) ink box inlays with enamel from the Museum of the faculty of applied arts in Cairo, Egypt has been investigated to identify manufacturing process and its effect on the ink deterioration. Scanning Electron Microscopy coupled with Energy Dispersive X-ray Spectrometry (SEM-EDS) method has been used on samples to reveal chemical composition of the alloys and the effect of various fabrication and thermal treatment. The results indicated that all samples were made of silver-copper alloys, other elemental corrosion layers have detected in contents such as C, O, S, Cl, Si, Na, Ca, Al. Fracture surfaces provide with important information helping to recognize failure causes, so the fracture surface investigation and etching by means of alcoholic ferric chloride was carried out for microstructural analysis. Scanning Electron Microscopy SEM-micrograph of etching sample showed pores and cracking propagation. Crack initiation us

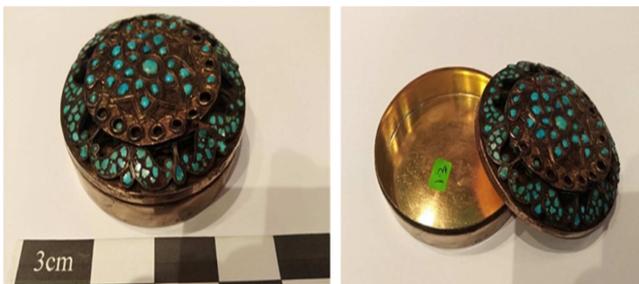
The ink box is made from two parts Figure 1, the upper part is an ink box cover and the lower part is a box body. The ink box cover has been built up from sheet components brazed together to form outer and inner jackets, the outer sheet engraved with decorative channels or chased and inlaid with enamel. The lower part (box body) is made by casting.

Figure 1. The ink box made from two parts and inlays with enamel.

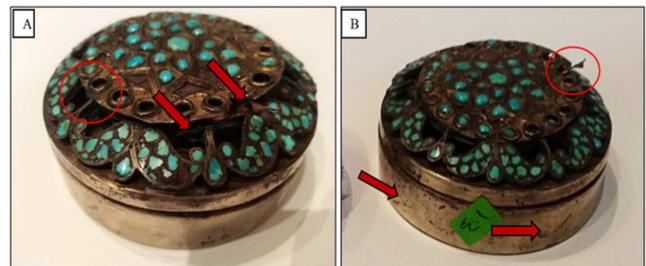
Investigation of ink box revealed that the object consists of two parts which are the ink box cover and the box body, the ink box cover appeared missing parts in inlay layers with different coloured of corrosion products, cracks, and distortion the surface or warp which built up by cold-working. The body box revealed many blowholes and shrinkage Figure 2. The body box is made by hot-working or simplest mold. This technology is like sand casting [6].

Figure 2. (2A) ink cover shows missing parts in inlay, corrosion products, cracks and distortion the surface or warps (2B) the body box shows blowholes and shrinkage.

Visual examination of silver copper ink box showed that the box made of two separate parts, the cover which made by cold-working and body box made by cast. The cover had layers of corrosion, miss in inlay layers, cracks, and distortion the surface or warp. The body box had blowholes and shrinkage in outer surface.

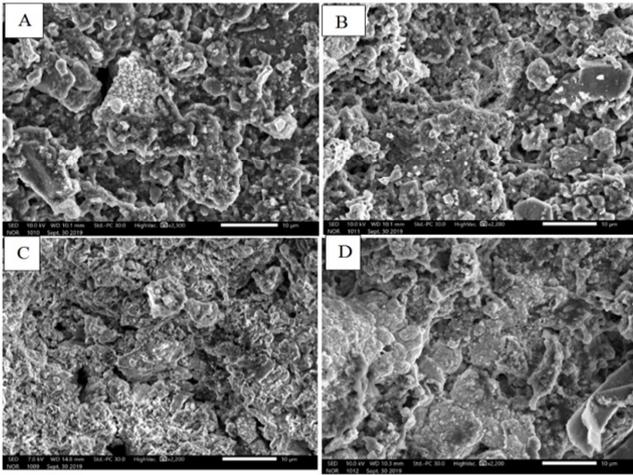
SEM micrographs of fracture surface showed the presence of corrosion layers with different grain size, Figure 3 intergranular cracking and regions of ductile fracture and brittle. EDX Figure 4 and tables 1 and 2 determined chemical composition of the ink box alloy from 15.4% silver Ag, 2.1% copper Cu, 2.5% Zn and the elemental corrosion layers from C, O, S, Cl, Si, Na, Ca, Al.

Figure 3. SEM micrograph showed fracture surface for interfacial cracking (a, b) corrosion layers with different grain size, (c) intergranular cracking and regions of ductile fracture, (d) brittle intergranular fracture.

Examination by SEM micrograph revealed embrittlement in corrosion layers. The corrosion layers showed intergranular cracking and regions of ductile fracture. SEM micrograph reveal the object has undergone extensive plastic deformation, resulting in strain-hardening. SEM micrographs for etching sample showed pores and crack propagation.

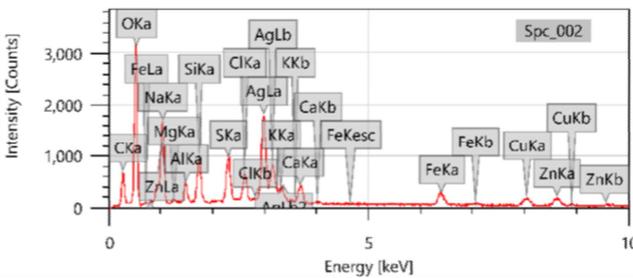
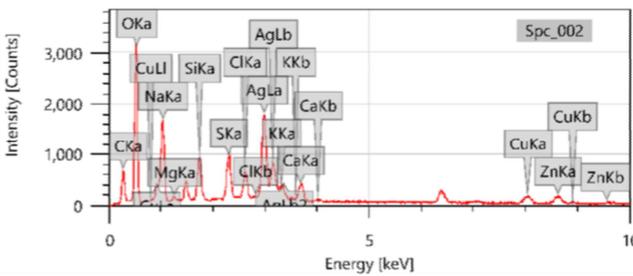
Figure 4. EDX of samples show the alloy consists of silver and copper and elemental corrosion layers from C, O, S, Cl, Si, Na, Ca, and Al.

The EDX analysis reveals that the object is made of silver Ag that contains Cu and Zn. Elements such as C, O, Cl, S, Al, Si, Na, K, Ca, Fe observed at the corrosion layer of the object.

The occurrence in the sample of elements such as Si, Al, Fe, S and Cl (plus oxygen in most of the cases) in the corrosion layers of the object can be indicated to likely superficial long-term contamination and oxidation, which led to the formation of secondary corrosion products.

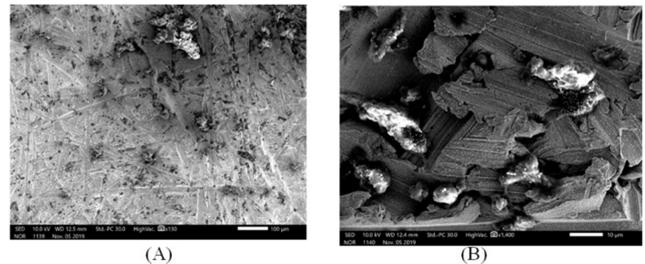
SEM micrographs of polishing surface sample and etching by alcoholic ferric chloride are showed crack propagation and pores Figure (5A) and cleavage fracture Figure (5B).

Figure 5. SEM micrograph after etching revealed fatigue fracture surface (A) pores and crack propagation, (B) cleavage fracture.

SEM observation after etching revealed the cover of the box undergone extensive plastic deformation, resulting in strain-hardening and propagation of cracks. plastic deformation relates to the net movement of large numbers of atoms in response to an applied stress. During this process, interatomic bonds must be broken and then reformed. In crystalline solids, plastic deformation most often includes the motion of dislocations, linear crystalline defects [13].

Pores in metals and alloys are as microcavities mostly a consequence of material shrinkage through the casting and solidification process and can be basically reflected as existing microcracks. pores developed in the phase distribution in two or multiphase materials, where cracks typically originate during dendritic solidification.

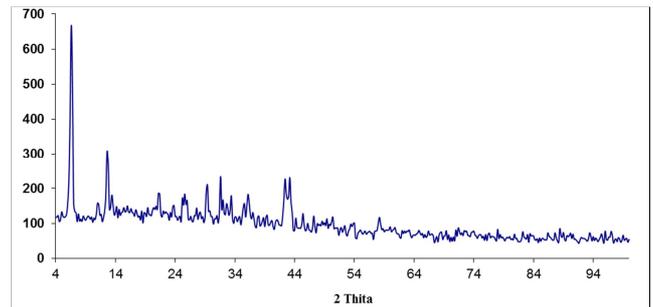
X-Ray diffraction analysis Figure 6 and table 3 revealed the corrosion layers consisted of Montmorillonite as a major mineral, Atacamite, Malachite as minor minerals; and Paratacamite, Cuprite, Acanthite, Tenorite, Calcite, Chlorargyrite, Copper as traces minerals.

Figure 6. X-Ray diffraction analysis showed corrosion layers consisted of Montmorillonite as a major mineral, Atacamite, Malachite as minor minerals; and Paratacamite, Cuprite, Acanthite, Tenorite, Calcite, Chlorargyrite, Copper as traces minerals.

The XRD analysis confirmed the EDX analysis that the corrosion compounds consist of Montmorillonite $\text{NaO}_3(\text{Al, Mg})_2\text{Si}_4\text{O}_{10}(\text{OH})_2 \times \text{H}_2\text{O}$, Atacamite $\text{Cu}_2\text{Cl}(\text{OH})_3$, Malachite $\text{Cu}_2\text{CO}_3(\text{OH})_2$, Paratacamite $\text{Cu}_2\text{Cl}(\text{OH})_3$, Cuprite Cu_2O , Acanthite Ag_2S , Tenorite CuO , Calcite CaCO_3 , Chlorargyrite AgCl , Copper Cu .
