Failure Analysis Report on Fractured Torsion Bar in Suspension of a Vehicle

Nan Nan, Jijun Feng. Failure Analysis Report on Fractured Torsion Bar in Suspension of a Vehicle. *International Journal of Materials Science and Applications*. Vol. 11, No. 2, 2022, pp. 55-61. doi: 10.11648/j.ijmsa.20221102.13

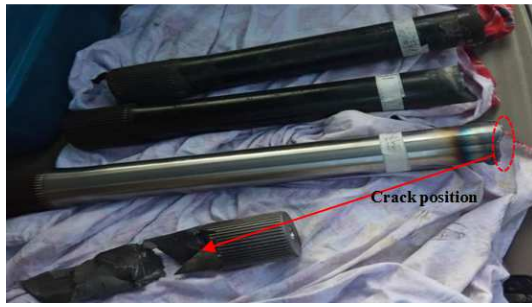
$\sim 10^5$ cycles of cyclic torsion, and cracking of the torsion bar was diagnosed as the main cause after a disassembling inspection. The crack origin is located at the spline on the small end of the torsion bar, as illustrated in Figure 2 (indicated by a red arrow), and all cases have identical fracture modes, which implies that there must be an inherent commonality. This paper presents the techniques and procedures that were used to diagnose the cause of failure.

Figure 2. Crack position on torsion bar spline.

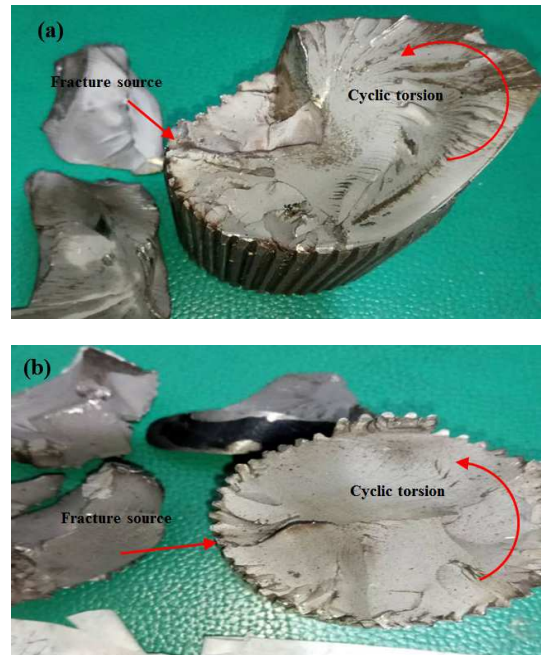
There are secondary cracks near the main crack initiation excluding the part that has already cracked, and these cracks have an irregular pattern. The main crack is disassembled for further information on the failed surface. The fracture morphologies of S1 and S2 are shown in Figure 3. The main fractures of S1 and S2 initiated from the place marked by the red arrow in Figures 3a and 3b. The fracture sources and adjacent areas appear to be quite brittle. The fracture

initiation site is on the spline part, which is approximately 10 mm from the joint place between spline tail and shaft, as observed from the side view.

Figure 3. Morphology of main fractures of samples, (a) S1, (b) S2.

The fracture of S1 appears to be very informative, as shown in Figure 3a. The fracture of S1 exhibits a ratchet pattern and a 45° inclination, which is easily identified as a torsional fatigue fracture that failed under alternating torsional stress, since a ratchet pattern is a typical feature of torsional fatigue fracture [6, 7]. This is a mixed fracture, and the stair-step phenomenon is generally explained by the combined effect of maximum direct stress and shear stress. Some distributed secondary cracks are also found, which extended into the internal part of the fracture of S1. S2 has a similar fracture morphology to S1: S2 exhibits the ratchet feature, but it has a less obvious 45° inclination, as shown in Figure 3b, which is still proven to be torsional fatigue fracture.

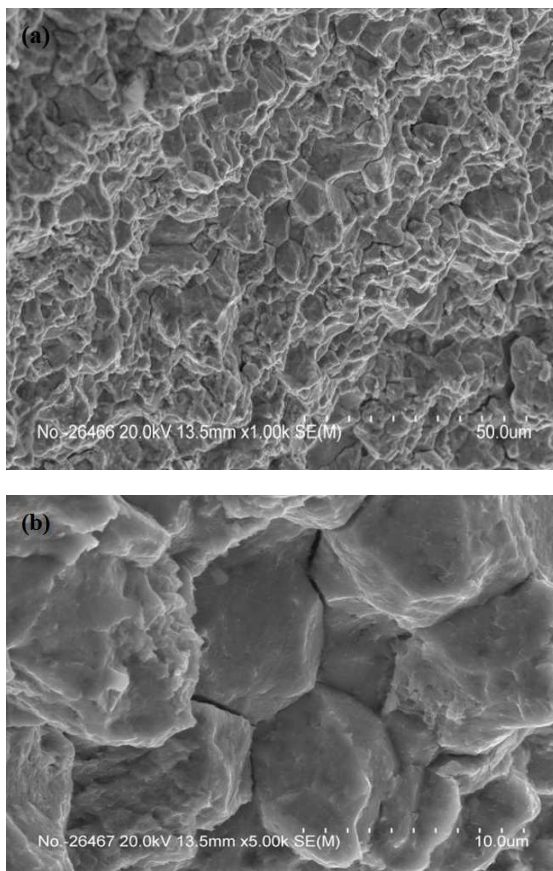
The SEM image of the fracture source region of S1 is shown in Figure 4. Characteristics of grinding and rough marks are shown in Figure 4a. A large proportion of intergranular areas was also noticed in this region which indicates that this area is very brittle. However, such brittleness is usually considered a deficiency for torsion bars, which implies mechanical degradation. Instead, a dimple feature of the area is desirable. As shown in Figure 4b, the grain boundary surfaces are clear and clean and no microscopic features, such as cross feet or obviously distributed micro holes, were found on these surfaces; thus, the possibility of hydrogen embrittlement and harmful precipitates at the grain boundary (temper brittleness) should be excluded. Fatigue fracture usually exhibits transgranular features, and fatigue striations can be found in many cases. However, intergranular fracture can form on fatigue fractures as if it is a complete static-load fracture for high-strength steels if the tensile stress is very high or the material is brittle [12, 13]. In other words, S1 is only a particular case, since its macroscopic fracture exhibits the fatigue feature as mentioned in the macroscopic observation part, and the failure life of S1 is close to that of S2 after mileage conversion. The area of the fatigue expansion zone is quite small that it only covers a distance of approximately 10 mm to the surface, which indicates a high stress condition.

Figure 4. SEM images of fracture source region of S1: (a) Low magnification (b) High magnification of intergranular area.

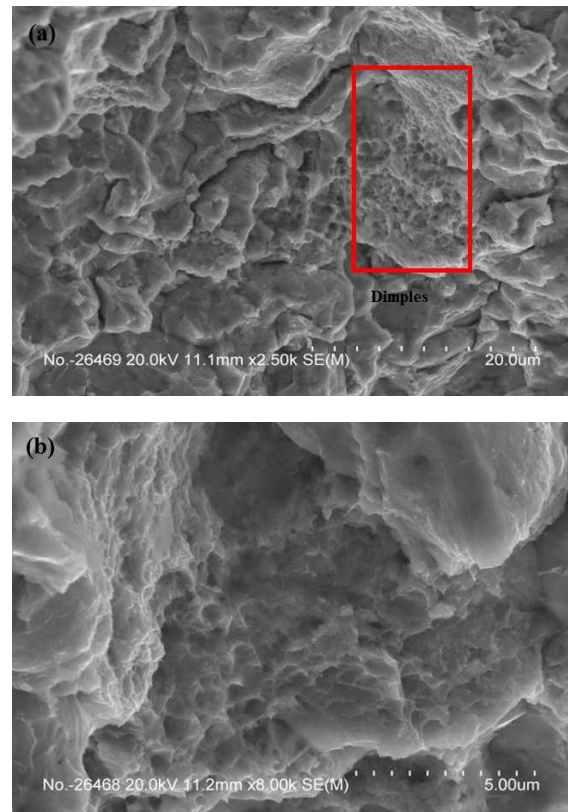
In regions relatively far away from the fatigue expansion zone (approximately 20 mm to the crack initiation point), the fracture begins to exhibit mixed features of the intergranular section and very small areas of dimples (Figure 5). Despite the ductile property of dimples, the brittle fracture still dominates, which strongly proves the inhomogeneity of the microstructure caused by inadequate tempering, since the torsion bar experiences an integral heat treatment.

Figure 5. Mixed fracture of intergranular section and dimples away from fatigue propagation area on S1: (a) Low magnification (b) High magnification of dimples.

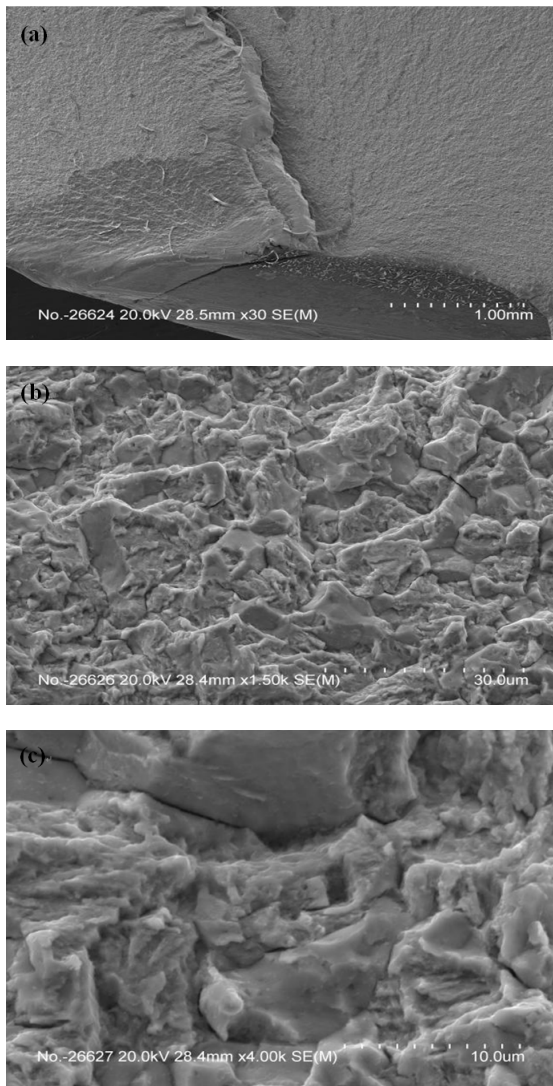
S2 is our referencing control sample from the fatigue test, the fracture source of S2 is shown in Figure 6a. The crack of S2 initiated from the same place as S1 (Figure 6a) with a few secondary cracks. More detailed information can be obtained from Figures 6b and 6c. The intergranular section is also a main part in the crack initiation area, as shown in Figure 6b, which reveals the brittleness of the main fracture. The grain boundary is clean in the intergranular zone, and no features of hydrogen embrittlement and harmful precipitates were found. In the magnified picture (Figure 6c), fatigue features clearly appear, which imply a fatigue fracture. The fatigue expansion zone is a semicircle area with a radius of approximately 10 mm.

Figure 6. SEM images of Fracture source region of S2: (a) Position of fracture source, (b) Low magnification of fracture source. (c) High magnification of fracture source.

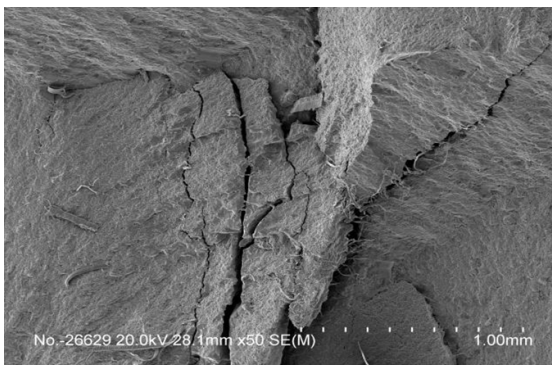
Figure 7 shows the region near the fatigue propagation zone, which cracked in a crisscross pattern with some parts cracked into pieces. This situation unquestionably shows that the part was working under complex and high three-dimensional stresses.

Figure 7. The region with crisscross cracks near fatigue expansion zone of S2.

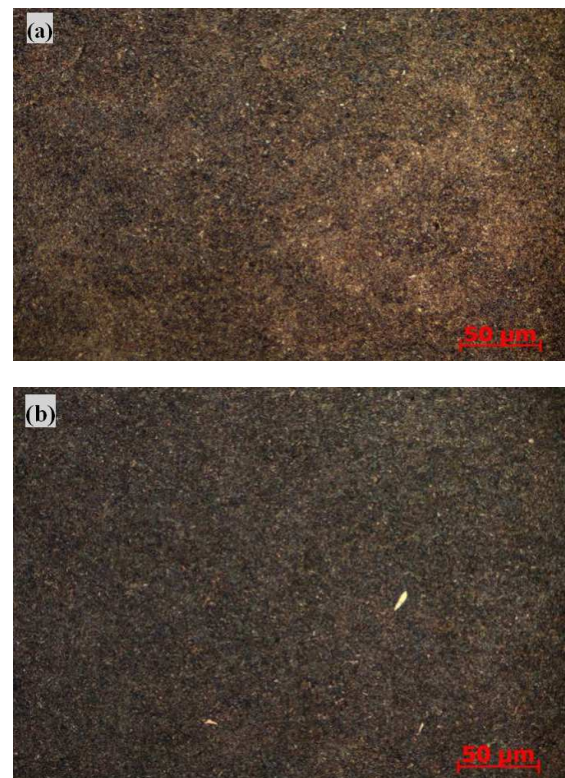
Samples S1 and S2 were made into metallographic specimens and treated by 4% NITAL to investigate the structure. The microstructures of all samples are tempered troostite, which is considered the required structure of spring steels [16]. The metallographic structures of S1 and S2 are shown in Figure 8. No structure defects such as inclusions and decarburization were detected.

Figure 8. Metallographic structures of S1 and S2: (a) Structure of S1, (b) Structure of S2.

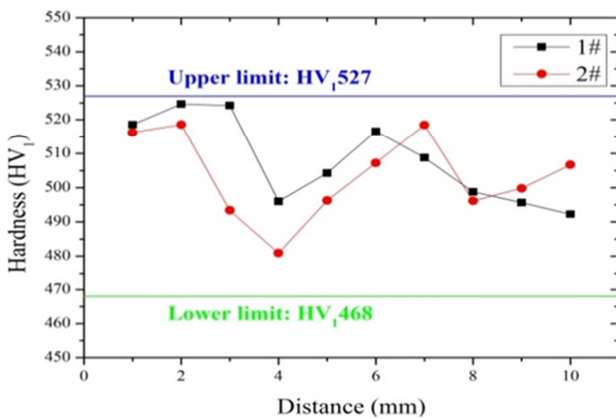
measuring result (Figure 9) shows that the hardness of S1 ranges from HV₁496.03 to HV₁524.26 within the measuring distance and that of S2 varies from HV₁480.90 to HV₁518.57. The dramatic oscillation of hardness value is another evidence of inhomogeneous microstructures which might cause residual stress [17]. Furthermore, the hardness values of the near-surface region are very close to the upper limit, which proves again the insufficient tempering after the quenching process (refer to Figure 1). Apparently, the hardness result confirms the previous conclusion in 3.2. If there is high residual stress caused by insufficient tempering, which causes unexpected brittleness, once the fatigue core is formed, the fatigue crack will rapidly propagate if there is a lack of deformation compatibility [18, 19].

Figure 9. Hardness values of fatigue expansion zone.

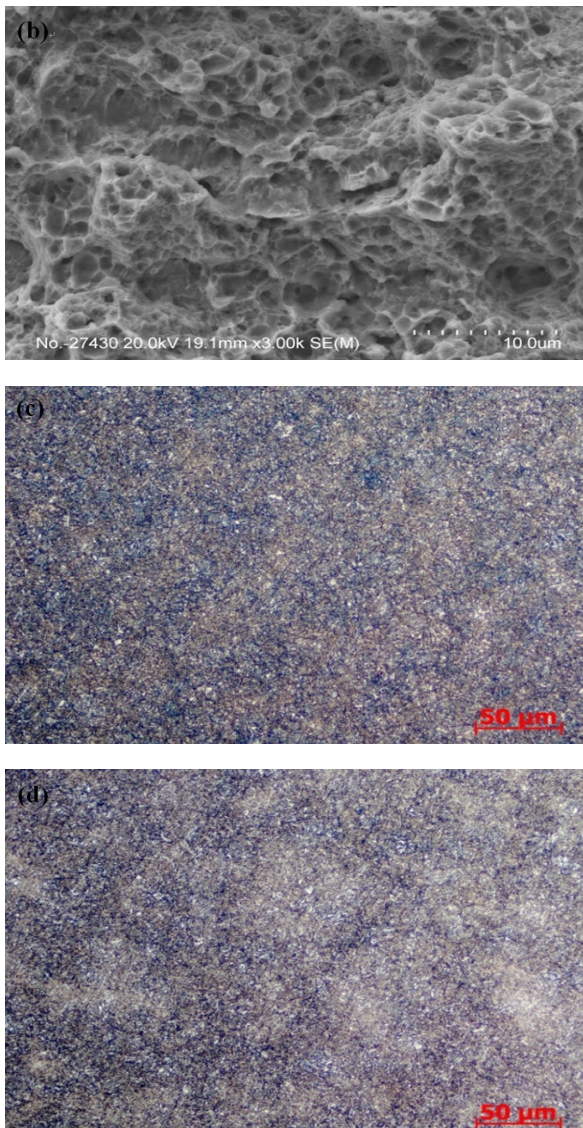
The tempering simulation experiment was performed on the spline coupons of S1 and S2; then, a hammer was used to make their artificial struck-fractures under normal stress, and an SEM analysis was performed to check the fracture property. A metallographic specimen of the retempered part was also prepared to check the metallographic structure. The results are shown in Figure 11. The brittle feature of the spline root area totally disappeared, since the artificial fractures of S1 and S2 are 100% large dimple ones as shown in Figures 11(a)-(b) instead of intergranular-dominant fractures. Furthermore, as shown in Figures 11(c)-(d), the microstructures of S1 and S2 after the tempering simulation experiment are still tempered troostite, which implies that our tempering simulation experiment did not induce a fundamental change in type of metallographic structure.

Figure 11. SEM images of artificial-struck fractures and metallographic structure of spline part of S1 and S2 after tempering simulation experiment: (a) SEM image of struck fracture of S1, (b) SEM image of struck fracture of S2, (c) Metallographic structure of S1, (d) Metallographic structure of S2.

The prevention of such problems depends on sufficient tempering to uniform the structure and eliminate large residual stress. From the view of this investigation, extending tempering time is recommended as an option to solve this problem.

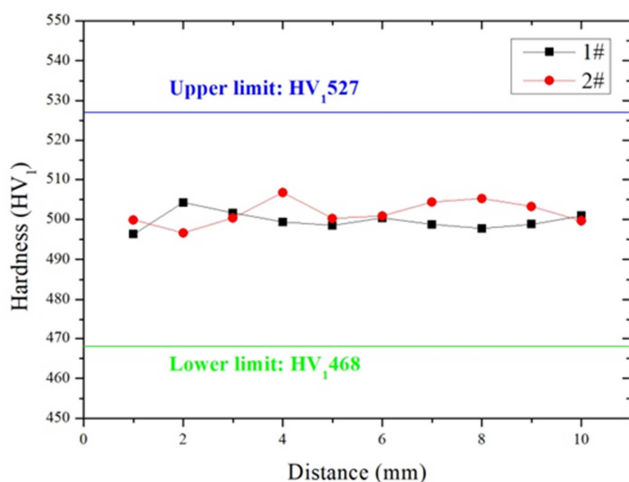
The next procedure was to investigate the hardness of the tempered sample. A spline root area within 10 mm to the surface on each sample was selected to measure the hardness values of S1 and S2. The results are illustrated in Figure 12. The brittleness-ductility transition appears to have been achieved at a small sacrifice of hardness. However, the hardness values were controlled in more reasonable range, and the hardness curves tend to become more uniform, which implies that proper and sufficient tempering time could eliminate the harmful brittleness and structure inhomogeneity of the spline root area.

Figure 12. Hardness values of spline root area on S1 and S2 after tempering simulation experiment.
