Supervisor-Field Engineering Approach (S-FEA) of Determining Tyre Failures in the Haul Trucks at Newmont Ahafo Mine

Department of Mining Engineering, University of Mines and Technology, Tarkwa, Ghana

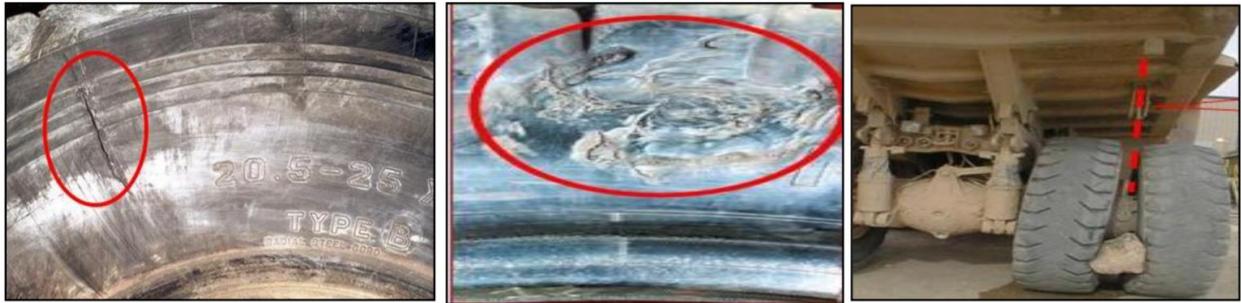
Figure 6. Haul Truck Tyre Sidewall Cut.

extreme forces and pressures often experienced while driving. This helps to keep the haul truck stable. Though the tyre sidewalls are built to be strong, they can be damaged in several ways, as shown in Figure 6. A literature review was done to identify the major causes of Tyre sidewall cut/damage, which apply to NAM, Ghana. These are: Hitting a kerb (HK); Sharp objects in the work area (SWA); Rocks caught between the dual wheels (RDW); Operator negligence (ON); Under inflation or overloading (UO) and Poor underfoot conditions or water (PUC). Field observations were undertaken from 2010 to 2020 in the Subika and Awonsu pits to identify the most frequent cause of the haul truck tyre’s sidewall cut/damage. A total of 42 haul truck tyre sidewall cuts/damage was recorded over the 12 months of study, and the breakdown of the result is present in Figure 7. The field study showed that among the causes of tyre sidewall cut/damage at NAM, paramount among them are poor underfoot conditions or water; sharp objects in the work

area, hitting a kerb and operators' negligence.

- 1) Sidewall cut.

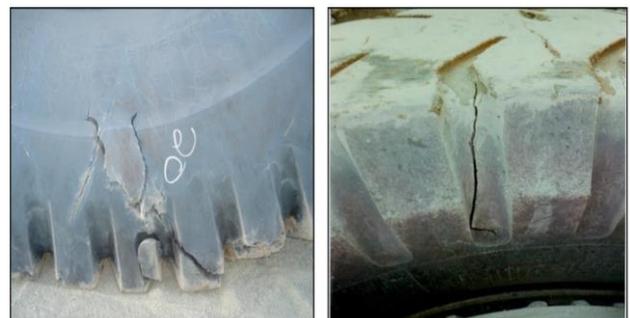
Figure 8. Haul Truck Tyre Shoulder Cut.

In interviews with field workers, supervisors and superintendents from the mine operation and tyre maintenance departments, the following were identified as contributing factors: Spillage and foreign objects; Course material on the berm/windrow; Poor pit conditions; and aggravated by water. Following the identified causes of shoulder cuts, a field study was conducted in the Subika and Awonsu pits of NAM, Ghana. The data collected recorded 8 cases over the period of 12 months. The breakdown is presented in Figure 9. It was clear that the major causes of premature tyre failure by shoulder cut are aggravations by water and poor pit conditions. Figure 8 below shows a cut in the shoulder area but no casing damage.

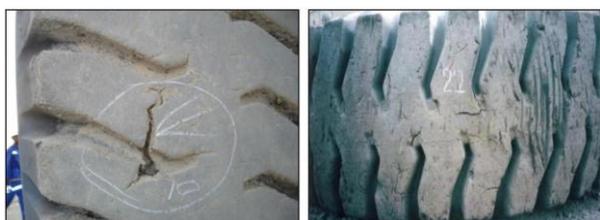
Figure 10. Tread Cut.

A typical example of a cut in the tread crown but not penetrating the casing is presented in Figure 10. The causative factors of the tread cut include Improper inflation or underfoot conditions (IUC); Aggravated by water (AW); Sharp objects in the work area (SWA); and spinning, skidding or sliding (SSS). The number of cases recorded for the factors that cause tread cut was taken and analysed in Figure 11.

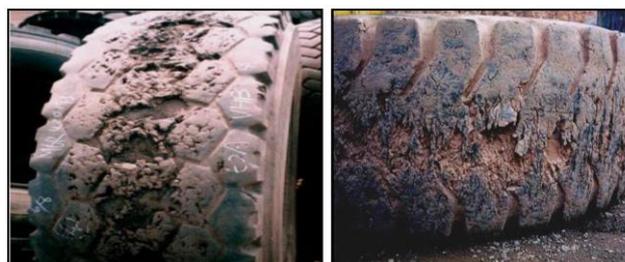
Figure 12. Haul Truck Tyre Tread Chunking.

Chunking refers to the phenomenon of missing tyre tread sections, as depicted in Figure 12. It appears the tread has been removed in pieces or ripped away from arbitrary locations on the tyre. In interviews with relevant workforces, contributing factors revealed the following: Improper infla-

tion (II); Underfoot conditions (UC); Excessive speeding (ES); Aggressive braking (AB); Overloading (OL); Mismatched diameters on dual tyre machines (MD); and spinning, skidding or high torque (SSH). Data collected over a period of 12 months, from January 2020 to December 2020, on Haul truck tyre premature failure resulting from tread chunking has been analysed and presented in Figure 13.

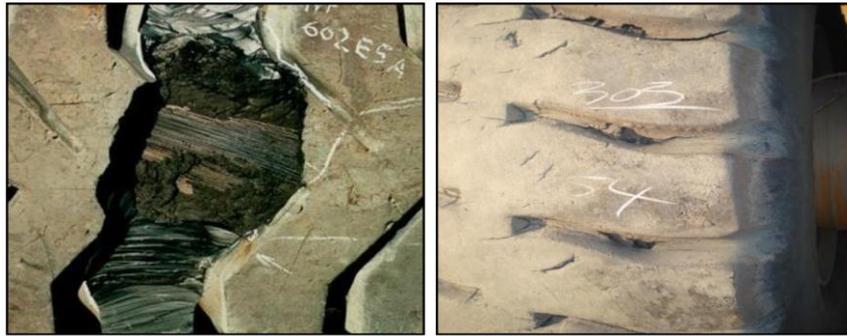
Figure 14. Haul Truck Tyre Separation.

Tyre tread separation is a dangerous condition wherein the tyre’s tread separates itself from the casing or body of the tyre. Thus, it is the deformation of the tread area due to the tread band separating from the casing ply, as shown in Figure 14. The contributing factors are excessive heat generation (EHG), exceeding the TKPH for the tyres (ETT), excessive cornering (EC), incorrect inflation or speed (IIS), and overloading (OL). Having identified the major causes of the haul truck tyre failure by separation, fieldwork was done over 12 months – January 2020 to December 2020, to obtain data regarding the most applicable causes of tyre separation at NAM, Ghana. The result obtained has been summarised in Figure 15.

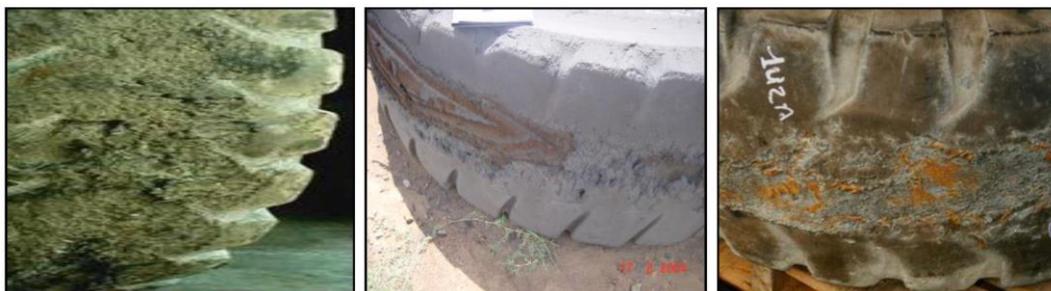
Figure 16. Tyre Worn Out.

Tyre wear results from on or beyond the bottom of the tread grooves. Small bars of rubber running across the grooves in between the tread – called tread wear indicators –

point out that the tyre is worn out. If the tread is worn down to these bars on any part of the tyre, it's worn out, unroad-worthy, and needs to be replaced. An example of tyre worn is presented in [Figure 16](#).

According to the tyre damage report acquired from the maintenance department, factors contributing to the wear of haul truck tyres include i) improper inflation or overloading, ii) unfavourable operating conditions such as water or undulations, iii) defects in repairs, iv) repairs conducted outside recommended specifications, v) subpar workmanship, and vi)

secondary damage caused by the repair process. A field study on the causes of haul truck tyres worn out at NAM, Ghana, was carried out by recording the various factors that contributed to tyre worn out from January 2020 to December 2020. The result is presented in [Figure 17](#).

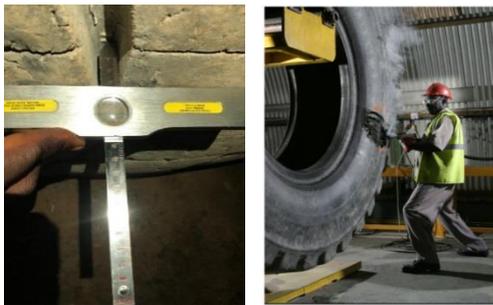
Figure 21. Haul Truck Tyre Being Repaired at NAM Site.

Repairing rubber tyres from Caterpillar haul truck mining vehicle in maintenance workshop to maximise tyre life. Prematurely failed haul truck tyres that are not spoilt repairs are sent to the Mine's maintenance workshop to be repaired and reused. A pneumatic wire brush is used to clean up the damage from the inside of the tyre before repair, as shown in [Figure 21](#). At NAM, the commonly used method for repairing haul truck tyres is the internal patch method. The tyre is checked to identify the damaged location, the damaged area is then planished, and glue is applied around the hole. A special rubber patch is attached to the damaged area and pressed firmly. After that, a layer of protective glue is smeared in the area and allowed to dry. The tyres are then stored for reuse. Repairing old tyres helps maximise tyre life during supply shortages and decreases operational costs. However, the disadvantage of this method is that the damaged parts are easily corroded by rainwater and other pollutants.

ating natural degradation due to exposure to oxygen, ozone, and sunlight. Furthermore, the study recommended replacing the internal patch method used for repairing old tyres with a more reliable repair method.
