# Key Technologies for Cutterhead Repair of Large-Diameter Slurry Balance Shield Under Atmospheric Pressure Access

This paper draws upon the large-diameter shield project on the left line of the Zhijiang Road Water Conveyance Pipe Gallery and Road Improvement Project in Hangzhou to systematically investigate the construction technology for cutterhead repair under atmospheric pressure access in hard rock strata. The study elucidates key aspects including stratum suitability, access conditions, chamber support, cutterhead repair processes, quality inspection, and safety control measures, thereby establishing a replicable and transferable technology package [4, 11].

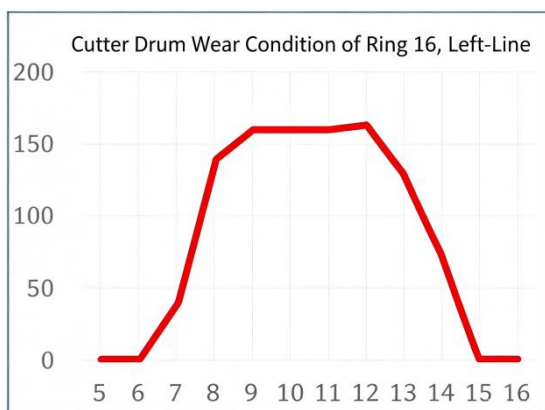
After 39.7 m of tunneling, the shield was stopped for inspection, revealing typical hard rock abrasion damage characteristics on the cutterhead. As illustrated in Figure 3, cutter housings No. 5 through No. 16 exhibited widespread wear, with a maximum wear depth of 163 mm. Six cutter housings experienced seal failure, and the cutter box protection rings exhibited a maximum wear depth of 120 mm, with wear extending to the seal mating surface at several locations. As shown in Figure 4, the central region of the cutterhead panel exhibited a maximum wear depth of 43 mm, with the wear pattern diminishing progressively from the center toward the periphery. Additionally, three central flushing ports and the wear detection pipelines all sustained abrasive damage. The temperature in the central region of the cutterhead reached up to 80 °C, indicating a significant risk of overheating-related wear.

Figure 3. Tool wear inspection of the 16th ring on the left line.

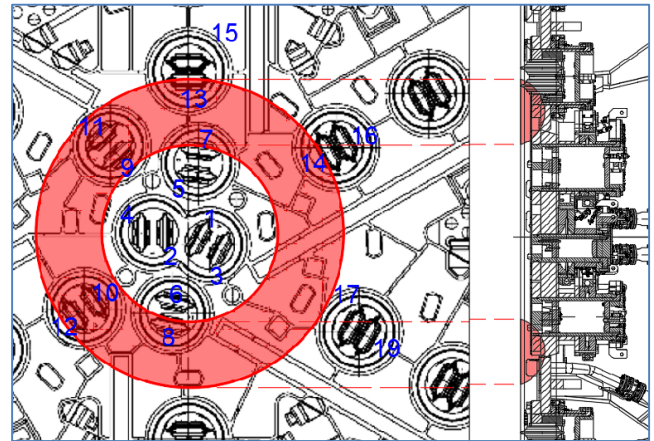
Figure 4. Cutterhead and panel wear of the 16th ring on the left line.

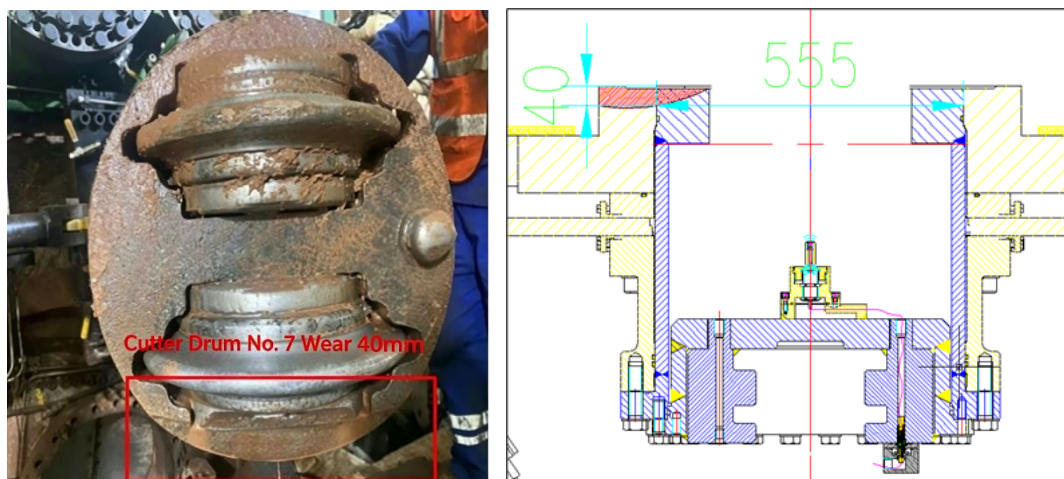
① Wear condition (cutter box seal not worn): The cutter box protection ring exhibited a maximum wear depth of 40 mm, with the worn region extending approximately 80 mm in length, as shown in [Figure 5](#).

**Figure 5.** Tool wear of No. 5-7.

② Repair scheme: 1) The irregular worn areas of the cutter box protection ring were ground smooth and bright using an angle grinder. 2) Given the relatively minor wear on cutter boxes No. 5–7 and No. 14–16, overlay welding was applied to the ground wear regions using the cutter housing as the positioning reference. 3) After completion of buildup welding on the cutter housing protection ring, the inner bore of the cutter box protection ring was ground to a tolerance of  $\pm 0.3$  mm. A pressure holding test was conducted upon completion of the cutter box repair.

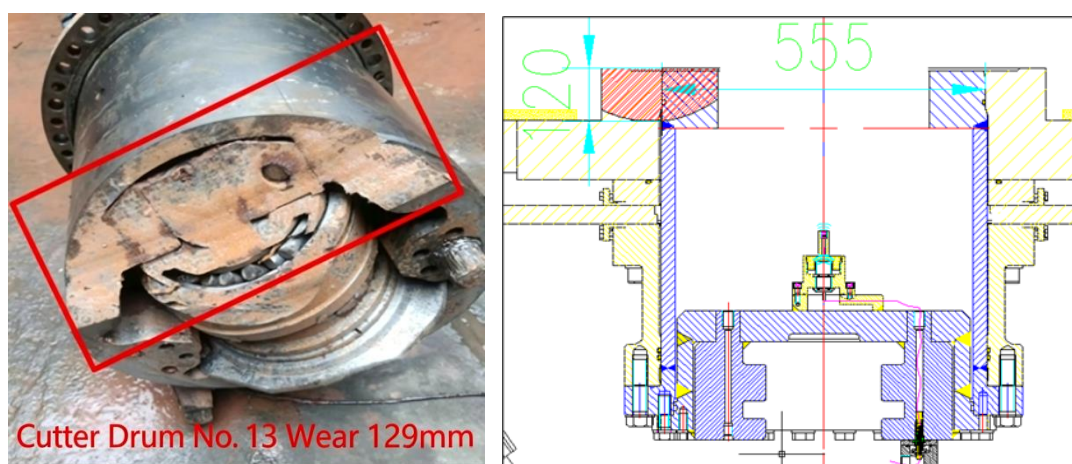
① Wear condition (cutter box seal worn; panel not worn): Cutter boxes No. 6–8: Maximum cutter housing wear of 120 mm; no panel wear; cutter box protection ring maximum wear of 120 mm; No. 6 disc cutter exhibited 2 mm of wear, and the cutter ring of No. 8 disc cutter was worn off. Cutter boxes No. 13–15: As shown in [Figure 6](#), maximum eccentric wear of the cutter housing was 129 mm; panel wear was 9 mm; cutter box protection ring maximum wear was 120 mm; the cutter ring of No. 13 disc cutter was worn off, and No. 15 disc cutter exhibited 40 mm of eccentric wear. Cutter boxes No. 14–16: Maximum eccentric wear of the cutter housing was 72 mm; no panel wear; cutter box protection ring wear was 72 mm; No. 14 and No. 16 disc cutters exhibited no wear.

**Figure 6.** Tool wear of No. 13-15 (maximum wear).

② Repair scheme: 1) Externally fabricated cutter box protection rings were procured, manufactured from S355 steel with a thickness of 100 mm, an inner diameter of 551 mm (cutter housing outer diameter of 555 mm, providing 2 mm clearance on each side), and an outer diameter of 856 mm. A 45° bevel was machined on the welding surface. Concurrently, positioning fixtures for the center cutter housing and face disc cutter housing were fabricated using used cutter housings, as

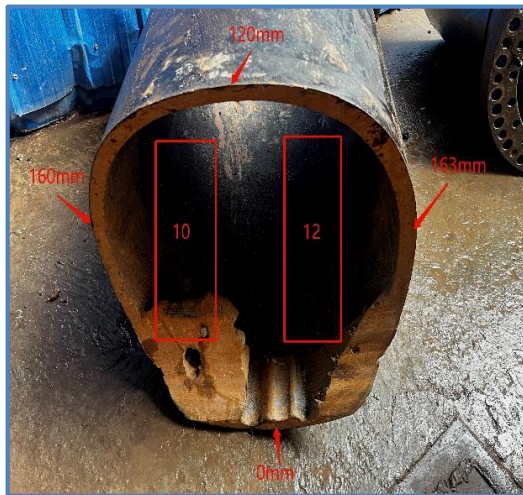
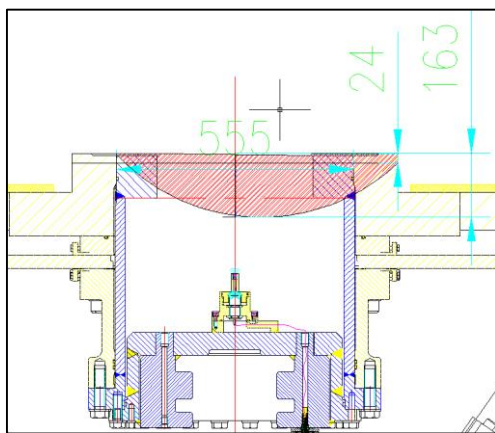
① Wear condition (seal and panel worn): Cutter boxes No. 9–11: Maximum cutter housing wear of 160 mm; panel wear of 40 mm; cutter box protection ring wear of 120 mm; the cutter rings of both No. 9 and No. 11 disc cutters were worn off. Cutter boxes No. 10–12: As shown in [Figure 9](#), maximum cutter housing wear of 163 mm; maximum panel wear of 43 mm; cutter box protection ring wear of 120 mm; the cutter rings of both No. 10 and No. 12 disc cutters were worn off.

Figure 9. Tool wear of No. 10–12 (maximum wear).

② Repair scheme: 1) Externally fabricated cutter box protection rings were procured, manufactured from S355 steel with a thickness of 100 mm, an inner diameter of 551 mm (cutter housing outer diameter of 555 mm, providing 2 mm clearance on each side), and an outer diameter of 856 mm, with a 45° bevel machined on the welding surface. 2) The worn area of the cutter box panel was ground smooth and bright; after grinding, overlay welding was performed using the cutter housing as the positioning reference. 3) Upon completion of overlay welding, the inner bore of the cutter box was ground, with the clearance fit controlled within 0.3–0.5 mm. 4) The worn region of the cutter box protection ring was completely removed by gouging and the surface ground smooth and bright. 5) The positioning fixture was installed and used as the reference for welding the new cutter box protection ring. 6) After welding of the cutter box protection ring was complete, the positioning fixture was removed. The boring equipment was installed using the gate cutter housing bolt holes as the positioning center, and its centrality was verified. 7) After confirming accurate positioning, boring of the cutter box protection ring commenced, with the clearance fit between the cutter housing and the cutter box protection ring controlled within 0.3–0.5 mm. 8) A pressure holding test was conducted upon completion of the cutter box repair.

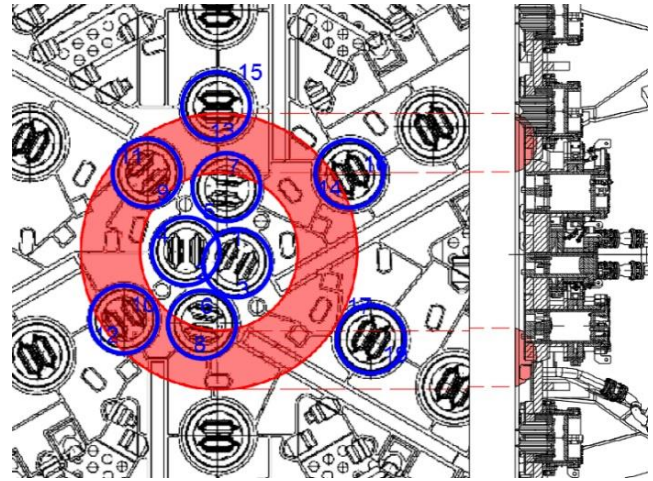
(1) Wear condition: The wear of the cutterhead panel diminished progressively from a maximum depth of 43 mm at the center toward both sides, as schematically illustrated in Figure 10.

Figure 10. Schematic diagram of panel wear.

(2) Repair scheme: ① The worn areas of the cutterhead panel were ground to a regular and bright surface. ② The dimensions of the ground wear areas were measured, and prefabricated steel plates of the same material were externally machined to shape. ③ The machined steel plates were welded to the parent material and reinforced with rivet welding; the welding surfaces were beveled. ④ Unfilled recesses were

treated by overlay welding; after welding, the surface was ground, with the flatness of the cutterhead panel controlled within  $\pm 5$  mm. ⑤ Upon completion of panel welding, dye penetrant inspection was performed to ensure weld quality.
