# Fault Analysis of 600MW Generator Stator Bars in a Power Station

The manufacturer of the generator for Unit 5 at a certain power station is Toshiba Hydro Power Equipment (Hangzhou) Co., Ltd. The generator model is SF600-66/17150, and it was commissioned for power generation on May 27, 2016. It has a rated capacity of 666,670 kVA, a rated power factor of 0.9 (lagging), a rated voltage of 20,000 V, and a rated current of 19,246 A. The stator winding is a 3-phase, 6-branch Y-connection with 35 slots per branch, totaling 630 slots.

At 00:56:16 on June 13, 2024, while Unit 5 generator at the power station was operating with a load of 600 MW, the stator grounding protection of both Sets A and B of the generator protection activated, followed by the shutdown and decoupling of the generator. Based on the comprehensive analysis of the protective action report and fault waveform recording, it is determined that a single-phase ground fault occurred in the unit, with Phase A being the faulted phase.

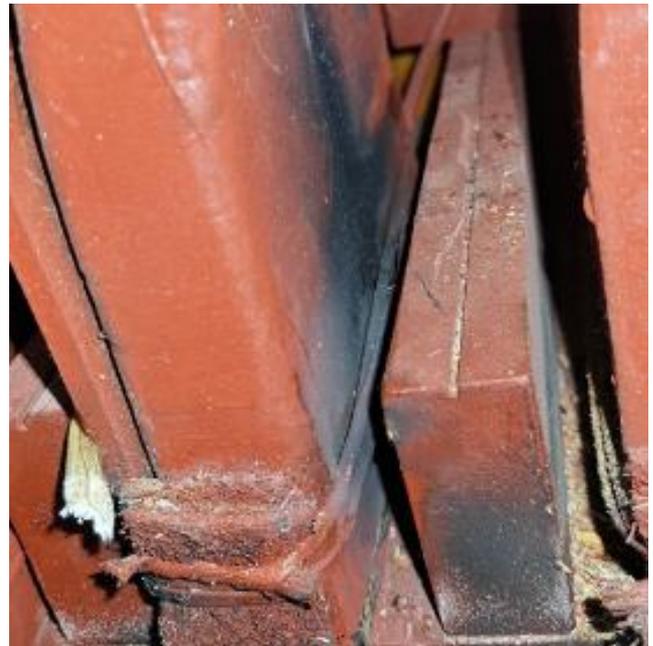
identified as the upper-layer bar in slot 331. Inspection revealed that there was obvious carbonized material adhering near the tooth pressure plate on this upper-layer stator bar, as shown in Figure 1. This adherent material should have been produced during the discharge of the faulty stator bar. Additionally, no abnormalities such as foreign objects, contamination, or loosening of the slot wedge were found on or around the stator bar.

Figure 1. Carbonized material attachment.

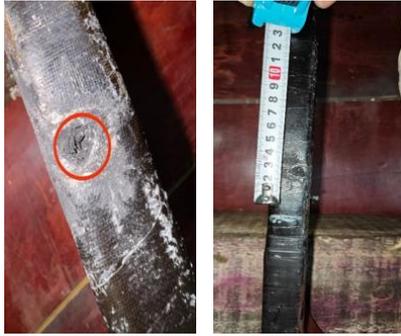
To further investigate the cause of this fault, the faulty stator bar was lifted out for inspection, and two major abnormalities were found: First, there was a noticeable discharge ablation and carbonization point on the interlayer side of the stator bar. The main characteristics of this discharge point were as follows: It was located approximately 20mm from the slot outlet on the interlayer side of the stator bar and about 180mm from the upper end of the straight segment of the stator bar. The discharge point was approximately a 10mm diameter circular pit, exhibiting a typical concave hollow morphology overall. Second, there was a hollow and loose air gap at the edge of the discharge point on the stator bar, accompanied by a circular arc-shaped pit with a length of about 5mm and a depth of about 0.8mm. This pit was likely caused by factors such as compression, while the hollow and loose air gap was believed to have been formed when the insulation layer of the stator bar expanded due to heat during the fault, allowing air to enter and causing the hollow and loose condition, as shown in detail in Figures 2 and 3.

Figure 2. Breakdown point of stator bar.

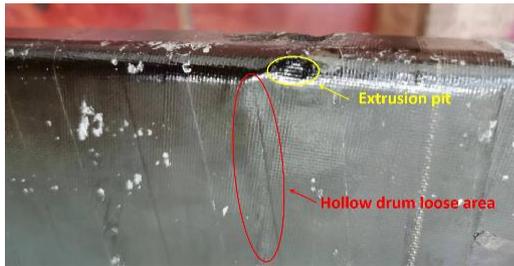
Figure 3. Hollow drums and pits at the edges of stator bar.

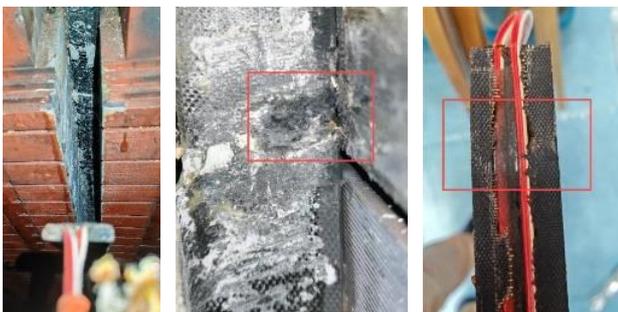
During the inspection of the slot, it was found that the temperature measurement pad corresponding to the discharge area of the stator bar had a certain degree of burnout and carbonization. As shown in Figure 4, after removing the temperature measurement pad, it was observed that the underlying stator bar was free of any abnormalities. Upon layer-by-layer stripping of the temperature measurement pad, it was found that the carbonization point did not penetrate through, and the lead-out wire and potting of the pad were intact and without damage. Therefore, it could be ruled out that the stator bar fault was caused by overheating due to a short circuit in the temperature measurement pad. Combining the inspection results, it can be concluded that the discharge point was caused by discharge breakdown originating from internal factors within the stator bar.

Figure 4. Location of the burning point of the side temperature measuring pad between layers.

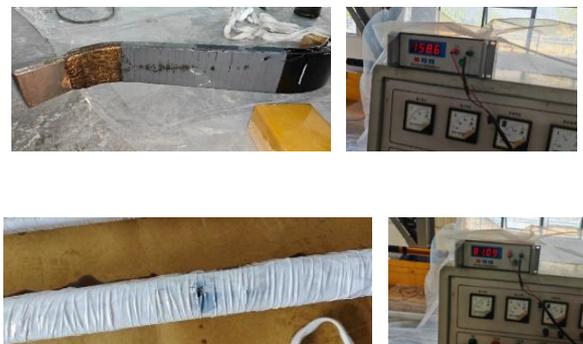
The surface resistance tests of the two stator bars showed no abnormalities; the partial discharge values of both stator bars at 20 kV did not exceed 200 pC; the initial dielectric loss values were both less than 0.6%, with  $\Delta \tan \delta$  less than 0.5%; there was no corona phenomenon during the 45 kV/1 min AC withstand voltage test; in the instantaneous breakdown test, the spare stator bar did not experience creepage breakdown at 158.6 kV, while the remaining section of the repaired faulty stator bar had a breakdown voltage of 81.1 kV, as shown in Figure 5.

Figure 5. Stator bar transient breakdown test.

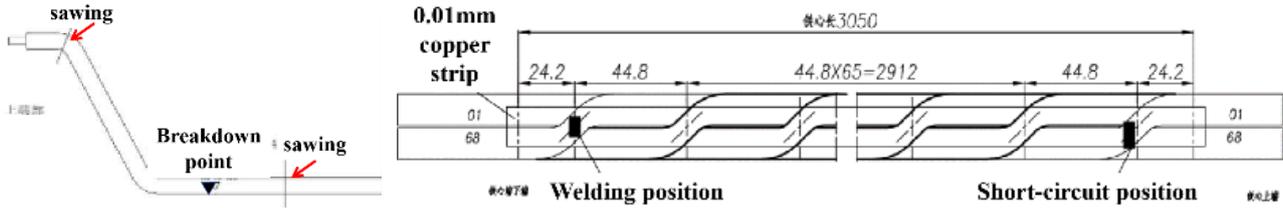
After removing the welding head and separating the strands of the faulty stator bar, it was found that there was a short circuit between wires number 1 and 68. After truncating the faulty section, the remaining part showed no short circuit. The short circuit was caused by the damage to the insulation between the copper tape and the conductor at the transposition point at the upper end, resulting in a short circuit between strands number 01 and 68. The short circuit was confirmed by measuring the resistance between the copper tape and the transposed strands (only 8.5Ω), which verified that there was a short circuit between the copper

tape and the transposed strands within the breakdown section. Figure 6 illustrates the truncation position of the stator

Figure 6. Internal shielding process diagram.

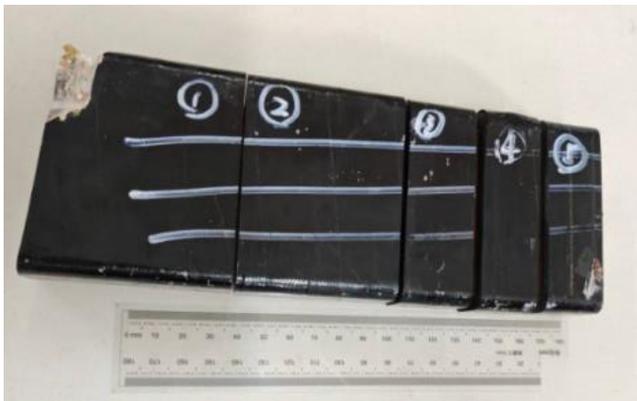
Figure 7. Stator bar segment marking.

Mark the cut off breakdown segment bar in sections and then cut the segment as shown in Figure 7, so as to observe the wide and narrow sides of insulation and peel the insulation to observe the copper conductor surface.

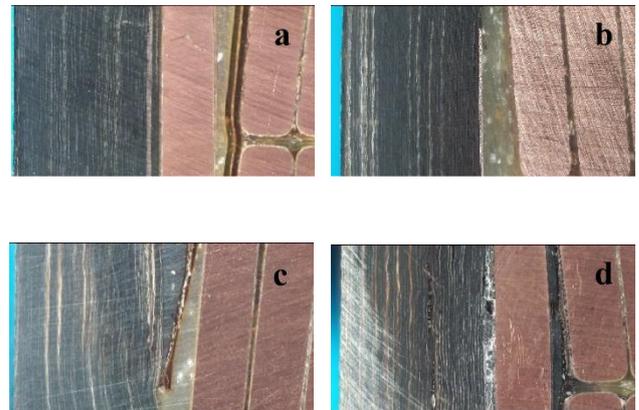
Through microscopic inspection of the cross-sections of the segment containing the breakdown point and its adjacent segments, as shown in Figure 8, the following observations can be made: The main insulation on the left side of Segment 3, which is on the same narrow surface as the breakdown point, has slight burning, but there is no insulation delamination. The main insulation on the right side of Segment 5, which is also on the same narrow surface as the breakdown point, exhibits slight delamination. On the left side of Segment 4, the insulation near the conductor surface below the breakdown point shows significant deterioration, with clear delamination of the insulation. On the right side of Segment 4, the insulation near the conductor surface below the breakdown point also shows significant deterioration, and the degree of deterioration is more severe than that on the left side. Additionally, the filling putty is overall darkened, and tiny air gaps are visible.

Figure 8. Microsection (a) the left of 3, (b) the right of 5, (c) the left of 4, (d) the right of 4.

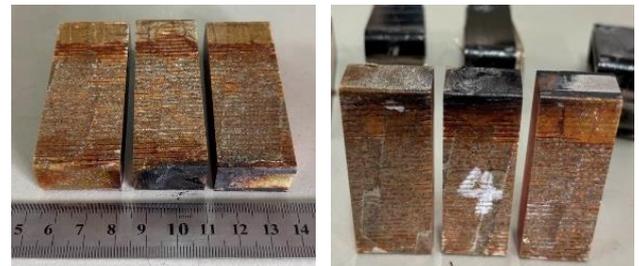
After stripping the main insulation for observation, as shown in Figure 9, it was found that there were burn marks on the narrow surface of the copper conductor, which developed towards the end of the stator bar. Additionally, the hollow bulge only existed on the outer layer, and it was judged to be caused by occasional collisions and compression during the installation process, which then developed due to the insulation expanding and heating up during the fault.

Figure 9. A copper conductor stripped of the main insulation.

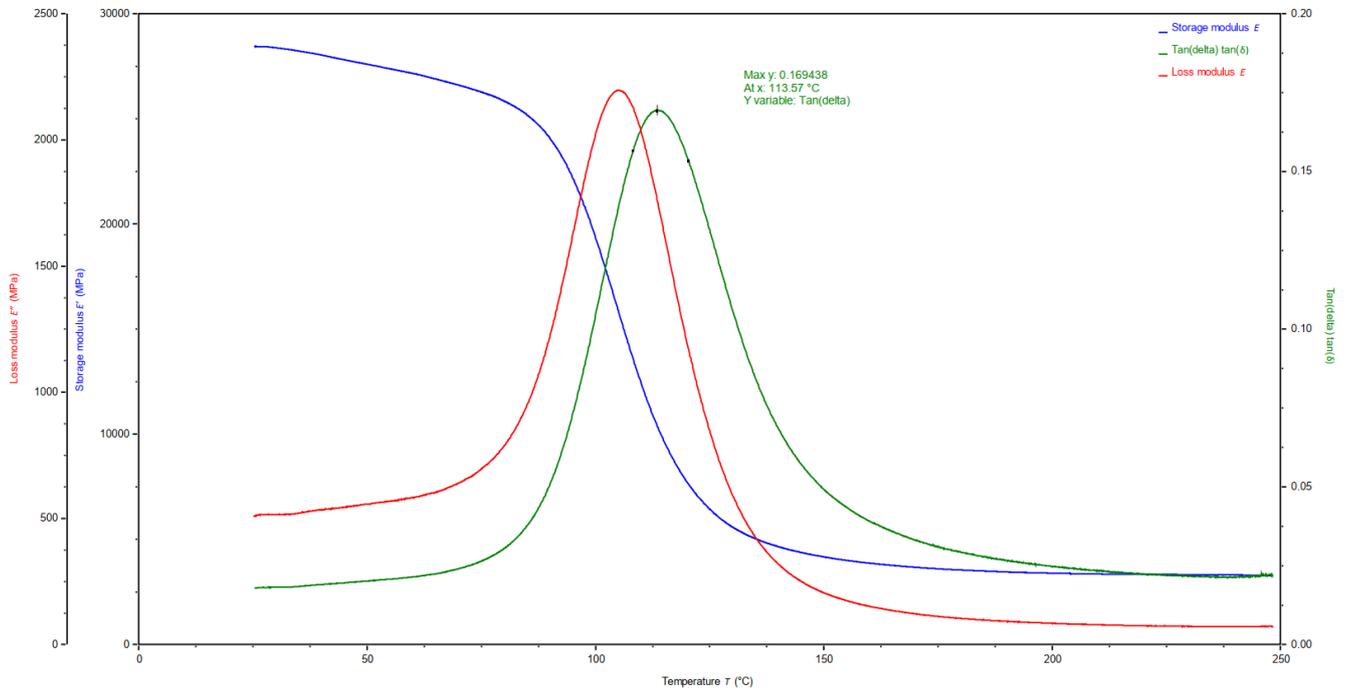
Figure 10. Sample in the middle of the linear part of the faulty stator bar (113 °C).

The glass transition temperatures of the samples taken from the linear sections were similar, and the glass transition

temperatures of the samples taken from the end sections were higher than those of the linear sections. All glass transi-

tion temperatures were above 110 °C, which was comparable to the specified value of the main insulation material, indicating that there was no abnormality in the performance of the main insulation material.

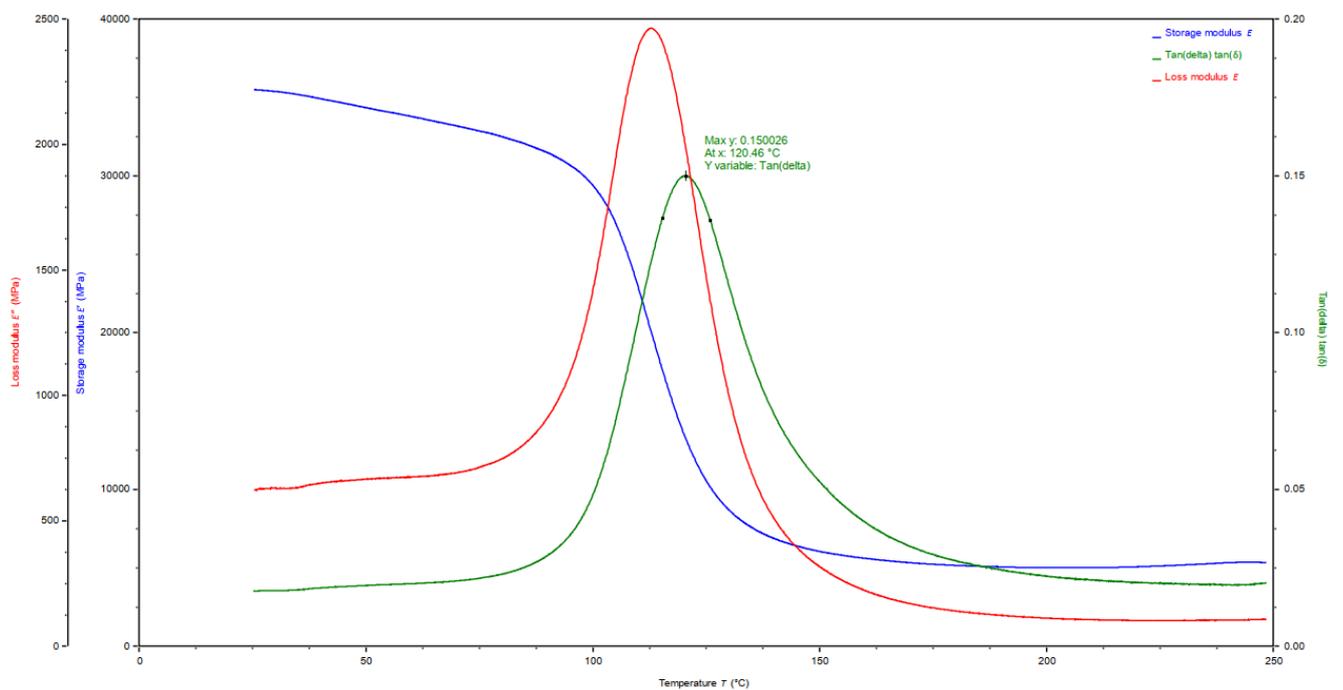
Figure 11. Sample with the linear part of the faulty stator bar near the breakdown point (120 °C).

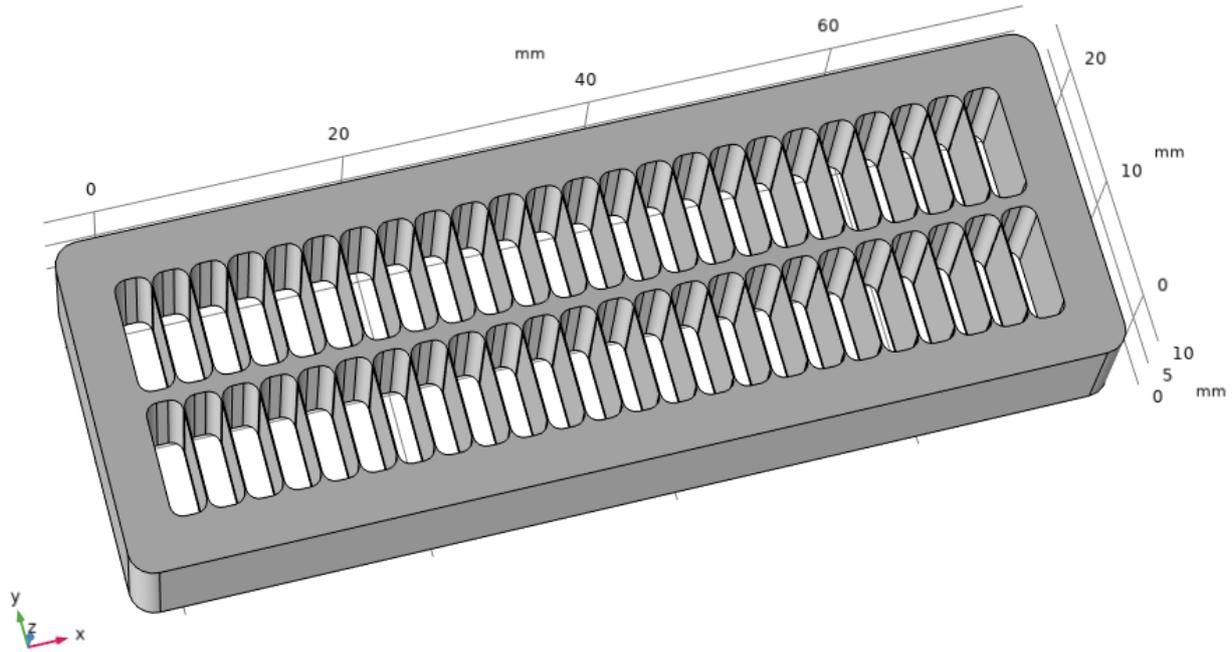
Figure 12. 3D model.

Using the corresponding dimensional data and material design values of the faulty stator bar, a three-dimensional simulation model was established, as shown in Figure 12. By setting the potential of the copper conductor to 20kV and grounding the outer edge of the main insulation, the operating conditions were simulated. A tiny bubble with a radius of 0.1mm was introduced within the narrow-side main insulation layer to mimic the air gap defects that may arise after compression. The resulting electric field intensity distribution from the simulation is presented in Figure 13. It can be seen from the figure that the presence of the bubble leads to distortion in the electric field intensity, with the highest field intensity at its boundary reaching  $1.4 \times 10^6$  V/m. Clearly, when bubbles defects exist in the main insulation, they will inevitably cause excessively high local field intensities under the action of operating voltages, leading to partial discharges and subsequent insulation degradation.

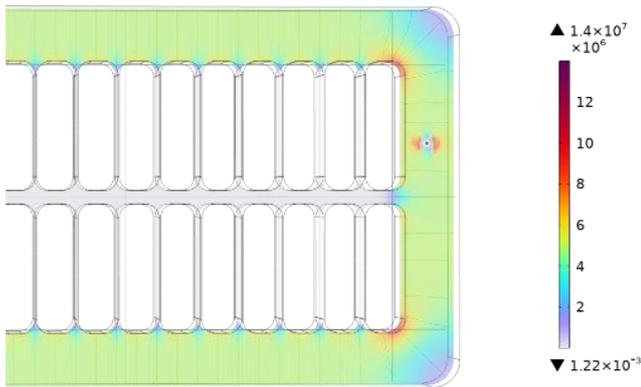
insulation layer on the narrow side of the stator bar, thus deteriorating the overall electric field environment. If non-conducting materials are also mixed in, the risk of partial discharge is high.

Figure 13. Main insulation electric field distribution with bubble defect.

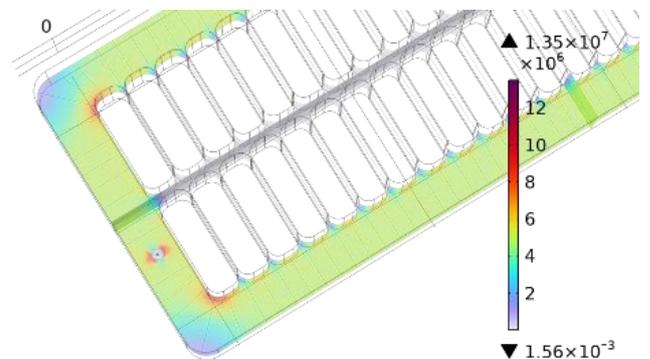
By setting a copper particle with a radius of 0.1mm in the main insulation to simulate metal impurities entering during the production process, with other parameter settings the same as in Section 4.1. When metal impurities are mixed into the main insulation material due to production processes, the corresponding electric field distribution is shown in Figure 14. At this time, the maximum electric field intensity is  $1.35 \times 10^7$  V/m, and the metal impurities are at a floating potential in the main insulation material. Similar to the bubble defect, the presence of metal particles leads to an expansion of the high electric field intensity area in the main insulation, and the area of electric field distortion almost spans the main

Figure 14. Distortion of electric field distribution caused by metal defects.
