Cause Analysis of the Secondary Mountain Disaster Chain in Wenchuan Earthquake

Abstract: Earthquakes and their secondary disaster chains are often destructive. It poses a great threat to the social development, economic development and cultural development by studying the typical disaster chains in the 5.12 major earthquakes in 2008. This paper analysis of its universal causes and summarizes characteristics of the disaster to prevent and control the harm caused by earthquakes and their secondary disaster chain more effectively is the urgent need of I in the contemporary society. In order to study the causes of the mountain secondary disaster chain, with the typical secondary mountain disaster chain of the 2008 earthquake in Wenchuan as an example, this paper analyzes the causes of disasters using field investigation, remote sensing technology, the method of data analysis. The study found that the typical disaster chains of Landslide - Debris flow - Dammed Lake, Earthquake - Landslide - Dammed Lake - Debris flow are affected by topography and geomorphology. At the same time, it is also related to precipitation, accumulation bodies and other factors. Ginkgo Mozigou located in Chapin

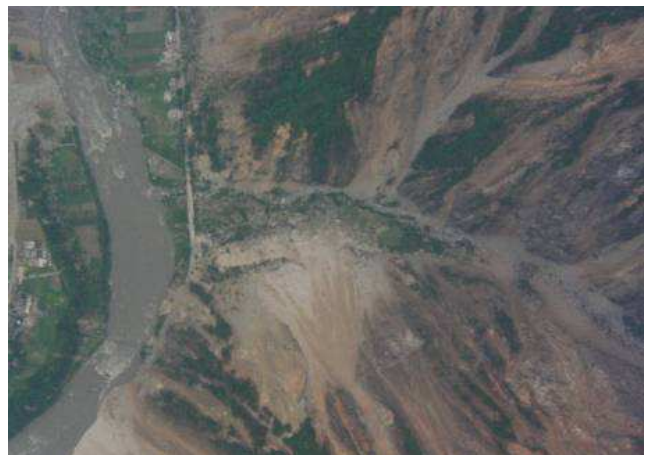
A large number of beng accumulations have been accumulated in the channel after the earthquake gully. In December 2008, the situation was studied, and the average thickness of Mozigou accumulation of debris flow fan is about 30 meters. The accumulation body side is about 1 million and 500 thousand m^3 (Figure 1). A large number of deposits decline in water, resulting in river blockage, the formation of lake.

Figure 1. Mizoguchi earthquake aerial remote sensing images (2008. 05. 26).

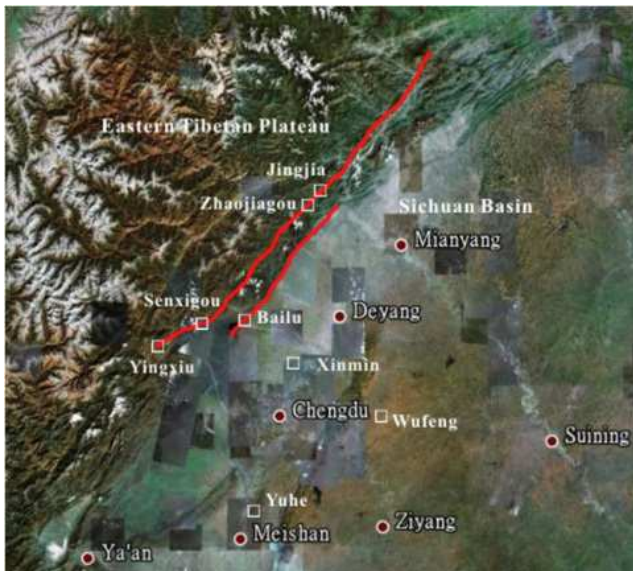
Figure 2. Regional river basin distributions (Jianjin Cao, *et al.*, 2017).

A typical landscape is located in the mountains around the basin. Longmen mountain area is mainly composed of a mountain near the North West to the east. The Jiaoziding peak is elevation of 3045 m, and the lowest point is in the South Fujiang River confluence of 700 m dam. The vertical is height of 2256 m, and the maximum distance is 16.94 km. Located in the tributary of the left bank of river, the shape of the basin is a typical pattern of the plume. The basin area is 158 km², and the confluence of the catchment area is large (Figure 2).

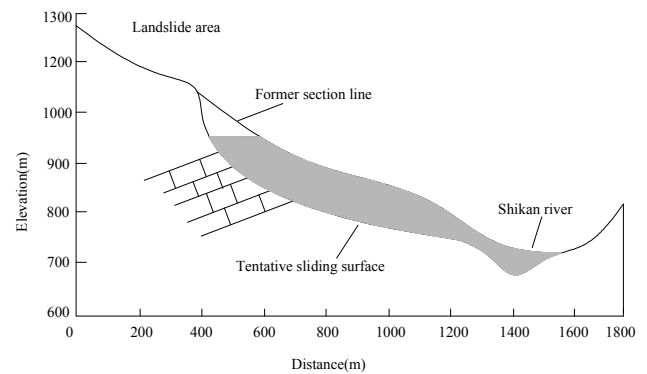
Figure 3. Schematic diagram of Wenjiaba landslide profile.

From the Figure 3, the accumulation body morphology integrity of Wenjiaba landslide, a square shaped stacking approximation, spreading in the river on the slope and rock ridge (Figure 3). The accumulation body slope than the original slope slightly slow, about 25 degrees. The landslide material is mainly composed of yellow, yellow brown soil and Quaternary layers of Cambrian altered sandstone and sandstone of gravelly soil. The transverse tensile fractures on the surface of the accumulation bodies develop, and the surface is stepped or steep in shape. The uplift phenomenon is not very obvious, basically cannot see the rollover phenomenon and slope of rock and soil, scattered vegetation is still in order. These characteristics show Wenjiaba landslide, the relatively slow movement characteristics of decline, and the movement of landslide to traction activities.

The lithology formation of the Yu Wen Jia landslide is the black manganese - carbonaceous silicon phyletic in the Qiujiage formation. White clouds limestone is in the central. The lower

part contains manganese siliceous rocks, youfang group metamorphic crumbs sandstone, Shiying sandstone, siltstone.
