Analysis of Vegetation Effects on Slope Stability of Embankment

Md. Murad Hasan, Mehejabin Chowdhury Ankan. Analysis of Vegetation Effects on Slope Stability of Embankment. *American Journal of Civil Engineering*. Vol. 8, No. 4, 2020, pp. 77-86. doi: 10.11648/j.ajce.20200804.11

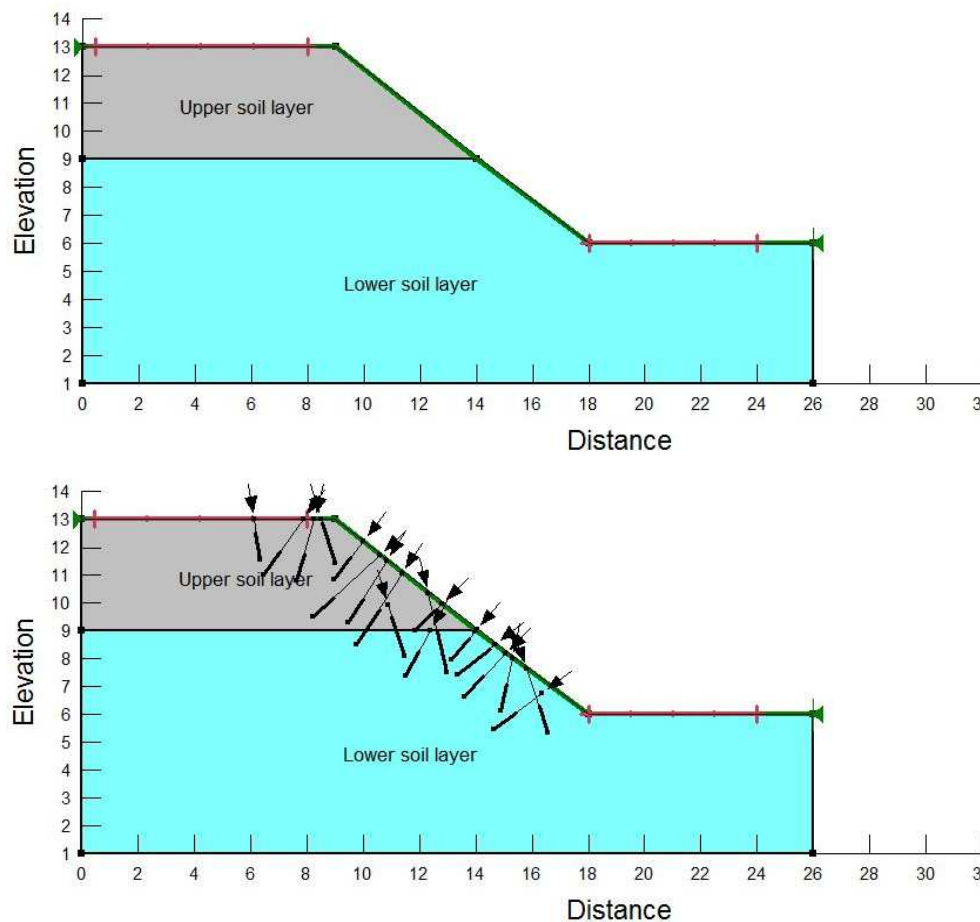
The general geometry of a layered soil slopes with and without roots are given below figure 1:

Figure 1. Slope of layered soil without root and with root. Dimensions are in meters.

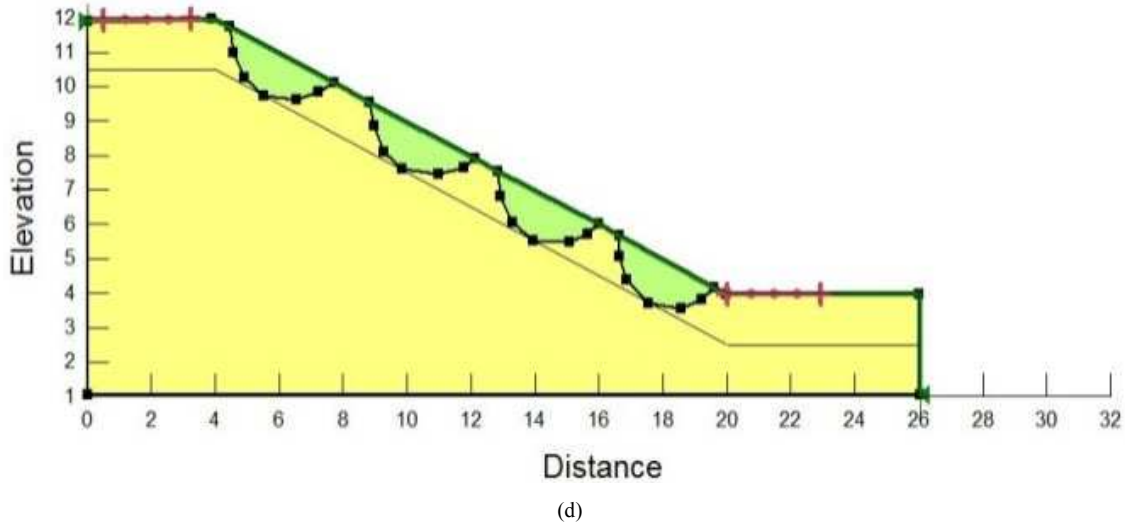
Three types of root morphology are considered: uniform 0.5 m deep plate root system, 2 m diameter and 1.5 m deep cylindrical system, and 1.35 m radius semi-spherical system.

In addition to the three types of vegetation, a slope with no vegetation as a reference is also analyzed. The models are shown in the following figure 2:

Figure 2. Slope models with: a) no vegetation, b) uniform vegetation layer, c) cylindrical vegetation layer and d) semi-spherical vegetation layer. All dimensions are in meters.

From the numerical analysis results, it is clear that factor of safety increases for the presence of vegetation. The cohesion provides significant strength and consequently requires more mass to create unstable conditions. However slip surfaces are deeper than the root

zone, therefore the presence or absence of vegetation has little influence on slope stability. Plants with cylindrical root architecture increase the most significantly slope stability. Uniform root architectures are not deep enough and semi-spherical root architectures have very few deep roots.

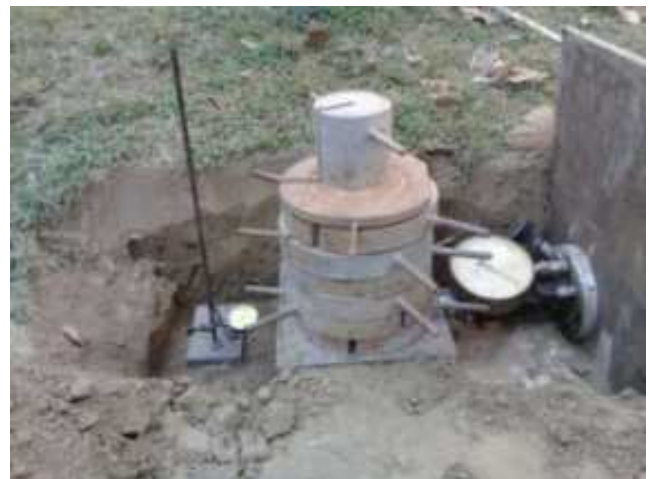
An experimental setup was developed in this study to determine the in-situ shear strength of soil profile vegetated with tree root and without root. The shear box was made of 6 mm thick steel plates (0.30 m x 0.30 m x 0.10 m) capable of holding firmly a soil block of 0.30 m x 0.30m x 0.15 m in dimensions. A hydraulic jack with load gauge having

capacity of 5 tons was used to apply shear force and a Linear Variable Displacement Transducer (LVDT) was used to determine the horizontal displacement while applying the shear forces. The applied shear forces were read directly from the load gauge that was set with the hydraulic jack. The detail experimental setup has been shown in the figure 3.

Figure 3. Experimental setup of in-situ direct shear test.

A lebbek tree and a royal poinciana were selected for the in-situ direct shear test. In order to perform the test, the lower edges of the steel shear box were made sharp to penetrate the shear box into the soil cutting the roots at ground level. This operation was done such that the soil specimen in the shear box remained undisturbed with roots. A trench was excavated around the soil block, approximately 0.5 m square and 0.15 m deep, sufficiently enough to accommodate the all

experimental setup and isolate the soil block from the surrounding soil. The shearing force was applied by hydraulic jack that acted on steel plate of the shear box. The hydraulic force was applied by operating a lever arm and enough space was provided on the opposite side of the hydraulic jack of the shear box for the shear displacement. The shear force was obtained from the load gauge attached to the hydraulic jack and the shear displacement was measured using the dial gauge. Block samples were tested at 0.15m depth under different normal stresses at the field to know the in-situ shear strength of the rooted soil and soil without root following this procedure. The test was performed at 0.15 m depth of each two trenches (i.e., soil block with root and without root) applying the same normal load to determine the increase in shear strength of soil specimen due to penetration of tree root for the same normal load. After shearing the soil block to fail, the shear surface and the orientation of the failed roots were examined carefully to estimate the shear distortion during failure. A total of 9 block samples were tested in the field under different normal stress (i.e., 6.18 kPa, 8.73 kPa and 10.89 kPa) at 0.15 m depth from the existing ground level excavating 9 trenches. Out of 9 samples 6 samples were rooted soil (3 samples for lebbek tree and 3 samples for royal poinciana) and 3 samples were soil without root. Figure 4 and Figure 5 shows the failure plane of soil block without root and with root respectively.

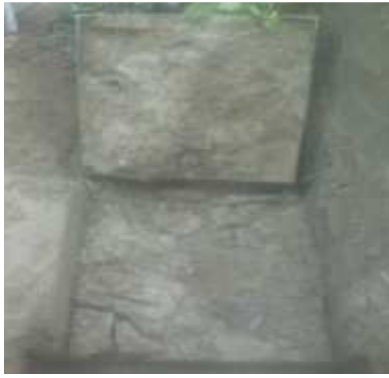
Figure 4. Failure plane of soil block without root.

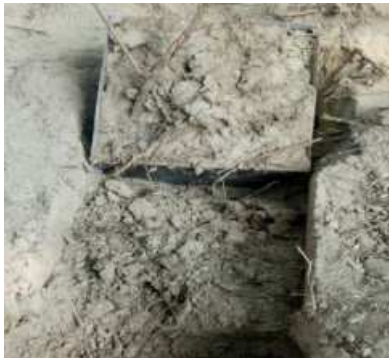
Figure 5. Failure plane of soil block with root.

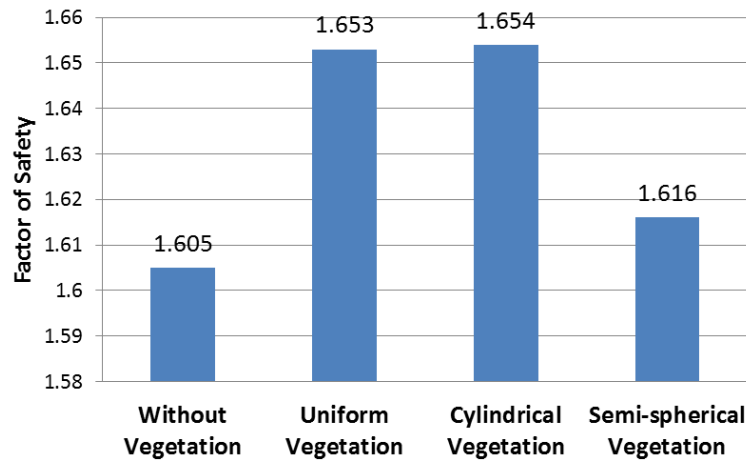
The factors of safety calculated for different types of vegetation by software are shown below figure 8:

Figure 8. Factor of safety for different types of vegetation.

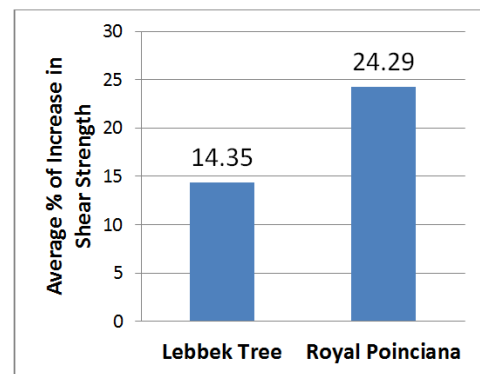
From table 9 it is seen that under the same normal stress the shear stress of soil specimen with root is greater than the soil specimen without root. The average percentages of increase in shear stresses of soil specimen are 14.35% and 24.29% of lebbek tree and royal Poinciana respectively. It can be clearly seen that the average percentage of increase in shear strength for royal poinciana is higher than that of lebbek tree. This is because the root density of royal poinciana in soil is higher than that of lebbek tree. This indicates that royal poinciana roots induce higher shear strength to soil than lebbek tree roots. Figure 12 Comparison of average percentage of increase in shear strength between Lebbek Tree & Royal Poinciana

Figure 12. Comparison of average percentage of increase in shear strength between Lebbek Tree & Royal Poinciana.

A comparative study has been made on field test result and numerical analysis result to evaluate the efficiency of the overall work. From the results it is seen in the figure 12 and figure 13 that the average percentage of increase in shear strength for numerical analysis is 26.07% whereas this value for field test is 24.29% for royal poinciana and 14.35% for lebbek tree.

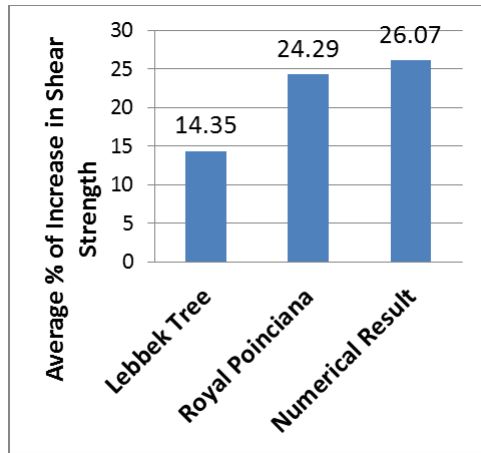
Figure 13. Comparison of average percentage of increase in shear strength between numerical analysis & field test results.

During shearing of root-permeated soil, the tensile strength of each and every root was not mobilized completely as assumed in the model. Some roots were pulled out completely or partly by a rupture at finer point below the shear surface providing a lower resistance to shearing than expected. The penetration of root is assumed to be vertical in the model but some root orientations oblique to the shear surface can give rise to lower shear strength increase in soil. In actual conditions, the root crookedness, jointing and the presence of young roots yield lower shear strength values than those expected from straight, unbranched and mature root which are stronger than the former.
