A Study of Measurement for Dangerous Prediction on Static Lording Test Using Piezoelectric Limit Sensors

Nobuhiro Shimoi, Carlos Cuadr. A Study of Measurement for Dangerous Prediction on Static Lording Test Using Piezoelectric Limit Sensors. *American Journal of Remote Sensing*. Vol. 3, No. 3, 2015, pp. 43-48. doi: 10.11648/j.ajrs.20150303.12

Abstract: Applicability of a new piezoelectric limit sensor to detect premonitory failure during static loading testing is discussed in this paper. Brick masonry specimens were subjected to compression tests to evaluate their mechanical properties and to investigate proposed sensor response. These new sensors consist of a glass pipe containing piezoelectric film elements for the measurement of signals during static loading tests. The glass pipe can be installed directly in brick masonry specimens or inserted into the holder. For this research, a brass tube holder was made. This report discusses examinations for glass pipe alone and glass pipe with brass holder.

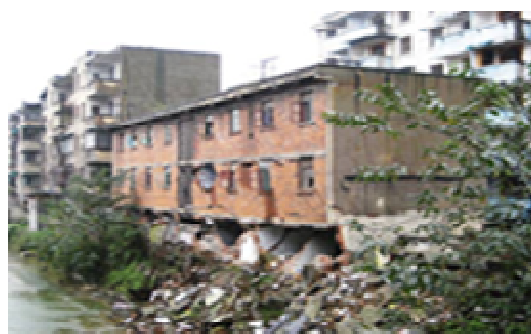
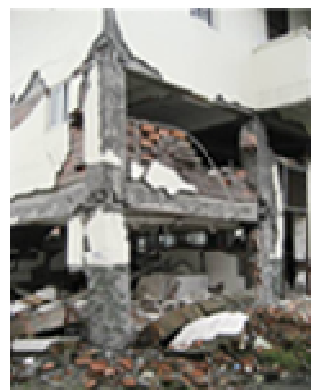
Fig. 1. Reinforcing the brick wall by earthquake effect⁶⁾.

available. Moreover, procuring proper materials for reinforcement is extremely difficult.[3]–[6] Figure 1 presents photographs of collapsed brick walls in Sichuan Province, China, taken immediately after a M7.9 earthquake occurred

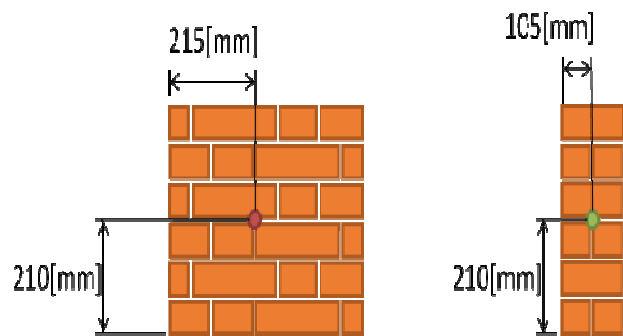
Fig. 2. Location of the sensor unit.

We conducted loading tests for a brick wall specimen of masonry structure, 210×490×420 [mm], presented in Fig. 2 using a compression testing machine. We conducted compression measurements using a Pi-shaped displacement

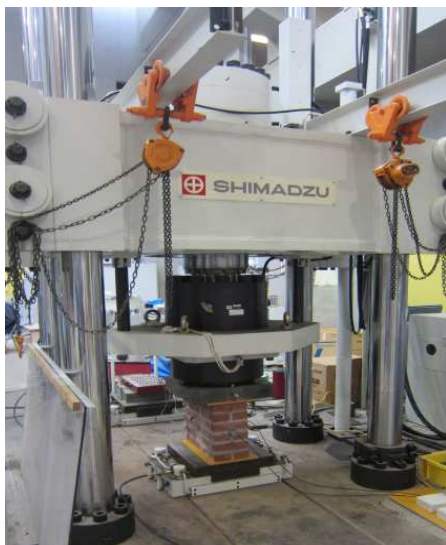
Fig. 3. Compression testing machine.

Figure 3 portrays the compression testing machine (UH-5000kN I; Shimadzu Corp.) we used. Table 1 shows its specifications. We prepared two each of Flemish bond and English bond specimens for destruction testing. Then we set up sensors for specimens of these two types with different brick stacking patterns. We drilled $\phi 15$ holes in the front surfaces of these four specimens to insert sensors. Professional technicians stacked brick wall specimens for our quantitative measurements. Figure 4(1) presents details related to the piezoelectric limit sensor; Fig. 4(2) shows sensor setup patterns. When the sensor detects a load exceeding its limit by static loading, the piezoelectric film in the sensor deforms to generate a voltage. Because the sensor generates voltage proportional to deformation, we can

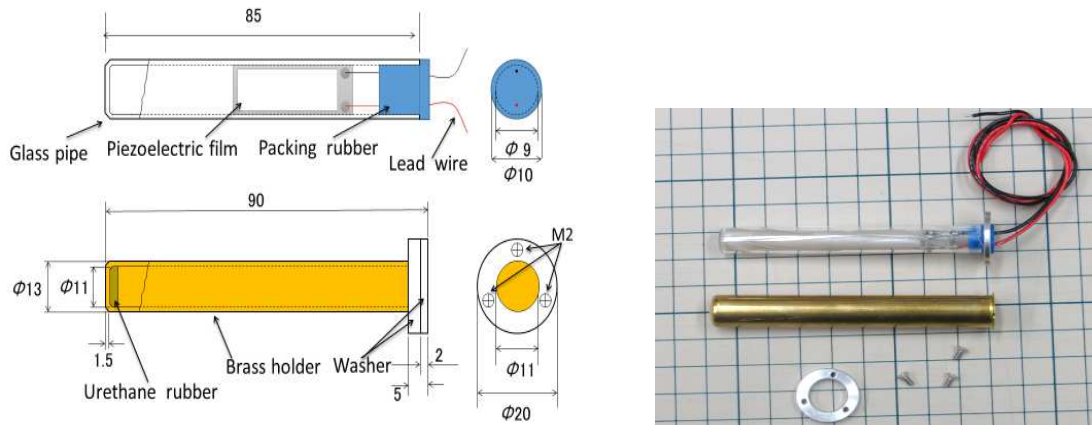
(1) Piezoelectric limit sensor.

Fig. 4. Experiment for sensors unit and test specimen.

estimate the scenario of destruction from its voltage output. The Pi gauge was fixed to the specimen by a bolt and a nut. The strain gauge was affixed to the specimen using adhesive and fixed to the specimen surface by mortar together with the piezoelectric limit sensor after it was inserted into the hole located in the center of the front surface. Sensors were wired to a high-performance memory logger (LR8431; Hioki E. E. Corp.) with a covered ϕ 4-mm-diameter and 2-m-long lead wire. The cover of the wire provided proper electric insulation.

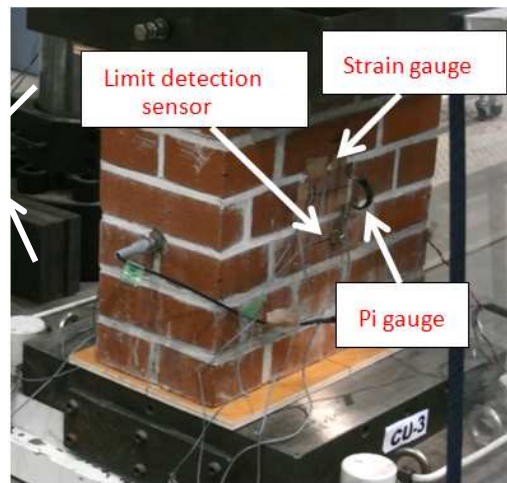
(2) Sensors and measurement setup.

The two Pi gauges (LR8431; Hioki E. E. Corp.) were fixed using a bolt (planted on the brick surface) and a nut on each front and rear surface of the specimen. Furthermore, we put a strain gauge (PFL-20-11-3L; Tokyo Sokki Kenkyujo Co. Ltd.) around center of front surface of specimen using adhesive and used it as an auxiliary sensor. Signals from these sensors were stored in the logger as time-series data. The sensor sampling frequency was 100 Hz. That for gauges and compression loads was 1 Hz.

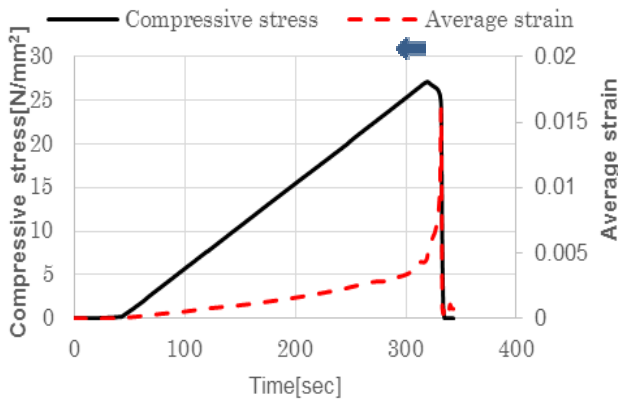
(1) Flemish bond specimen measurement for compressive stress and average strain

Fig. 5. Relation between compressive stress and average strain.

average strain in the specimen. Figure 5(1) is for Flemish bond specimen; Fig. 5(2) is for English bond specimen.

The average compression load and compressive stress at complete destruction in brick wall of masonry structure of the Flemish bond were about 3300[kN] and about 32 [N/mm²], respectively. Although in the brick wall of the masonry structure of the English bond, they were about 3450 [kN] and about 33 [N/mm²], respectively. For general evaluation of brick wall of masonry structure, people seem to expect better strength from the English bond than from the Flemish bond.[9] Our tests showed performance supporting that opinion. In design determination of safety load, people consider that about one-third of the destruction load might not cause any structural damage. These are calculated as shown below.

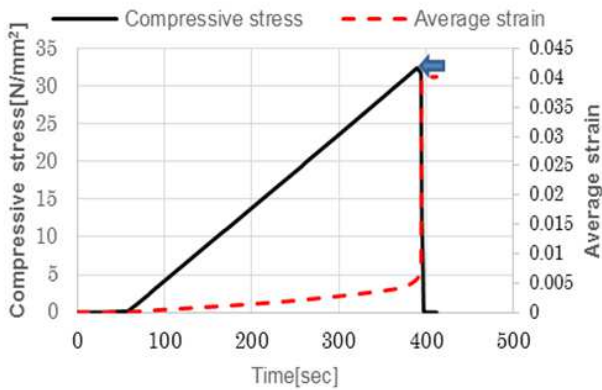
(2) English bond masonry specimen measurement for compressive stress and average strain

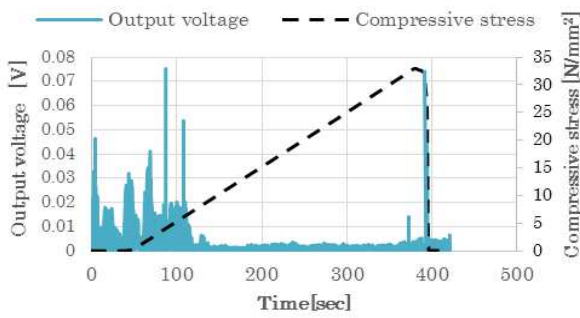
(1) Flemish bond specimen measurement by limit sensor with a brass holder for compressive stress and output voltage

Figure 6(1) shows the Flemish bond specimen and sensor in the brass holder. Results show that (1) occurred at ar-ound 130[s] and voltage of 0.008[V],(2) occurred at around 370 [s] and voltage of 0.016 [V] and (3) occurred at around 400 [s] and voltage of 0.07 [V]. Rather large voltages recorded until around 120 [s] were noise caused by fluctuation of the oil pressure in the testing machine. Because we were unable to manage this irregularity, we simply disregarded the data during this time period and made no evaluation of them. Results show that (1) was 10 [N/mm²], (2) was 31 [N/mm²], and (3) was 33 [N/mm²]. On comparing these measured values, the allowable one-third of the maximum compressive stress was 11 [N/mm²].

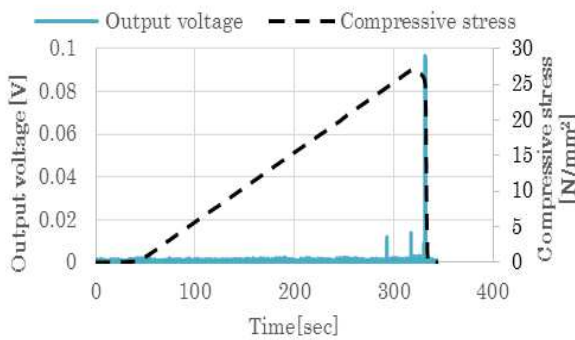
(2) Flemish bond specimen measurement by limit sensor with glass holder for compressive stress and output voltage

The maximum compressive stress was 33 [N/mm²].Both compare well with each other. Our sensor measured stresses of (1) - (3). Results confirmed 31 [N/mm²] as (2) with sensor output of 0.016 [V].Figure 6(2) shows the Flemish bond specimen and sensor in the glass holder: (1) was not detected; (2) occurred at around 320 [s] with sensor output of 0.018 [V]; and (3) happened at around 340 [s] with sensor output of 0.095 [V]. Actually, (1) was not measured, (2) was 26 [N/mm²], and (3) was 28[N/mm²]. On comparing these values with those obtained from Eqs. (1) and (2), we presumed that we measured 10 [N/mm²] at 140 [s] as output corresponding to (1). However, it did not appear. Because 28 [N/mm²] was recorded when the limit sensor indicated a maximum output, we confirmed that the measured value coincided well with the calculated one. Rather high sensor output at <3> might have been caused by destruction of a specimen subjected to buckling deformation. Furthermore, the sensor supplied an advance signal of 0.016 [V] and stress of 26 [N/mm²] corresponding to (2) at 295 [s]. That gives proper notice of final destruction.

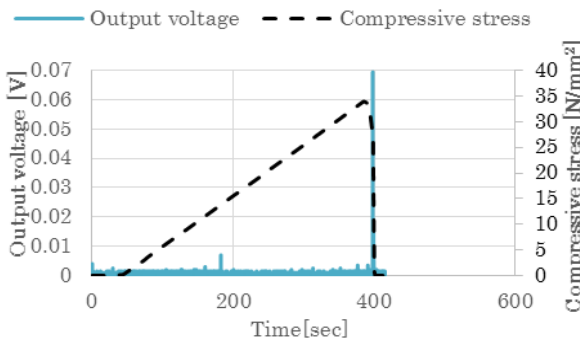
(3) English bond masonry specimen measurement by limit sensor with a brass holder for compressive stress and output voltage

Figure 6(3) shows the English bond specimen and sensor in the brass holder. Results show that (1) occurred at around 180 [s] with voltage of 0.008 [V], (2) at around 380 [s] with voltage of 0.038 [V], and (3) at around 400 [s] with voltage of 0.07 [V]. Also, (1) was 13 [N/mm²], (2) was 33 [N/mm²], and (3) was 34 [N/mm²] as the figure shows. On comparing these measured values, one-third of the maximum compressive stress is 11 [N/mm²] and the maximum compressive stress 34 [N/mm²]. We were able to recognize that when (1) arrived, the stress exceeded the allowable value and destruction started and confirmed that the calculated value of the maximum stress at destruction, (3), which coincided well with the measured one. In addition, the voltage output notifying arrival of (2) leading to final destruction was found as shown in the figure.

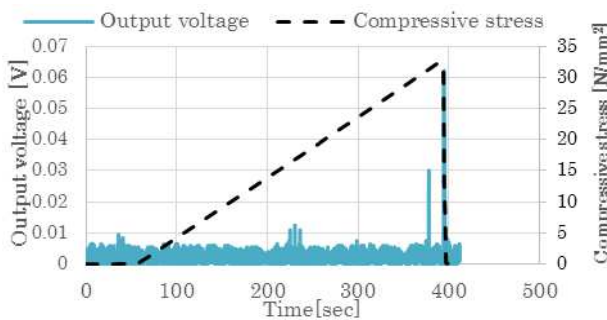
(4) English bond masonry specimen measurement by limit sensor with a glass holder for compressive stress and output

Figure 6(4) shows results for the English bond specimen and sensor in the glass holder. It is apparent that (1) occurred at around 220 [s] with sensor output of 0.013 [V], (2) occurred at around 380 [s] with sensor output of 0.03 [V], and (3) occurred at around 400 [s] with sensor output of 0.065 [V]. Also, (1) was 15 [N/mm²], (2) was 31 [N/mm²], and (3) was 33 [N/mm²]. The calculated value as 1/3 of maximum stress 33 [N/mm²] was 11 [N/mm²]. Although this predicts the start of destruction at around 160 [s], the specimen withstood compressive stress as high as 15 [N/mm²], apparently demonstrating the toughness of English bond. Prediction of destruction was done at 31 [N/mm²], (2), against the calculated value of 33 [N/mm²] for complete destruction, and (3) coincided with the calculated value.

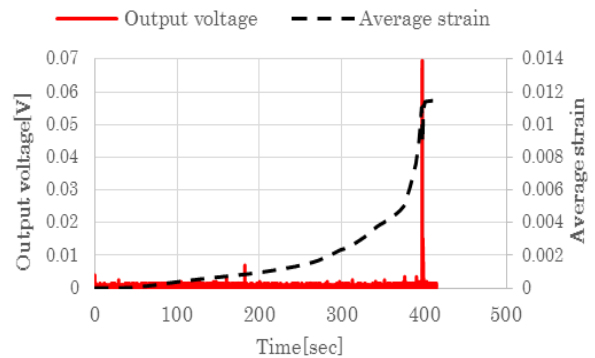
(1) English bond masonry specimen measurement by limit sensor with brass holder for output voltage and average strain.

Figure 7 shows output of the piezoelectric limit sensor and average strain. Figure 7(1) is for the English bond specimen and sensor in the brass holder. The sensor output is shown as a solid line. (1) occurred at 180 [s], (2) at 380 [s] and (3) at 400 [s], each with typical signal pattern. The strain is shown as a broken line, which indicates the escalation of strain synchronized with sensor output. Warning of destruction by arrival of (2) was done at about 60% of average maximum compressive stress.

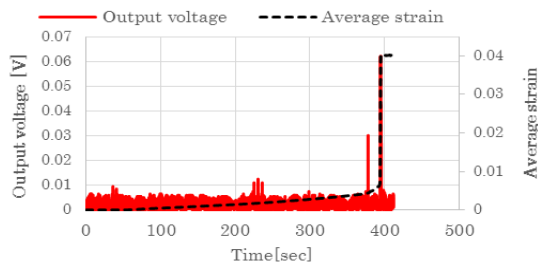
(2) English bond specimen measurement by limit sensor with glass holder for output voltage and average strain.

Fig. 7. Relation piezoelectric limit sensor output and average strain.

Figure 7(2) is for the English bond specimen and sensor in the glass holder. The sensor output is shown as a solid line. Results show that (1) occurred at through 220–240 [s], (2) occurred at 380 [s], and (3) occurred at 400 [s], each with a typical signal pattern. Strain is shown as a broken line, which shows the escalation of strain concomitantly with the sensor output. Warning of destruction by arrival of (2) occurred rather early at about 10% of the average maximum compressive stress.
