# A GIS Based Assessment of a Dynamic Watershed in Guam

Sydonia Manibusan, Shahram Khosrowpanah, Mark Alan Lander, Mohammad Golabi, Ujwalkumar Dashrath Patil. A GIS Based Assessment of a Dynamic Watershed in Guam. *Hydrology*. Vol. 7, No. 1, 2019, pp. 1-9. doi: 10.11648/j.hyd.20190701.11

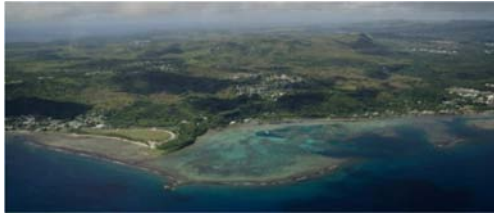
Figure 1. Aerial image of Piti-Asan watershed in Guam.

Piti-Asan watershed lies southeast of the Pago-Adelup fault, which divides the northern limestone and the southern volcanic uplands of Guam (Figures 1-2). The Nature Conservancy [6] created a Draft Conservation Action Plan with the aim in the village of Piti in Guam Island to become a model of a “community based, management driven, and environmentally friendly village with sustainable resources in harmony with the environment.” The above-mentioned plan is part of an effort to: preserve and enhance water quality, native forest, coral reef ecosystem, and endangered species in the Piti watershed. The plan includes an analysis of conservation targets, current condition, ranked threats, potential strategies, and a capacity assessment in order to better direct efforts to improve conservation and reduce human impacts on the natural environment [6].

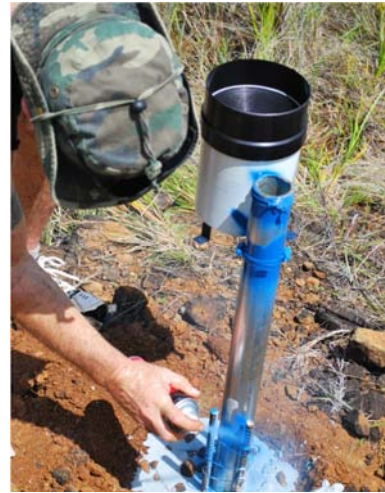
Figure 4. (a) Installation of rain gauge station at a site in Piti-Asan watershed; and (b) Stream flow measurements in Masso river.

Rainfall was measured using two tipping bucket HoboWare® data logging rain gauges (Figure 4a). The rain gauges were placed at two randomly selected sites around the Piti-Asan watershed. Site selection criteria included areas which were unobstructed by large vegetation, buildings, or any other large obstructions that could block rainfall to the rain gauges. Rain gauge sites were also chosen based on ease of access to the site and the risk of damage to the rain gauge by human activity.

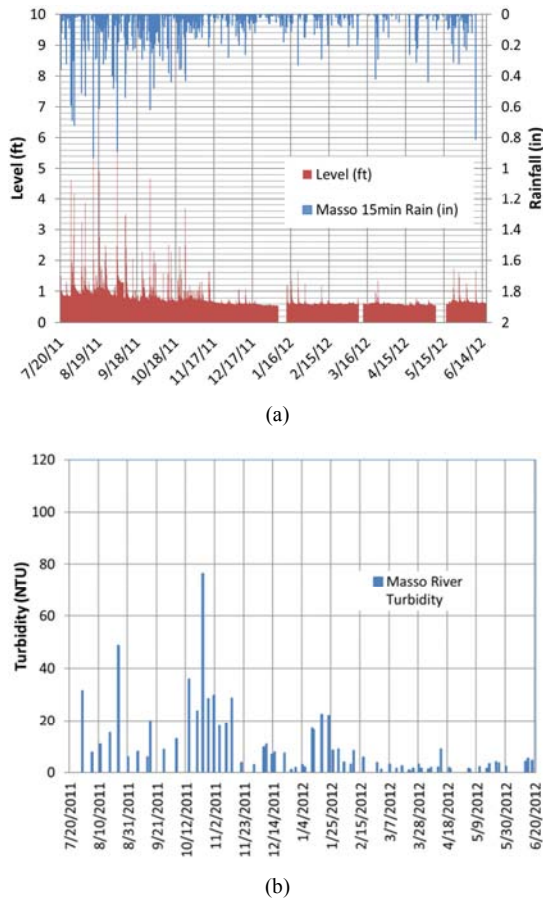
Figure 6. (a) 15-minute rainfall, river level, and (b) turbidity to the Masso River in Piti-watershed.

The hydrologic data including including the rainfall collected for each watershed, stream level measured at 15-minute intervals, and the biweekly turbidity measurements gathered in the course of the study from the Masso and Asan Rivers are shown in Figure 6 and 7 respectively. Figure 8 show the 15-minute rain and stream levels of both the rivers during a single storm event. These figures clearly display the reaction time of water level to changes in rainfall.

It should be noted that there was a gap in the rainfall data collected for the Piti-Asan Watershed (Figures 6-7) between

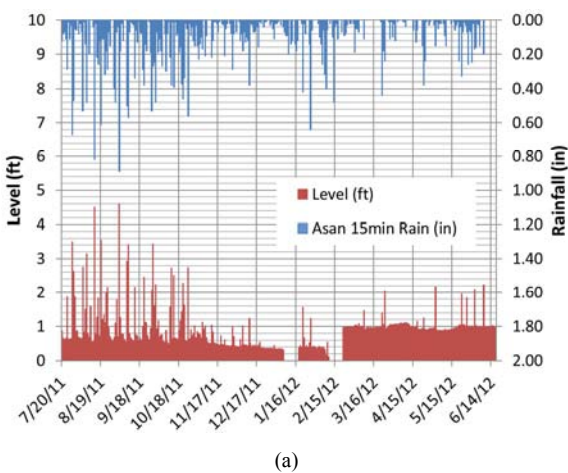
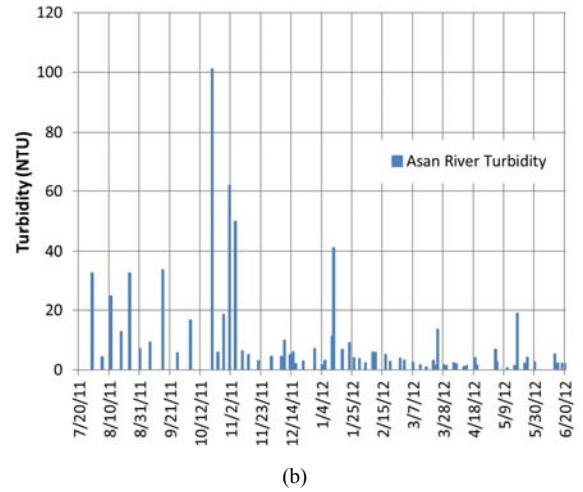
Figure 7. (a) 15-minute rainfall, river level, and (b) turbidity to the Asan River.

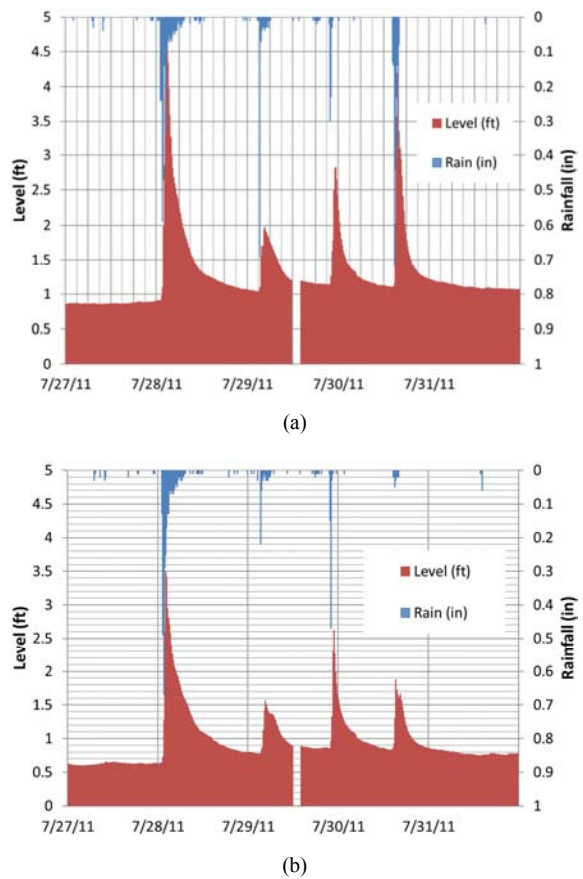
Figure 8. Storm events for (a) Masso river, and for (b) Asan river.

Figure 8a illustrates the reaction time of the Masso River's peak water level during storm events indicating that it occurred within 45 minutes of the peak rainfall during large rainfall events when compared at 15-minute intervals. On the other hand, Figure 8b indicates that the Asan River's reaction time has occurred within 30 minutes of peak rainfall during major storm events. This clearly indicates that the water level of the Asan River is more reactive to rainfall events.

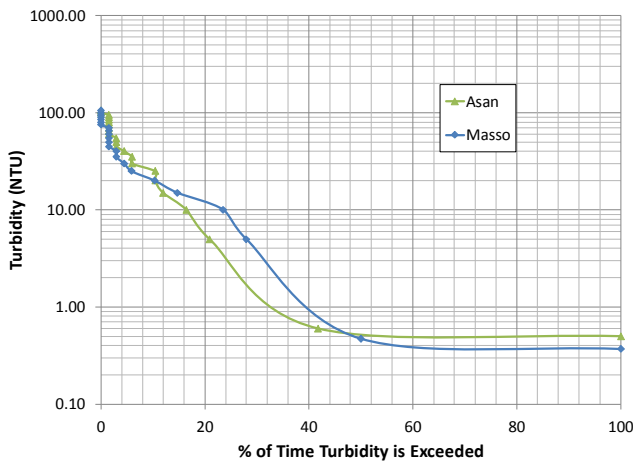
Figure 9. Turbidity duration for Masso and Asan river.

In order to understand the amount of turbidity found within the rivers over time, a turbidity exceedance curve (Figure 9) was created. Figure 9 measures the percent of time that turbidity was equaled or exceeded for the given river. The measure at 100% therefore indicates the base turbidity level. An examination of the graphs leads to the belief that turbidity levels for the Masso River often exceeds the turbidity in Asan River.

The lower level of turbidity shown in Figure 9 and 10 is influenced by the presence of the Masso Reservoir which is located less than a mile upstream from the Masso study site. Because of the reservoir’s position downstream of most of the watershed area, much of the sediment is trapped and settled to the bottom of the reservoir before reaching the Masso study site during low rainfall events. During high rainfall events that cause more erosion however, the sediment carried by higher amounts of rainfall is not given time to settle in the reservoir before being carried to the study site and the river outlet.

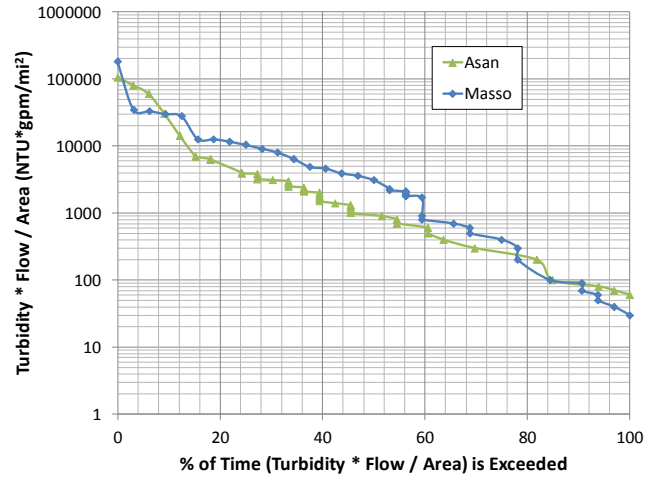
Figure 10. Relative sediment load duration curve for Piti and Asan Watersheds.

The primary interest of the turbidity exceedance, however, is in comparing the relative impacts of the sediment reaching the reef from the two watershed areas. In order to determine the relative measure of sediment load in the Masso and Asan Rivers, the following assumptions were made. First, turbidity is a relative measure of sediment load at a given point. Secondly, turbidity multiplied by the stream flow is defined as a flux rate (turbidity \* flow = flux rate). In order to compare the two watersheds, the flux rate was divided by the watershed areas to produce an area weighted flux rate. Figure 10 illustrates the results of this measurement. Figure 10 takes into account both the amount of flow observed during turbidity measurements and relative sizes of the watershed by factoring watershed area. The product of this is an estimate of the frequency at which the relative sediment load (NTU\* $gpm/mi^2$ ) exceeds a given value. The trends expressed by the relative sediment load duration curve seem to follow closely with the results of Figure 9. The median value of the relative sediment load is about 2000 NTU\* $gpm/mi^2$  for Masso River and 1140 NTU\* $gpm/mi^2$  for the Asan River (Figure 9). The average relative sediment load is 11646 NTU\* $gpm/mi^2$  for Masso River and 11201 NTU\* $gpm/mi^2$  for Asan River.

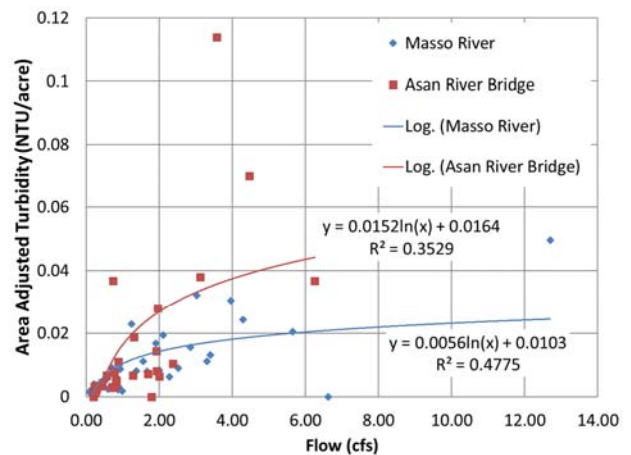
Figure 11. Flow versus Turbidity per Watershed Area of Asan and Masso Rivers.

A comparison of the measured flow and the area-adjusted turbidity for the Masso and Asan Rivers (Figure 11) shows that the Asan River is more reactive to changes in flow so that more turbidity per watershed area is produced by increases in stream flow than the Masso River. The turbidity measured within the Asan and Masso rivers (Figure 11) both reflect low overall turbidity levels, with the exception of major storm events, which produced large increases in the stream turbidity. This is caused by increased upland erosion during heavy rainfall events.

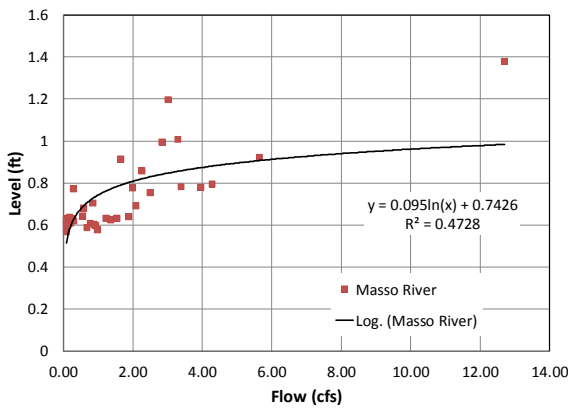
Figure 12. Masso River Stage Discharge Curve.

A preliminary stage discharge curve was developed for the Masso River (Figure 12) and the Asan River (Figure 13), which are the two major stream outlets for the Piti-Asan Watershed. The stage discharge curve was developed from the weekly stream flow measurements conducted within the Masso and Asan Rivers and the stream level measured by the installed level loggers.

The stage discharge curves developed for this study utilized only one-year of data collected. Therefore, this does not provide a fully accurate estimate of the flow and water level relationship of the Masso and Asan Rivers. However, the stage discharge curve developed can serve as the basis for future hydrologic studies within the Piti-Asan Watershed. It is recommended that flow and level recordings of the Asan and Masso Rivers continue to be measured in order to obtain a more accurate estimate of the watershed behavior for future studies.

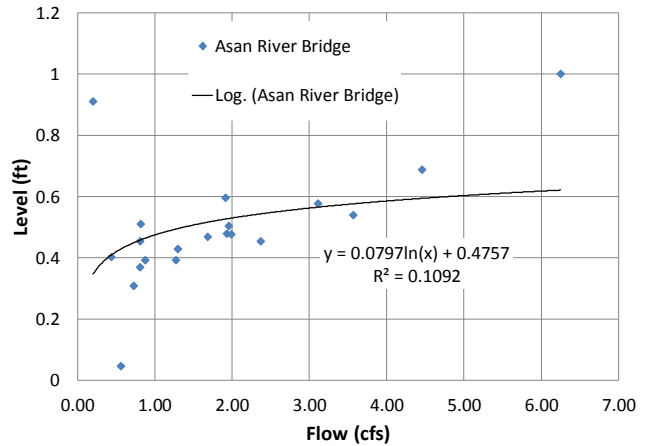
Figure 13. Asan River Stage Discharge Curve.
