# Environmental Pillars for Sustainable Management System in Ancient Olympia

**Abstract:** Sustainability and Environmental friendly management are meanings which were known since the beginning of ages; but were established by the UNEP in 1972 throughout the celebration of the World Environment Day (WED) every year on 5 June; in order to raise global awareness to take positive environmental action to protect nature and the planet Earth. The aim of this paper is to give a chronological series of changes at the unique place of Ancient Olympia, in order to show how nature was before and after the wild fire of Peloponnese at Southern Greece. As foresters and environmentalists we proposed some environmental friendly measures as a systematic treatment of the areas' sustainable management after a wild fire. The post-fire management of Kronius hill and a new plantation based on the existing species with the synergy of natural reforestation gave marvelous solutions after a decade. A series of technical works and protective measures against erosion are suggested in order to achieve the effective development of the area.

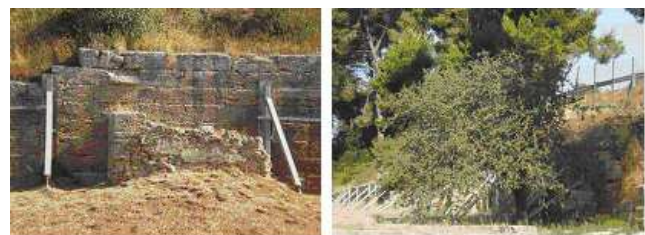
Figure 4. A anti-aesthetic retaining stabilization system with metallic pillars at the existing part of the ancient wall of Olympia.

At the ancient walls of Olympia two problematic areas were located which are prone to collapse after some time due to deforestation. Therefore it is essential to give a solution to this problem, without however affecting of the aesthetic of the sanctuary area is needed (Fig. 2). Firstly, the supporting wall at the Sanctuary area has inclined from the vertical alignments and the upper part of it has fallen down. The thrust of the coniferous routes, the country road that passes over the archeological area and the deforestation after the fire made the possibility of the fallen wall more obvious (Fig. 3, 4).

The second measure that has been proposed to be taken was the slope stabilization of Kladeos River. The existing narrow bridge which is narrow and the riot vegetation in the river bed minimize the flow in case of overflow. So the ancient wall near the river bed needs maintenance, stabilization and raise height (Fig. 4, 5).

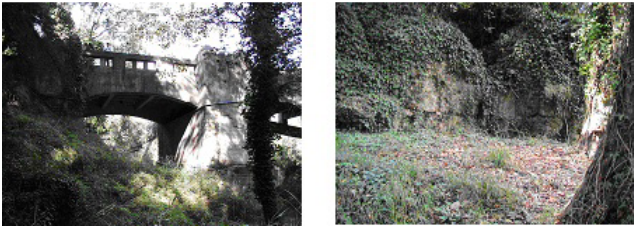
Figure 5. The bridge at Kladeos and the vegetation over the ancient wall at the river aside.

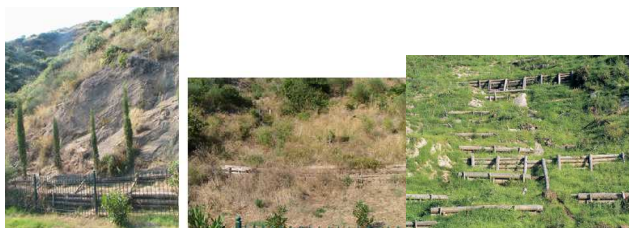
Figure 12. Unsuccessful, successful (a) and (b) retaining steps.

The anticorrosion measures of log bars Kronio hill were almost successful (figure 12b), except for a small area which required an enhanced bracing (figure 12a).
