Effects of Water Pipe Leaks on Water Quality and on Non-Revenue Water: Case of Arusha Municipality

Josephat Alexander Saria

The Faculty of Science, Technology and Environmental Studies, The Open University of Tanzania, Dar es Salaam, Tanzania

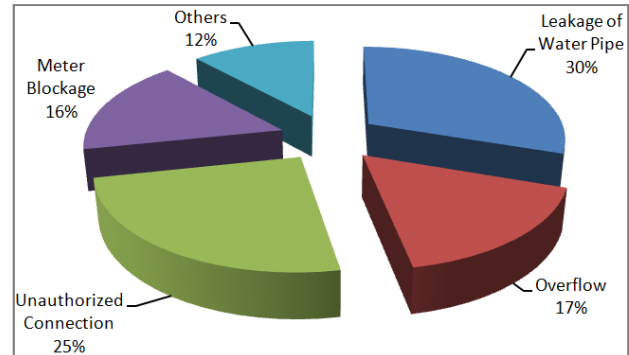
Figure 2. Reasons for an Increase in Non Revenue Water

lost from the distribution system without authorization [11]. When required to identify the main causes of Non-Revenue Water in Arusha Urban Water Supply and Sewerage Authority, the results for respondents are as shown on the figure 2.

Figure 2 revealed that, 24% of respondents pointed out that the main causes of NRW in Arusha Water Supply and Sewerage Authority was caused by unauthorized connections (illegal and by pass); 30% of respondents pointed out that NRW in AUWSA was caused by leakages from water system due to age of the water supply system (Figure 4).

About 16% of respondents mentioned that the causes of water losses caused by stopped/unfunction water meters (bulk and customer water meters), whilst 14% respondents enumerated that non- revenue water was caused by other reasons like corruption and bribery among meter readers,

wrong data capturing, improper customers records, water meter reversal, wrong water meter installations and unread water meters) and 16% of respondents mentioned that NRW was caused by overflow from storage tanks and break pressure tanks.

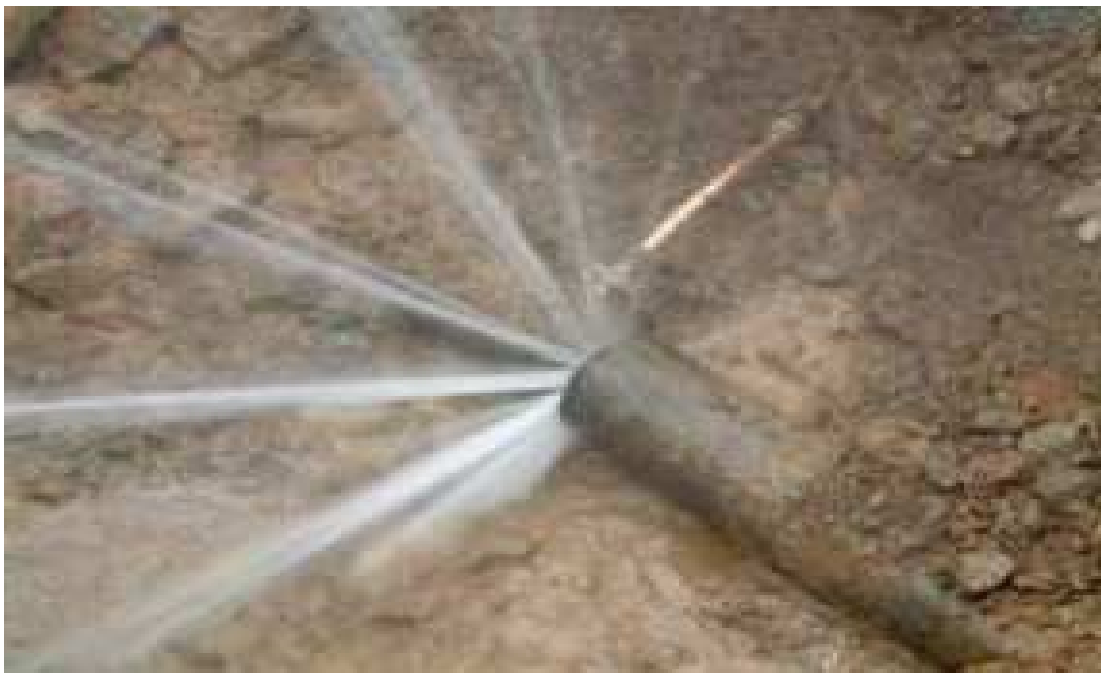
Figure 3. Pipe Bust Due to High Pressure in the Water System.

In Arusha municipality leakage of water pipes is estimated to be around 30% [12]. When management were interviewed they identified it is due to different reasons including old and poorly constructed pipelines, inadequate corrosion protection, poorly maintained valves, mechanical break and high pressure (Figure 3).

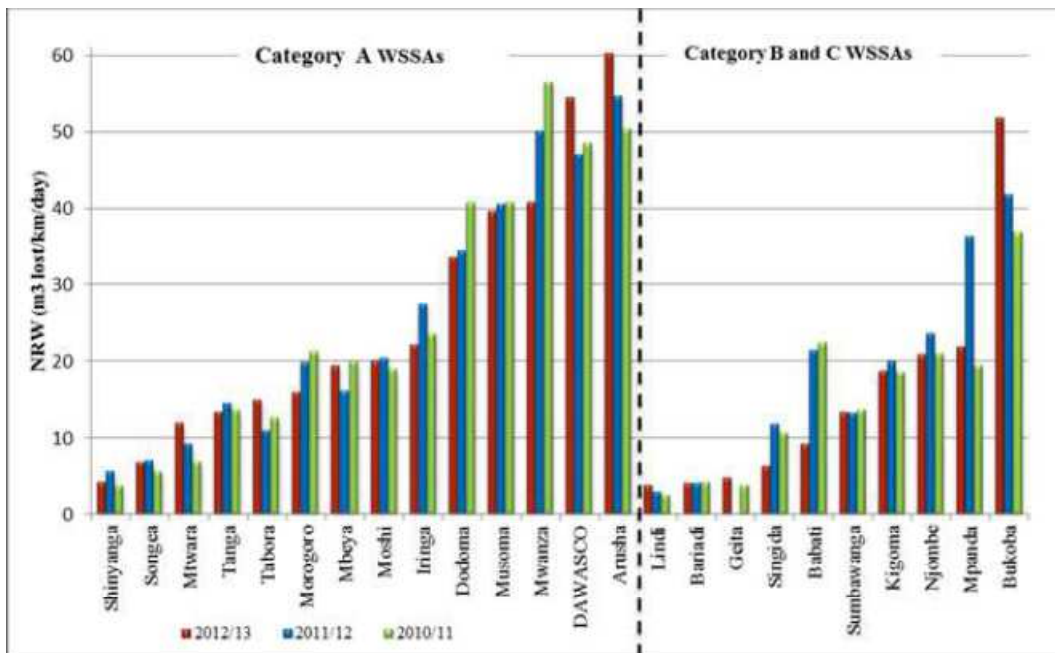
Figure 5. NRW Measured in a Kilometer Length of the Pipe Network in One Day [7].

The most commonly used indicator to measure NRW is the percentage of NRW as a share of water produced. When losses in terms of absolute volume are constant the percentage of NRW varies greatly with total water use, i.e. if water use increases and the volume of losses remains constant the percentage of NRW declines. This problem can be eliminated by measuring NRW not as a share, but in terms of absolute losses per connection per day, as recommended by other researchers [9]. Nevertheless, the use of percentage figures to compare levels of NRW remains common despite its shortcomings. Losses per kilometer of network are more appropriate to benchmark real losses, while losses per connection are more appropriate to benchmark apparent losses. On average, Arusha WSSA continued to have the highest NRW (m^3 lost per km per day) which was $60.2m^3$ of water per day in a kilometer length of the distribution network. Previously in 2011/12, Arusha WSSA had the highest volume of $54.48 m^3$ of water lost per km per day (Figure 5).

Apart from Arusha Municipality having high volume of water lost per kilometer in a day, also Arusha WSSA continued to have the highest water connection density in a kilometer of the water distribution network with 132 connections per kilometer of water distribution network. Meanwhile, Lindi WSSA remained with the lowest reported water connections density of 15 connections per kilometer. All these are the big source of NRW.

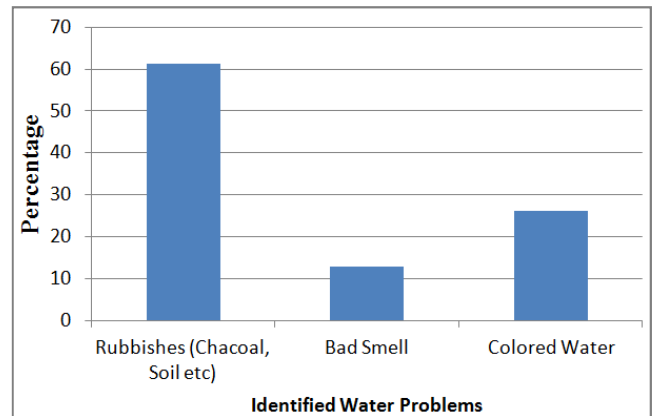
Figure 6. Issues Identified by Customers on the Quality of Water.

The responses showed that water from the taps is seen dirty (muddy) when there is a burst or broken pipe which creates a leakage somewhere in the network allowing mud to get into the network (Figure 6). Sometimes mud is seen in the taps when there is a new water connection made somewhere in the neighbourhood.

The highest number of respondents more than 60% indicated that they have seen rubbishes like charcoal, muddy and sand coming from their pipes.

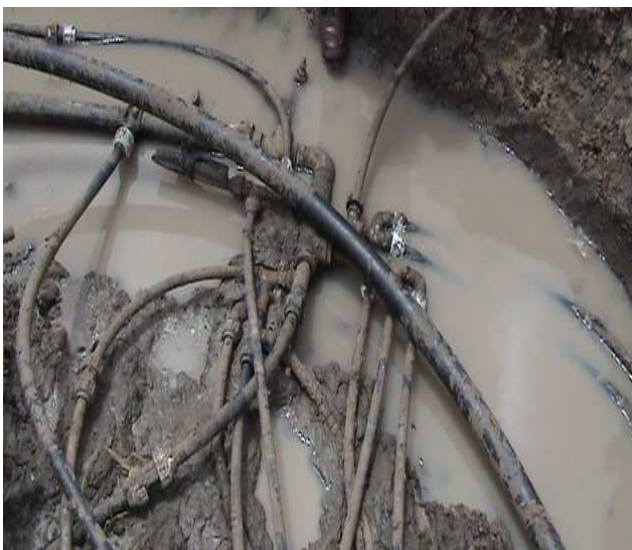
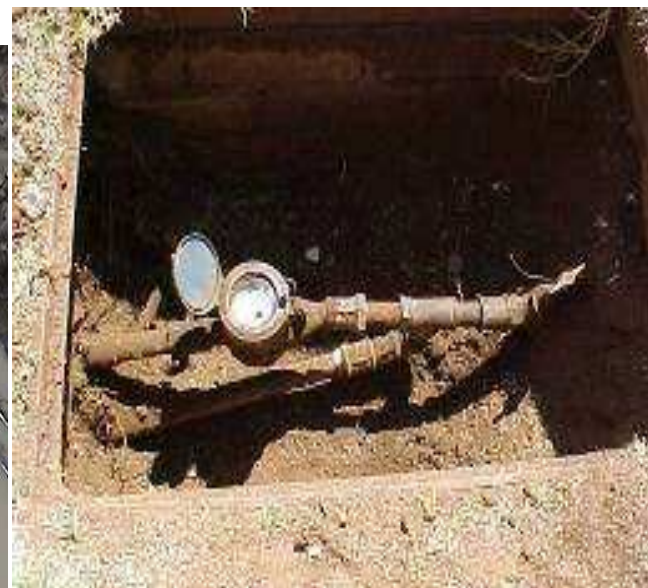
Figure 7. Poor Connections and Meter By-Passing.

In the discussion with AUWSAs management and the Annual reports the number of unauthorized connections increased from 129 during financial year 2009/2010 to 304. All these seem to be a big issue in having high NRW in Arusha Municipality.
