Restoration Efforts of Degraded Land, Challenges and Prospects: The Case of Soro Wereda, Hadiya Zone, Southern Ethiopia

Eyasu Estefanos Shanko. Restoration Efforts of Degraded Land, Challenges and Prospects: The Case of Soro Wereda, Hadiya Zone, Southern Ethiopia. *American Journal of Environmental and Resource Economics*. Vol. 7, No. 3, 2022, pp. 77-86.

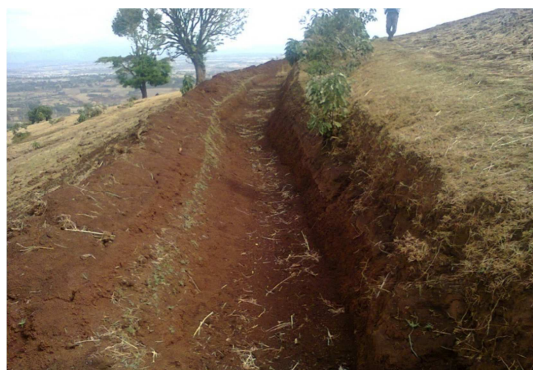
along the steepest slope on in a valley to receive accommodates runoff from cut-off drains and graded terraces/ bunds. This measure was used to carries the run-off to rivers, reservoirs or gullies safely without creating erosion [14] (See figure 4).

Figure 4. Practice of water way Photo by Researcher, 2015.

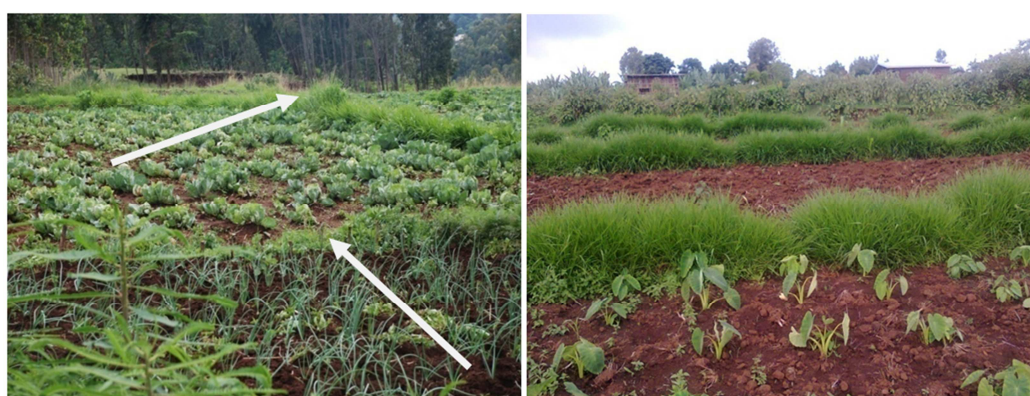
Figure 6. Grass strip by the local farmers at 1st Hankota Kebele Photo by Researcher, 2015.

Grass strip has been practiced by 35.1% of the sample households. The grass is either planted or naturally grow in narrow strips along the contour at intervals across the slope of a field for the purpose of reduce runoff, nutrient loss and for the improvement of the fertility of soil. This measure also involves the growth of natural grasses between croplands across the contour and planted grasses between the crops across the contour line (See figure 6).
