Slope Mass Rating Around Malekhu-Thopal Khola Corridor, Malekhu, Central Nepal Lesser Himalaya

Jaya Laxmi Singh, Naresh Kazi Tamrakar. Slope Mass Rating Around Malekhu-Thopal Khola Corridor, Malekhu, Central Nepal Lesser Himalaya. *American Journal of Science, Engineering and Technology*. Vol. 2, No. 1, 2016, pp. 6-14. doi: 10.11648/j.ajset.20170201.12

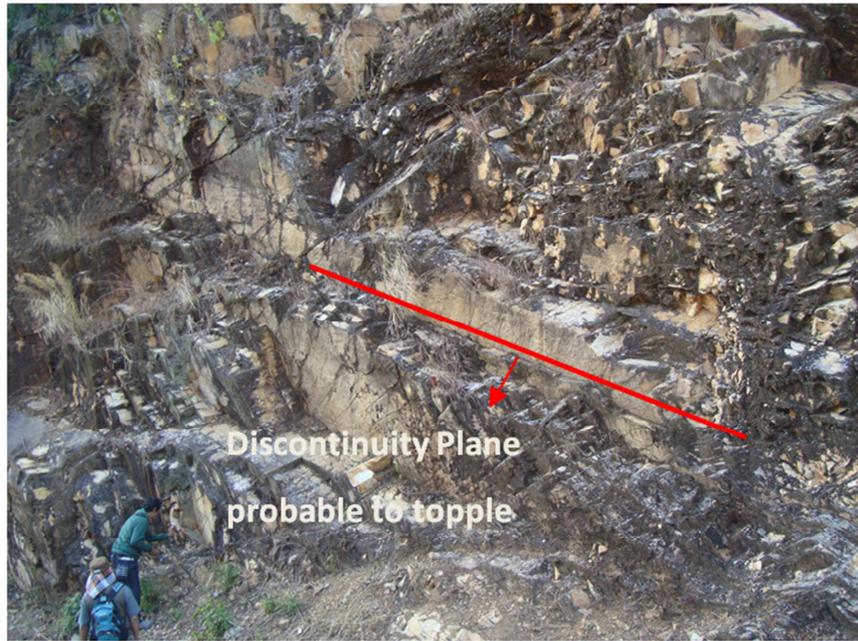
Figure 4. Hill slope of Fagfog Quartzite, near Kali Daha, Malekhu-Dhading road (location Fg1).

Three sites (Fg1(LS) left hillslope site, Fg1(RS) right hillslope site and Fg2) across the Fagfog Quartzite, were studied. Fg1(LS) is stable considering plane failure and wedge failure, but it is partially stable considering toppling failure. The condition of slope driving the toppling failure is shown in Figure 4. Fg1(RS) is unstable to stable in terms of plane failure, stable in terms of toppling failure, and is stable to completely unstable considering wedge failure. Fg2 is completely stable in terms of plane and toppling failures and few is stable in terms of wedge failure.

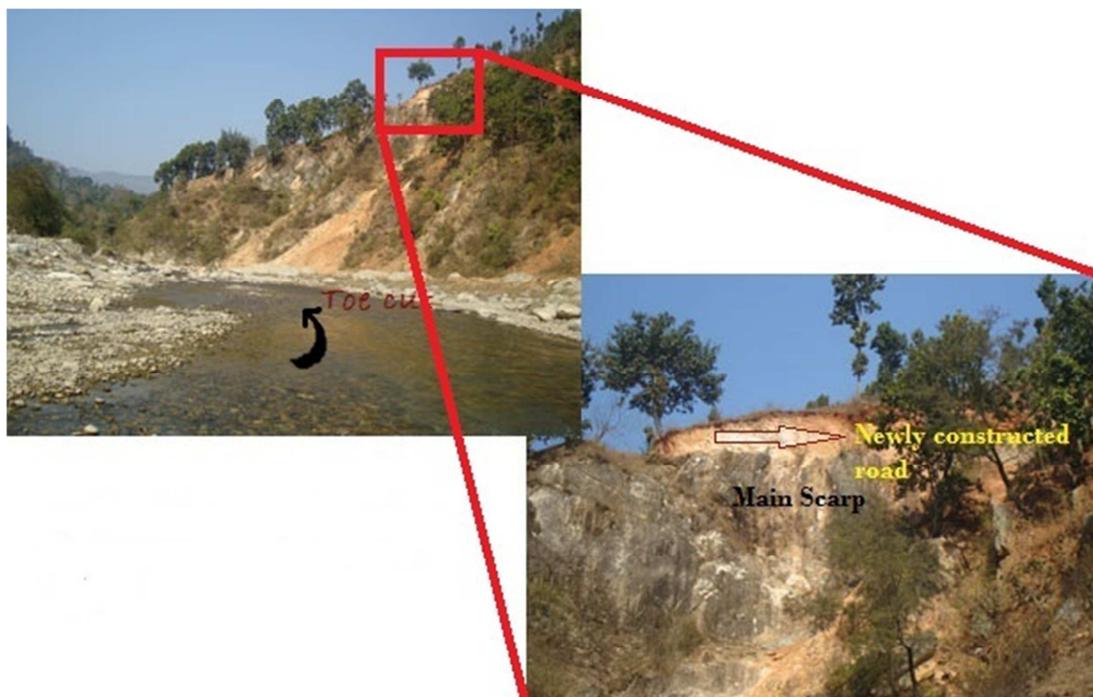
Figure 5. Unstable slope of the Robang Formation; Toe cut and newly constructed road damaged (right).

Rb1(site of the Robang Formation) is mostly stable. Slopes are partially stable in Rb2. Rb3 is stable to completely stable, partially stable to stable and is stable respectively in terms of plane toppling and wedge failure modes. Although the SMR shows stable slope of Rb1 in terms of toppling failure, such failure is generated by toe cut due to river flow as shown in Figure 5.
