Conservation-Oriented Structural Analysis of the Spire of Barcelona Cathedral

Abstract: The spire of Barcelona cathedral suffered from severe problems due to the corrosion of the steel ties used in reinforcing its stone masonry beams. Wide visible cracks were noticed in the stone beams and large parts were detached. Therefore, the full spire was dismantled and reconstructed using titanium ties to eliminate the corrosion problem. A finite element model of the spire was created and analyzed using DIANA software to support this decision. This analysis helped in understanding the role and strength contributions of these ties in resisting the applied loads on the spire, specifically, the lateral loads of earthquakes and wind. A nonlinear static (pushover) analysis was carried out to assess the spire capacity under the lateral loads. A number of constitutive models for modeling the masonry behavior were tried. Also, a number of seismic actions patterns were considered. As a main conclusion of this study, the ties were highly needed to carry the tensile stresses caused by earthquakes and wind loads. Therefore, in the reconstruction of the spire, such ties must be kept in the masonry beam

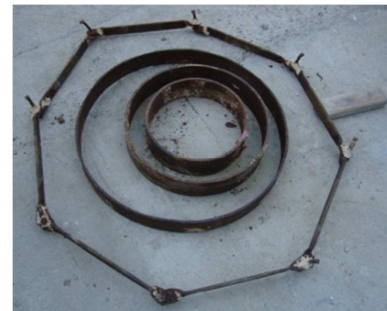
Figure 2. Corroded steel ties extracted from the spire.

The steel ties used in reinforcing the spire beams suffered from severe corrosion due to the rainy weather of Barcelona city, Fig. 4. Due to corrosion products the steel ties increased in volume (the volumetric increase may reach ten times the original volume) which caused pressure on the surrounding stone masonry and led it to crack (Fig. 5) or furthermore to fall down (Fig. 6). Big parts of some of the stone masonry beams were about to fail due to corrosion products and were temporary kept in position by some ropes (Fig. 7).

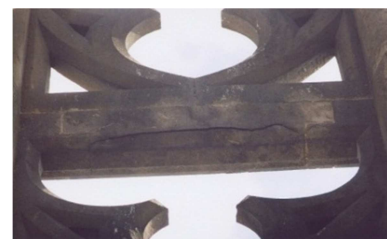
Figure 3. Wide cracks due to corrosion products.

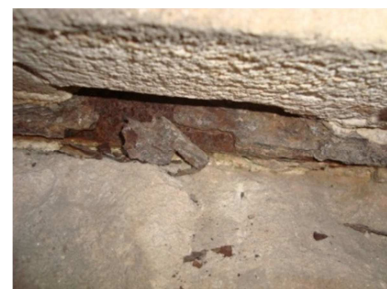
Figure 4. Corrosion products resulted in stone fall down.

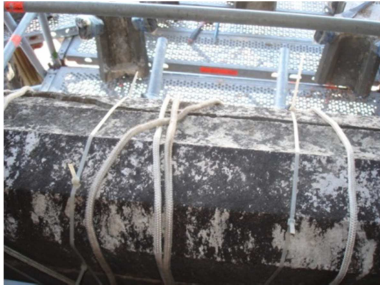
Figure 5. Detached parts kept temporary in position by ropes.

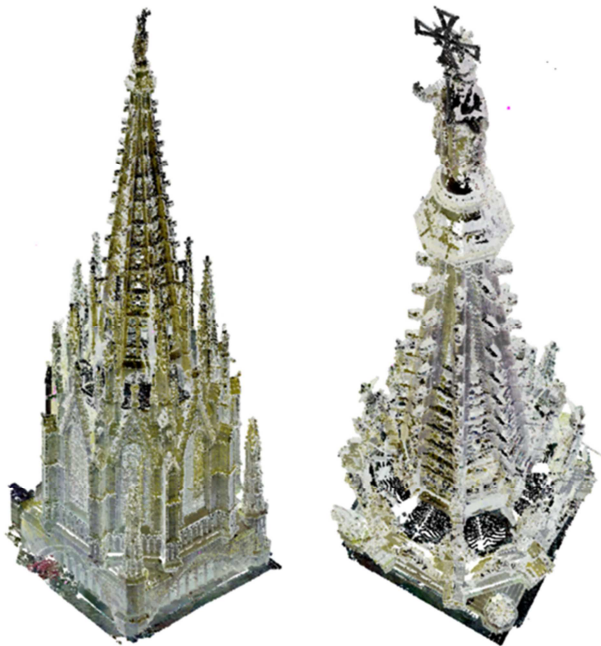
Figure 8. 3D laser scanning for the documentation of the spire (by TT12 Gabinet de Topografia i Construcció).

The spire was completely dismantled and reconstructed. Before doing so, the spire and the supporting cimborio were documented using 3D laser scanning (Fig. 8).

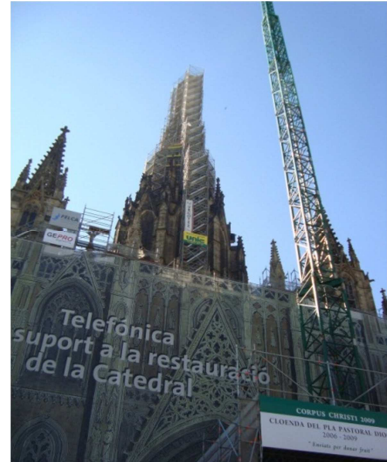
Figure 9. Complete scaffolding for restoration works.

In order to execute the restoration works, complete scaffolding started from the roof level and extended to the last top part of the spire was employed (Fig. 9). Another steel structure was constructed inside the spire (Figs. 10-11). This steel structure was used to support the spire during the dismantling and as well as scaffolding for the reconstruction process.

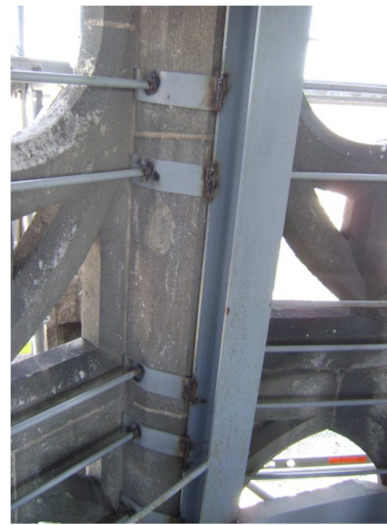
Figure 10. The columns of the steel structure and its connections with the spire.

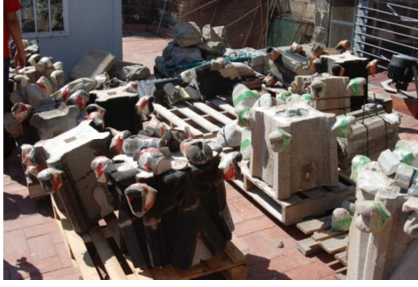
Figure 6. Storing the dismantled parts on the cathedral roof.

The different parts of the spire were numbered and then were cut at the locations of the mortar joints using electrical saw, Fig. 12. The spire pieces were stored on the roof of the cathedral, Fig. 13. The stone was cleaned and then the spire was reconstructed again.
