Preventive Work and Health Monitoring for Technology by Cracks of Concrete Surface Using Coating Type Resin Sensor

Nobuhiro Shimoi, Yu Yamauch, Kazuhisa Nakasho. Preventive Work and Health Monitoring for Technology by Cracks of Concrete Surface Using Coating Type Resin Sensor. *International Journal of Sensors and Sensor Networks*. Vol. 11, No. 1, 2023, pp. 1-10.

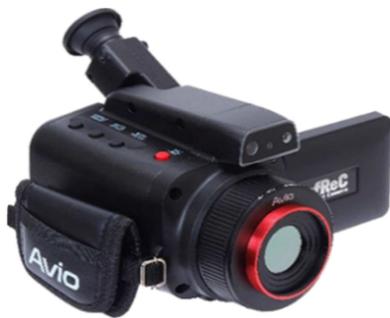
Figure 2. IR Camera.

To evaluate concrete structures' safety and soundness, long-term monitoring during more than 20 years is regarded as necessary. However, the difficulty exists that neither a measuring device able to guarantee the required monitoring period nor a smart sensing method that enables danger prediction exists at present [12, 14–17]. Table 1 presents specifications of the infrared camera used for measurement. Figure 2 portrays an image of the camera used for testing.

Model	InfRec R450; Nippon Avionics Co. Ltd.
Detector	Two-dimensional non-cooling method
Measurement temperature range	-40 to 1500 °C
Measurement wavelength	8 to 14 μm
Number of pixels	480 × 360
Measurement field of view	24 degrees × 18 degrees
Standard lens	10 cm to ∞
Weight	3.8 kg

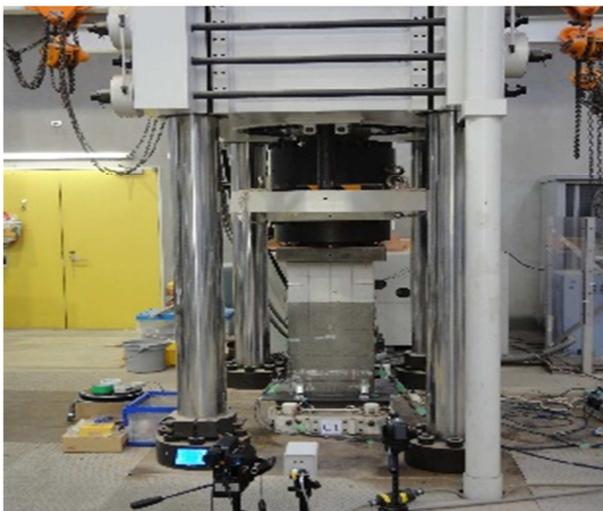
From the principle of the infrared thermography, when measuring with an infrared camera indoors, if no difference exists between the outside temperature in the atmosphere and the temperature of the test object, then one can forcibly heat the surface, perhaps using a halogen lamp, to heat the interior of the test object. A method of measuring cracks and floats based on the temperature difference between the surface and interior can be used. However, the use of such a method requires that the measurement conditions always be established and implemented under favorable conditions, with due consideration devoted to the influence of the outside air temperature, the measurement target material and color, the spectral reflectance, and the measurement distance. Actual practical measurements are expected to be difficult. Figure 4 portrays the influence of the loading tester of the specimen (a) and the reinforcement arrangement of the specimen (b). A test specimen is prepared using ordinary

concrete with a 2 cm cover thickness on this reinforcing bar. For this study, to improve the measurement level considering the problems caused by these thermal image characteristics, specimen A was an RC post with a $\phi 65$ hole drilled 23.5 cm below the center on the left side of the lower part of the specimen (a). Specimen (b) is an RC post with a $\phi 65$ hole drilled 235 mm above the center on the right side of the specimen.

Figure 4. Experiment of equipment and specimen.

A hole of $\phi 65$ was artificially machined to imitate the defect of a concrete support column. It was conducted to measure the strength effects on the upper and lower parts. However, to ascertain the measurement effects of the infrared camera by resin coating and the result of preventive work in the fracture situation, gel-like resin (CY52-276; Dow Corning Toray Co. Ltd.) was applied to the entire lower surface of each test body AB, except for the upper 300 mm. A coating film containing 1% aluminum powder with particles of 10–20 μm was applied to about 0.1 mm thickness. The material properties of this resin include resistance to ultraviolet rays, lack of hardening over time in the coating film, and maintenance of a gel-like property. Moreover, it does not retain water. It takes about 1 hr to harden after mixing 1 liquid and 2 liquids equally. The price is 1,000 yen per kilogram.

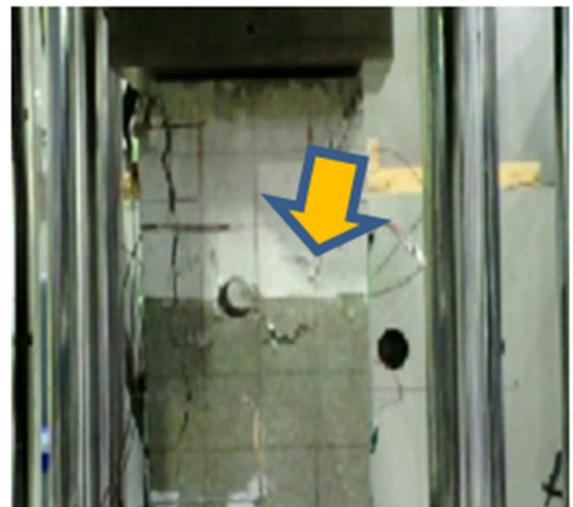
with this resin and parts not coated with this resin. Figure 7 presents specimen (b) after completion of the destructive test. Destruction is generated by the shearing force generated obliquely from the right side of the screen and compressive force applied from the top. Particularly, it seems that infrared measurement was able to confirm the effects of suppressing the scattering and collapse of concrete fragments because of compression failure and the "floating" situation indicated by the arrow, which is difficult to detect using a visible-light camera. Panel (a) depicts a thermal image of Specimen B taken using an infrared camera. Panel (b) portrays an image taken using a visible-light camera. In both cases, the elapsed times of force application were equal.

Figure 7. Infrared camera image and visible-light camera image.
