# UAV-Based Photogrammetric Inspection of an Urban Bridge in a Lagoonal Environment: Case Study of the Old Cotonou Bridge

Kora Farid Carlos Yarou<sup>\*</sup> , Valery Kouandete Doko, Boris Ganmavo ,  
Thede Agbelele , Mohamed Gibigaye

Civil Engineering Department, University of Abomey-Calavi, Abomey-Calavi, Benin

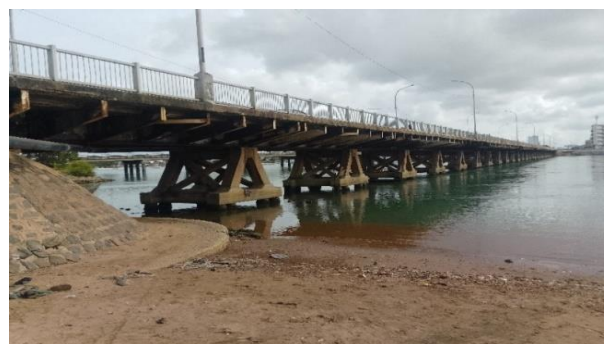
The Old Cotonou Bridge is a reinforced concrete under-roadway twin-girder structure, 380 m long, comprising 30 simply supported spans of 12.6 m, resting on two abutments and 29 intermediate piers. The deck is 11 m wide overall, with a carriageway of  $2 \times 3.70$  m, flush strips of 0.25 m on each side, footways of 1.50 m, and S8-type guardrails. The study area covers 0.118 km<sup>2</sup> in WGS 84 / UTM zone 31N (EPSG: 32631), centred on E 438 300, N 702 920.

**Figure 1.** View of the Old Cotonou Bridge crossing the Cotonou Lagoon.

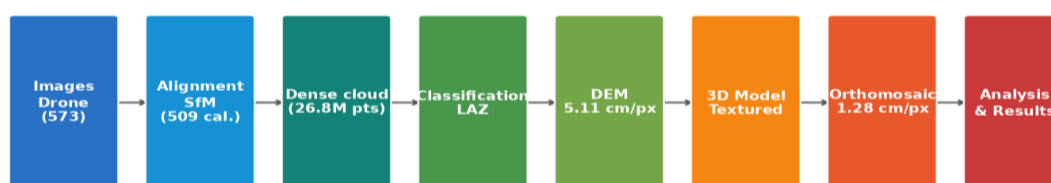
All processing was performed with Agisoft Metashape Professional 2.3.1 [10] on a workstation equipped with an Intel Core i7-9700KF at 3.60 GHz, 16 GB RAM, and an NVIDIA GTX 1060 GPU. The complete processing chain is shown in Figure 3. The alignment step retained 509 of the 573 images (88.8%) and generated 266,227 tie points with an RMS reprojection error of 1.40 px. The dense reconstruction, derived from 504 depth maps at “Medium” quality with “Mild” filtering, yielded a cloud of 26.8 million points.

Figure 3. Complete photogrammetric processing pipeline, from raw images to final products.
