Case Report

# Geotechnical Design and Construction of Gabion Shoreline Protection for an Integrated Creek Improvement Project in Diobu Creek, Port Harcourt, Niger Delta, Nigeria

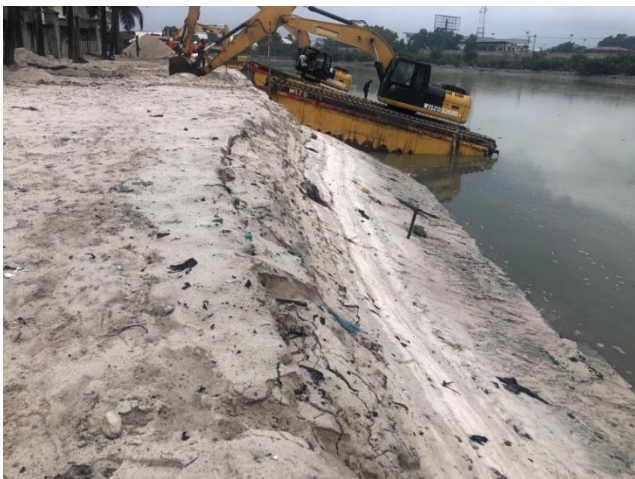
*Figure 4. Slip failures in formed sand slope.*

During periods of heavy rainfall and saturation, portions of the regraded sand slope experienced localized slip failures (Figure 4). These failures are attributed to transient increases in pore-water pressure and reduction in effective stress within the newly placed/regraded material. The occurrence of such failures highlights the importance of considering transient groundwater and seepage conditions in addition to drained shear strength.

Where localized failures occurred, the affected zones were excavated/treated with crushed stone and reinstated to restore the design profile. The practical response demonstrates that construction-stage stability may be more critical than the long-term drained condition, particularly where reclamation materials are placed rapidly adjacent to a tidal water body.

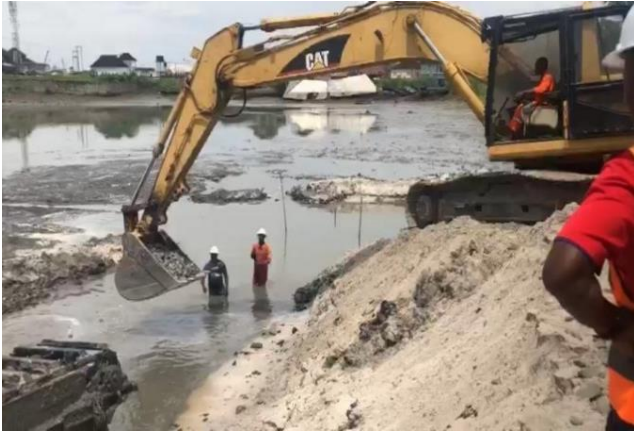
**Figure 5.** Placement of crushed stone footing.

Figures 5 to 8 show the sequence of installation of the Gabion Revetment. The completed gabion revetment produced a flexible, permeable and relatively rough shoreline surface [21, 22]. Unlike an impermeable concrete wall, the gabion system allows water to pass through the structure and dissipates part of the hydraulic energy through the voids and frictional resistance within the rock mass.

A practical construction response involved controlled mixing/treatment of the soft sediment with sand and subsequent placement of approximately 0.45 m of crushed stone to establish a stable foundation platform. The stone layer served multiple functions: it improved the working surface, distributed the structural load, provided drainage and reduced the likelihood of direct settlement or deformation of the gabion toe into the weak sediment.
