Case Report

Assessment of the Causes of Pavement Failure Due to Sub-Base and Sub-Grade Materials Along Nekemte-Bedele Road

Bulcha Assefa, Fikadu Fufa, Mesfin Dinku

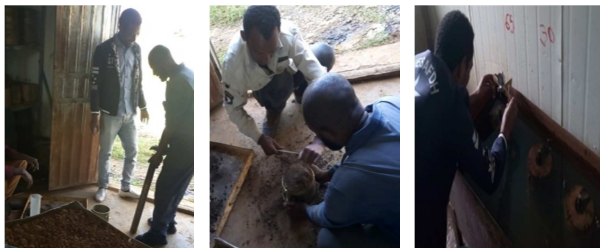
Figure 5. CBR test (photo taken by Imiru 17/10/2020@11:15 AM).

The California bearing ratio (CBR) test is a penetration test carried out to evaluate the mechanical strength of a sub-base, selected fill, and natural subgrade soil material. The soaked method of CBR was conducted to characterize the soil for use as a sub-base and selected fill material. A portion of air-dried soil sample was mixed with optimum moisture content. This was put in CBR mold in 5 layers with each layer compacted with 56 blows using a 4.5 kg hammer (Modified proctor test). The compacted soil and the mold were weighed and placed under the CBR machine and a seating load was applied. Load was recorded at penetration of 0.625, 1.25, 1.875, 2.54, 3.75, 5.08, 7.5, 10 and 12.5 mm.

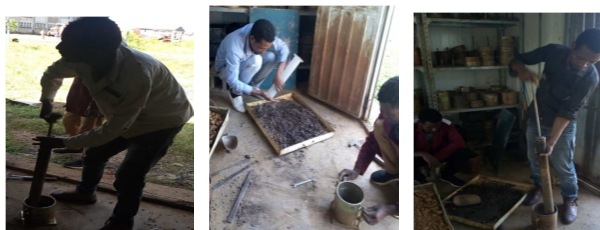
Figure 6. Proctor test (Photo taken by Kasahun 25/10/202).

Compaction tests were performed for sub-base, selected fill, and natural subgrade soil materials based on the AASHTO T-180 test procedure for compaction. The densification of soil with mechanical equipment thereby rearranging the soil particles which makes them more closely packed increasing the ratio of horizontal effective size to the vertical effective stress. The degree of compaction is measured in term of its dry weight and it increasing the bearing capacity of road foundation, stability slopes, controls undesirable volume changes, and curb undesirable settlement of structures. The mold is filled and compacted with soil in five layers of a 4.5 kg rammer.
