Accessibility of Commercial Buildings for Persons with Physical Difficulties in Addis Ababa

Eyuel Ketema, Esayas Deribe

Department of Architecture, Addis Ababa Science and Technology University, Addis Ababa, Ethiopia

Eyuel Ketema, Esayas Deribe. Accessibility of Commercial Buildings for Persons with Physical Difficulties in Addis Ababa. *Landscape Architecture and Regional Planning*. Vol. 7, No. 3, 2022, pp. 34-42. doi: 10.11648/j.larp.20220703.11

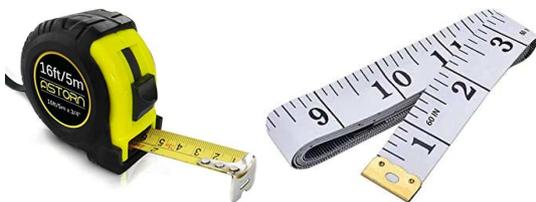
Figure 1. Measuring instruments, diy.com.

A measuring tape is an equipment that is used to get a numerical measurement of a physical feature (character). The researcher used an instrument based on a checklist to observe all four (4) commercial buildings that were chosen. The numerical measurements were then recorded in the notebook, together with other data captured by the camera.

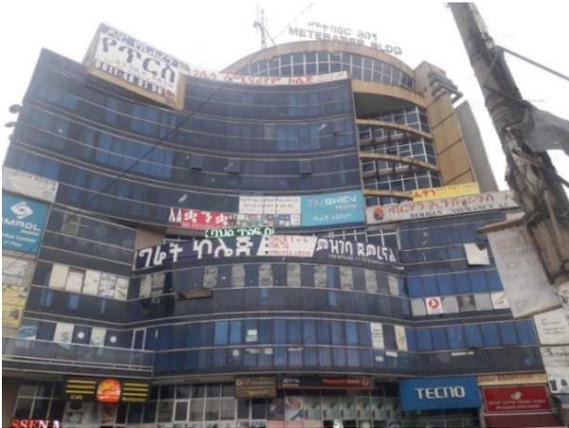
Figure 2. Metebaber building view.

It's a Basement+G+8-story commercial structure in the heart of the business center. The building features a large central circulation room with ceramic tile flooring. As part of the building circulation system, there is one (1) ramp, two (2) main stair cases, and two (2) supplementary supported staircases, as well as one (1) elevator at the main entrance. From the central space, two corridors lead straight forward from the main entrance and to the left side of the building, where the shops are located.

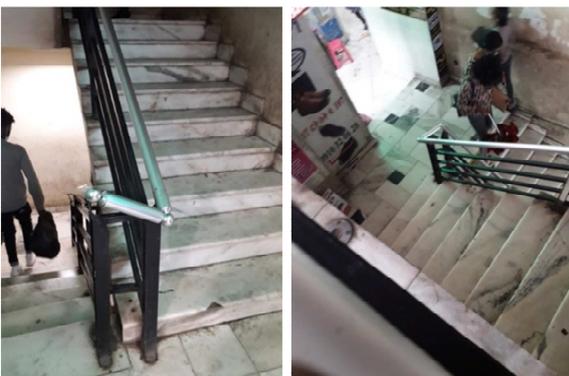
Figure 3. Metebaber building main stair cases view.

The main two stair types on this building are U-shaped staircases. Two parallel flights of straight stairs are connected by a landing, resulting in a 180-degree turn in the walk line. The main stair has a width of 3.3 meters and a landing area of 1.5 meters, while the second main stair has a width of 2.9 meters and a landing area of 1.1 meters.

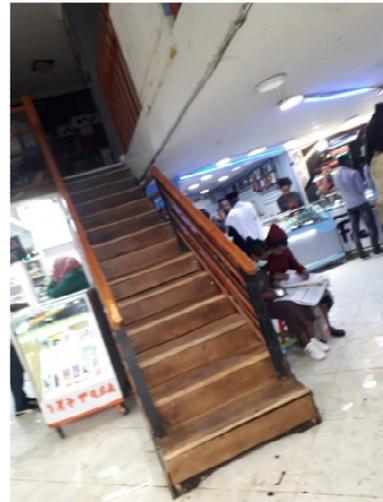
Figure 4. Metebaber building supportive stair case view.

Straight stair types are employed for the other two types of supported stairs. Straight stairs can be made more transparent than other types of stairs by selecting thinner treads, open risers, and thin metal stringers, allowing less obstruction to the view beyond. This is a sturdy staircase that was built with a distinct color scheme in mind having 1m width without any flights.

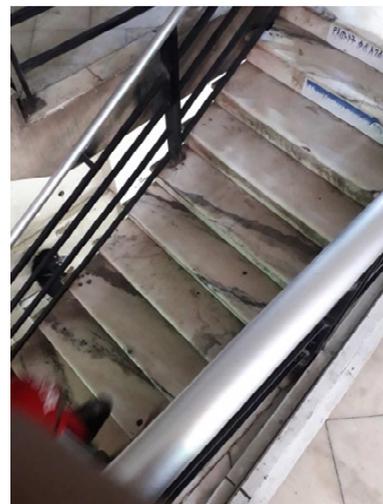
Figure 5. Stair case steps view.

Number of stair steps (risers): Stair 1 (Main stair) has 16 steps each flights which makes the users tired because the room height is 5.4m and stair 2 (main stair 2) has 9 steps each flights which was more or less comfortable for normal persons which doesn't have physical disability (3.06m room height). The other additional supportive stair cases (stair case 3 & 4) have 15 steps with one flight having higher riser height.

Stair Riser and Tread width: The step of stair 1 (Main stair1) and stair 2 (main stair 2) has 17x32 cm rise & tread width respectively and the other additional supportive stair cases (stair case 3 & 4) have 20.4x15 cm rise & tread width respectively.

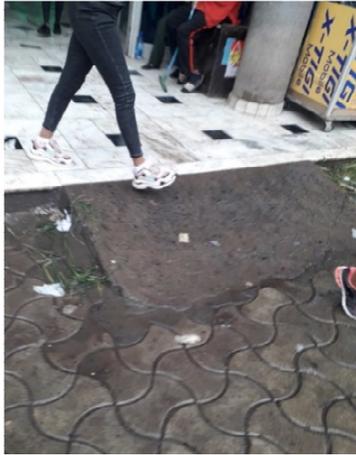
Figure 6. Metebaber building Ramp.

Ramp width and slope: Metebaber building has only 1 ramp at the main entrance. The ramp type used was like threshold ramps which has 1.5cm height rise with a good slope. These ramps are simple, cost-effective solutions for people using a wheelchair and canes. Also there is 1 elevator in the building used to simplify difficulties related to vertical circulation.

Material and texture: The material used for the ramp is concrete which is good material for wheelchair users because it's not slippery and for the stair 1 & 2 marble floor material and steel + Aluminum rail used and for the rest of the 2 additional supportive stair cases timber floor material and timber + steel rail used.

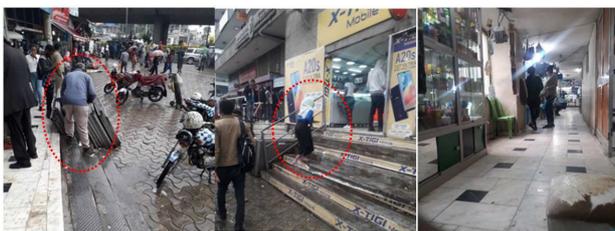
Figure 7. Metebaber building exterior steps.

Safe, convenient, rapid circulation is essential for all buildings under both normal and emergency conditions. Such circulation may be channeled through any of several different types of passageways, such as lobbies, corridors horizontally and stair, elevators etc... vertically so, equal distribution of vertical circulations, visibility and its safety from any obstructions are needed. In this building structure the orientation of stair cases and elevator are fair except the ramp access.

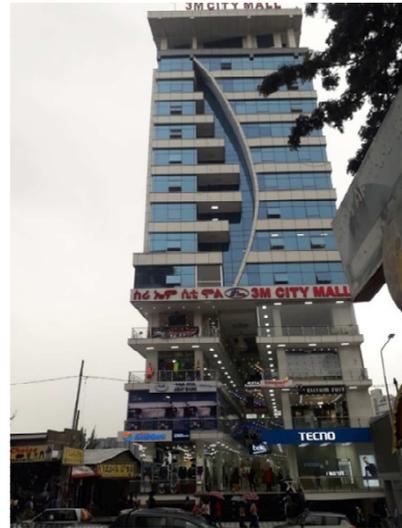
Figure 8. 3M City Mall view.

Megenagna, Addis Ababa, Ethiopia and it's found near to Betelhem plaza, Zef Mesh grand mall and Metebaber Notable buildings. The building has wide central circulation area which is covered by ceramic tile floor finish. Two (2) ramps one for car and 1 for wheelchair users, two (2) main stair cases, two (2) elevators and two (2) steps at the main entrance used to access the building.

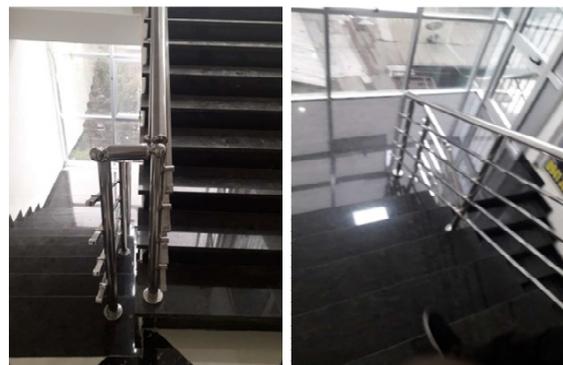
Figure 9. 3M City Mall stair case view.

Stair type: The main stair cases have 3m width with 1.5m landing area. Starting from the ground floor up to the 3rd floor the building room height is 3.91m then it becomes 3.4m when we go above.

A wide supportive steps are constructed which connect the site level to the building ground floor (which is elevated 1.36m).

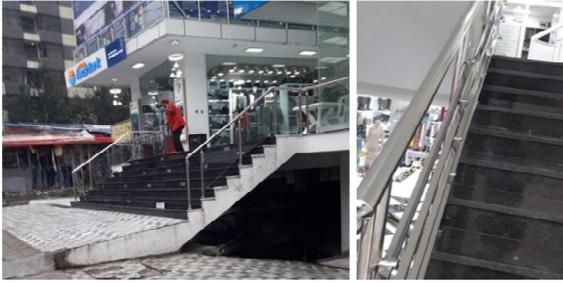
Figure 10. 3M City Mall exterior steps and stair steps view.

Both stair cases has 11 steps in one flight and 12 steps in the next flight from basement floor to G+3 story then both flights becomes 10 steps in each flights. The building has 3.91m room height starting from ground up to 3rd floor then the room height become 3m when we go to the upper floors. Both steps which lead from site road to the ground floor main entrance and the site road to the basement floor have 8 steps.

The step of both stair cases and front entrance steps have 17x32 cm rise & tread width respectively and the riser height makes tough to use for peoples with limited physical disability.

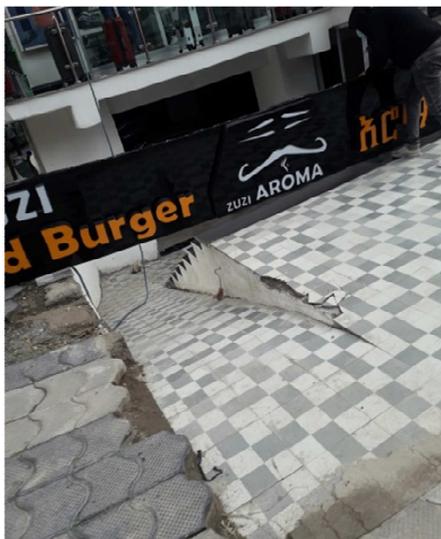
Figure 11. 3M City Mall ramp view.

The preferred slope for a building access ramp is 1:12 or 1 inch of rise per 12 inches of horizontal run - that's roughly an 8% slope. 3M City Mall building has 1 ramp which is constructed for wheelchair users which leads to the basement floor then the users get access of the two elevators. It's a simple ramp design which has 1.36m height rise, 90cm width with a one turn 8m run this means it have a steeper slope estimated to 17% slope without handrails on both sides.

Material and texture: The material used for the ramp is ceramic tile which is more or less good material for wheelchair users because it helps them to move easily and for both stairs & steps marble floor material + Aluminum rail used.

Because of lack of handrails the ramp is slippery (it is not safe) but the others are stable and slip-resistant.

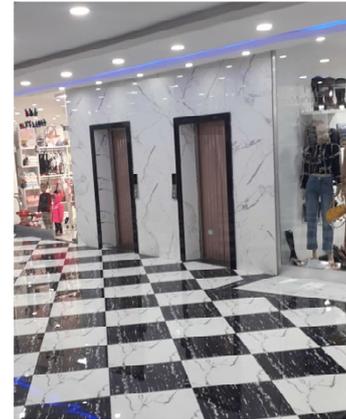
Figure 12. 3M City Mall interior view.

On this 3M City Mall building a good attention is given for color coding to convey information quickly, which facilitates visual search. For example, the vertical circulations (stair, ramp and elevators) can be differentiated because of their good color combination this creates easy access on the building structure.

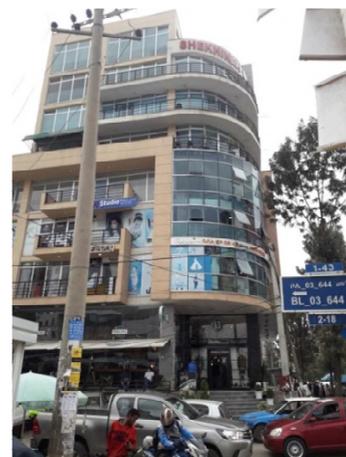
Figure 13. Shekinah building view.

Shekinah building is a Basement+G+7 story one of the newly constructed commercial buildings which are located at Bole Medhanealem, Addis Ababa, Ethiopia and it's found next to Bank of Abyssinia Tele Medhanealem branch on the road to embassy of Ukraine or near to Bole Medhanealem roundabout. The building has wide central circulation area which is covered by ceramic tile floor finish. Two (2) ramps one for car and 1 for wheelchair users, one (1) stair case, one (1) elevator and two (2) steps at the main entrance used to access the building.

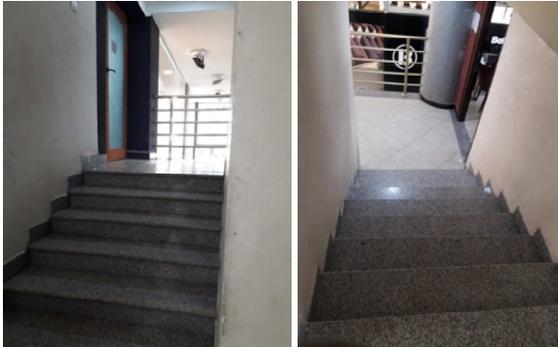
Figure 14. Shekinah building staircase views.

Stair type: The main stair case with elevator has 4.24m width with 1.24m stair landing area. A wide supportive steps are constructed which connect the site level to the building ground floor (which is elevated 1.12m and 69cm).

Number of stair steps (risers): The stair case has 8 steps in one flight and 7 steps in the next flight. The building has 2.5m room height. The 1st step has 7 steps and the 2nd steps which lead to the main entrance have 6 steps.

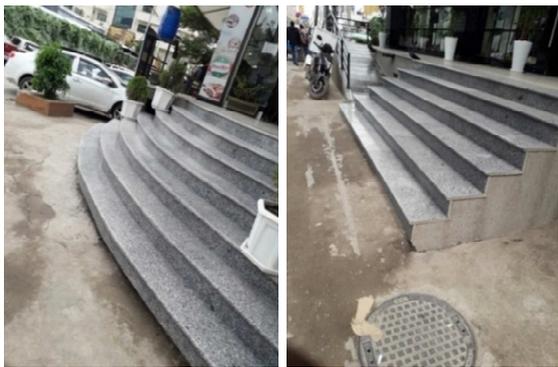
Figure 15. Shekinah building exterior steps view.

Stair Riser and Tread width: The building stair case has 16x32 cm rise & tread width and both front entrance steps has 17x32 cm rise & tread width respectively. The steps riser height makes tough to use for peoples with limited physical disability.

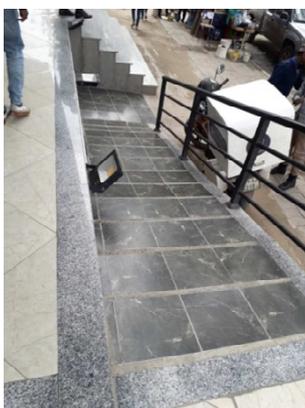
Figure 16. Shekinah building ramp view.

Shekinah building has 1 ramp constructed for wheelchair users which leads to the ground floor then the users get access of the elevator in the central part of the building. It's a ramp which has 1.4m height rise, 1.4cm width with a one flight 5m run this means it have a steeper slope estimated to 28% slope with one side handrail. This means there is a big difference with the preferred slope for a building access ramp (8%).

Material and texture: The material used for the ramp is marble finish which helps them to move easily and for both steps & stair marble floor material used without handrail.

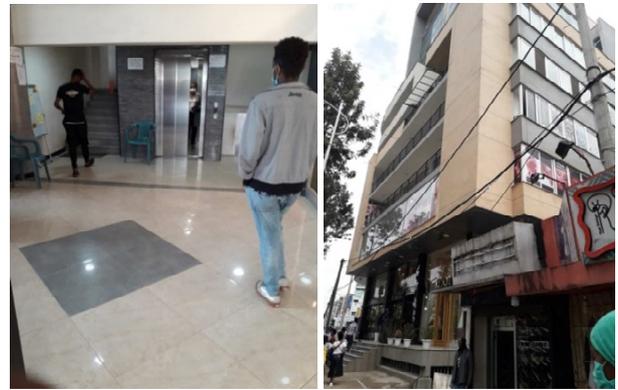
Figure 17. Shekinah building interior and exterior view.

Color: Shekinah building was built on a small space so, all the activities are gathered in one place. They give more attention for the exterior color selection than the interior because the building doesn't create confusion (The stair and elevator are located in the center of the building).

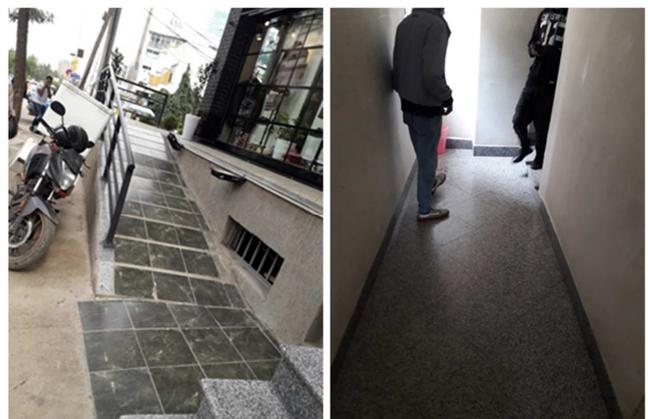
Figure 18. Shekinah building ramp and stair lading views.

Orientation and Safety: There is a well-organized distribution of vertical circulations, but the landing of the stair is narrow also the combination of the stair and elevator creates clash by blocking peoples view. In addition, the ramp is not safe to use and the step lack rails.

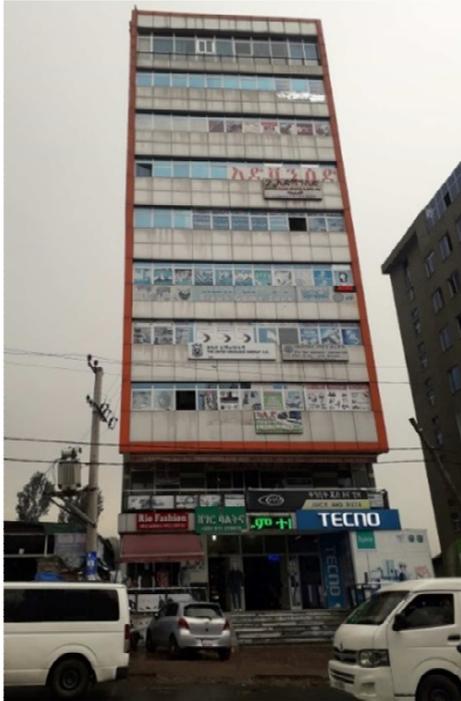
Figure 19. Aymen commercial center view.

AYMEN commercial center building is a G+9story newly constructed commercial building which is located at Mexico, Addis Ababa, Ethiopia and it's found next to K-Kare building on the road to Land Mark Hospital. The building has wide circulation area which is covered by ceramic tile floor finish. One (1) ramp for wheelchair users, one (1) stair case, one elevator and front entrance step used to access the building.

Orientation and Safety: The distribution of vertical circulations (Stair and elevator) are good but additional activities on the lobbies creates obstacles. The ramp slope and lack of handrails on both sides make the ramp slippery also the existing ramp has broken finish.

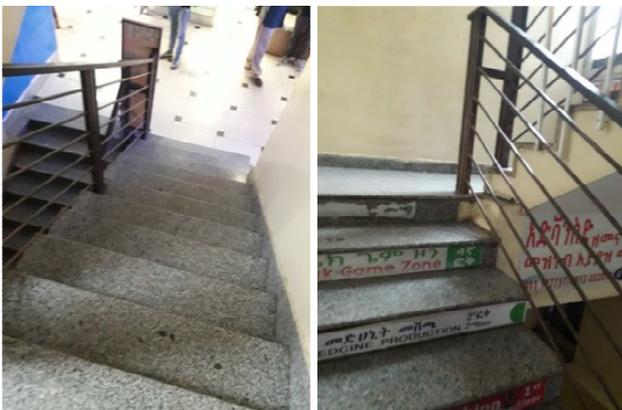
Figure 20. Aymen commercial center stair case view.

Stair type: AYMEN commercial center building has one (1) main stair case & steps on the main entrance. On this building U-shaped stair used (fit with the building an architectural plan well and landing offer a palace of rest but its narrow). The main stair case has 3m width including 0.93m x 3m stair landing area. Wider steps are constructed to connect the site level to the building ground floor (the elevated height is 30 to 40cm).

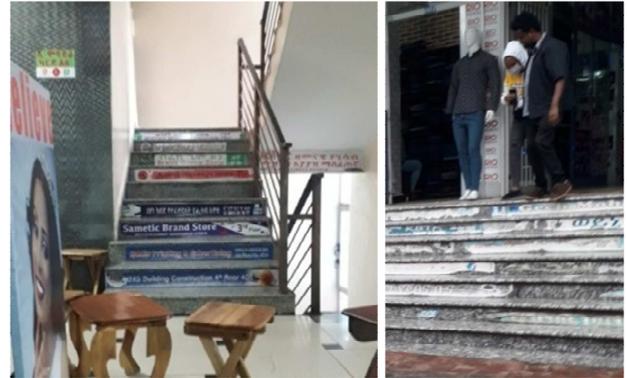
Figure 21. Aymen commercial center interior space and steps view.

The ground floor stair case has 11 steps in each flight and starting from the 1st floor the steps become 10 for each flight. The ground floor has 3.52m room height and the other floors have 3.2m room height. The main entrance step has 7 steps and the ground floor step has 3 steps.

Stair Riser and Tread width: The building stair case and steps has 16x32 cm rise & tread width respectively and the riser height makes tough to use for peoples with physical limitation.

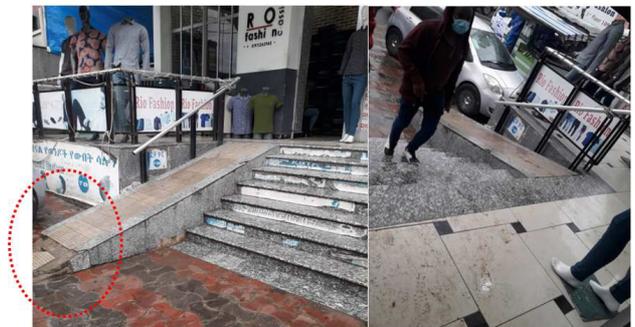
Figure 22. Aymen commercial center ramp views.

Ramp width and slope: AYMEN has a ramp which has 1.12m height rise, 90cm width with a one flight 4.48m run this means it have a steeper slope estimated to 25% slope with one side handrail. This means there is a big difference with the preferred slope for a building access ramp.

Material and texture: The material used for the ramp is combination of Terrazzo with marble floor finishing which is more or less good material for wheelchair users because its texture is not slippery also helps to move easily. For the steps and stair case marble floor material + Aluminum and steel rail used.
