Participatory Integrated Low-Cost measures Gully Rehabilitation and Reclamation for Sustainable Land Management in Ilasa Watershed of Goba Distinct Bale Zone

Mulugeta Eshetu*, Daniel Abegeja, Tesfaye Ketama, Girma Getachow, Regassa Gosa

Oromia Agricultural Research Institute, Sinana Agriculture Research Center, Soil Fertility Improvement, Soil and Water Conservation, Watershed Management Research Team, Bale-Robe, Ethiopia

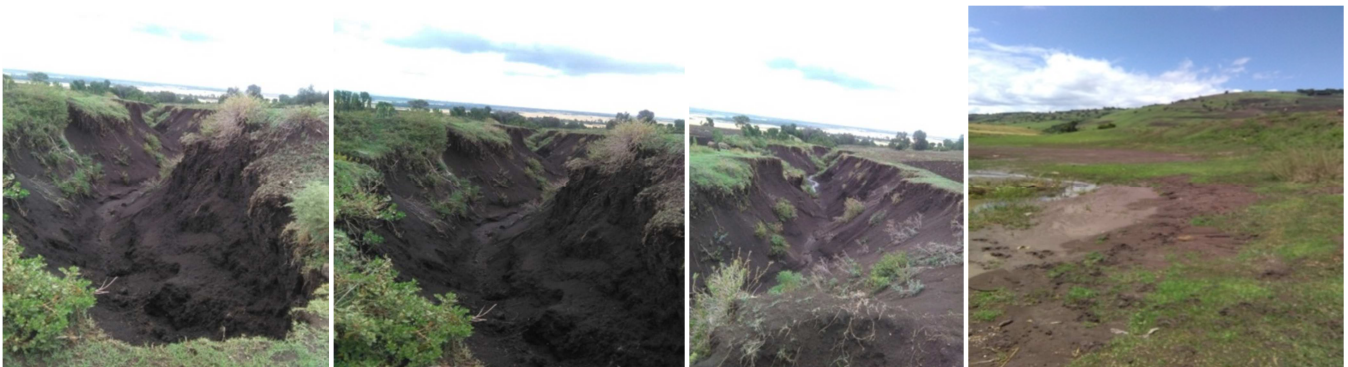
Figure 5. Status of land degradation and gully severist at Ilasa watershed before intervention.

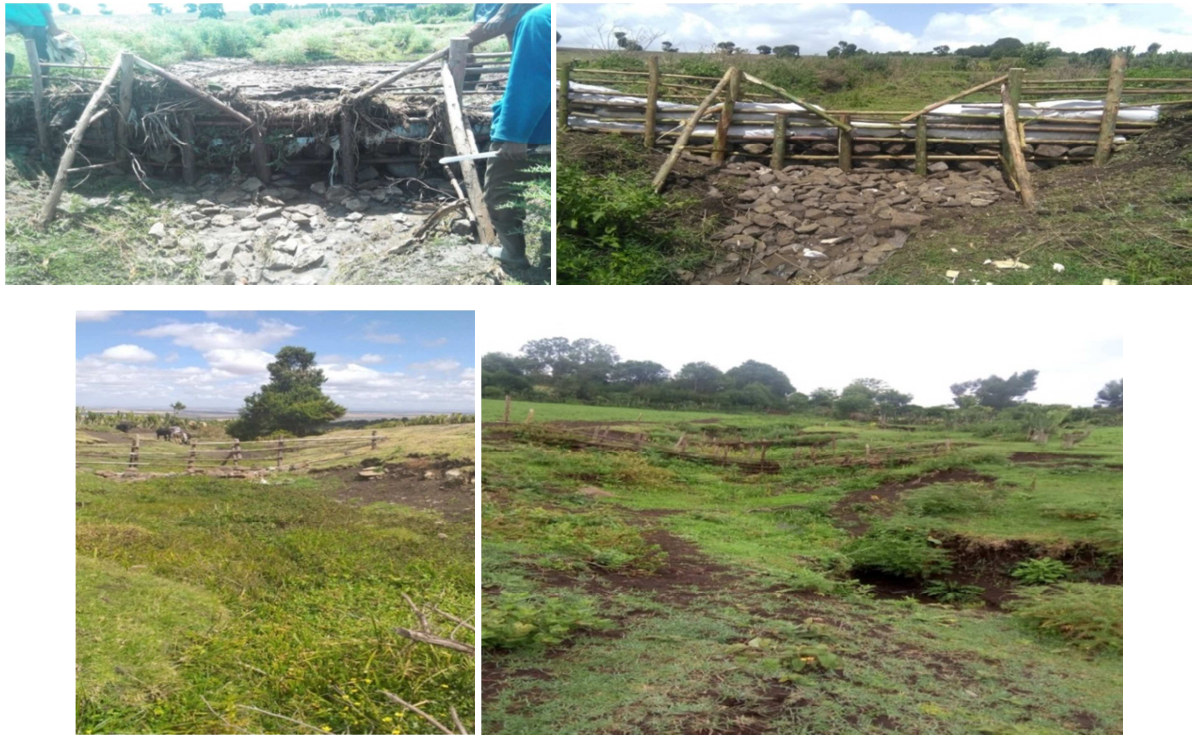
Figure 6. Illasa watershed status after innervations.

The gully reshaping, stone and wooden check dam, and cut-off drain supported with biological measures reduced sediment loss and further extension so that more efficient ways to mitigate gully erosion. Participatory approach and use of low-cost locally available materials to restore gullies are the efficacy and affordable gullies measures strategies.
