# Evaluation of Water Delivery Performance and Conveyance Efficiency in Gatto Small-Scale Irrigation Scheme, Southern, Ethiopia

**Tamirayehu Legesse, Amare Tadesse**

Faculty of Water Resources and Irrigation Engineering, Arbaminch Water Technology Institute, Arbaminch, Ethiopia

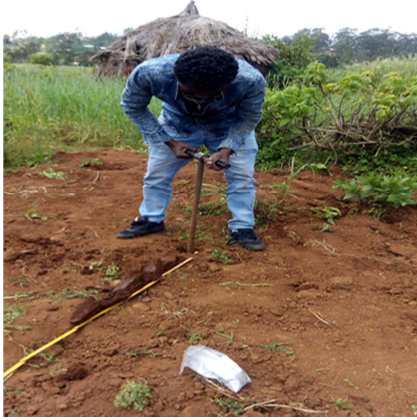
Figure 2. Soil sample from the farmers plot using augur.

As shown in figure 2. Soil samples were collected to determine soil moisture content, soil textural class, bulk density, field capacity, permanent wilting point of the soil from irrigated fields at depth interval of 20cm to maximum of 60cm depth. Samples were taken before and 2 days after irrigation events. This depth was considered as effective root zone of the crops at the time of measurement. The soil samples were placed in containers of known weight and then weighed. The samples were dried in an oven for 24 hours at temperature of 105°C with the containers cover removed. After drying, the soil and container were again weighed and the weight of water determined as following pre and post readings. The dry weight fraction of each sample was calculated using the equation [13].

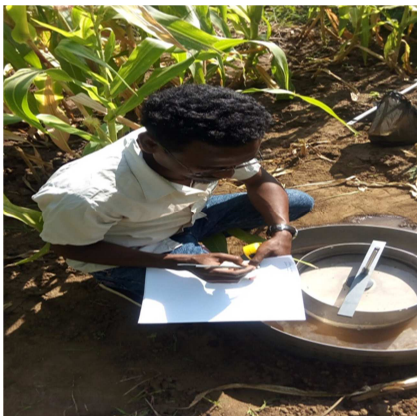
Figure 3. Infiltration measurement at plot by using double infiltrometer.

As shown in figure 3. The measurement of infiltration rate

was conducted using double ring infiltrometer at three random points of the experimental plot. The output of infiltration rate data was used as an input to the CROPWAT 8 computer model in determining irrigation scheduling. The inner and outer rings of the infiltrometer are 30 and 40 cm diameters respectively. Both rings were driven into 15 cm soil depth by hammering wooden plank placed on the top of them. Infiltration measurement was taken continuously until the infiltration of the soil reach constant.

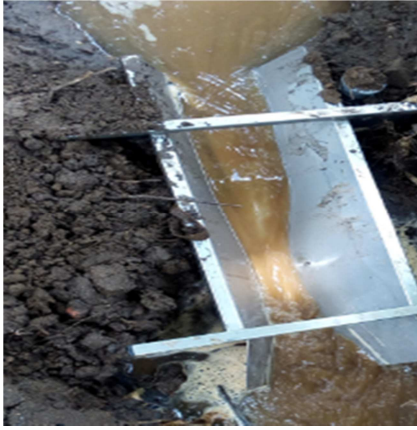
Figure 4. Infiltration measurement at plot by using double infiltrometer.

As shown in figure 4 for the purpose of flow measurement calibrated Parshall flumes of the standard size were used. To determine the amount of water applied by the irrigators to the field, during an irrigation event, automatic calibrated three inches (3") Parshall flumes were installed at the entrance of test plot. Frequent readings were taken when the farmers

irrigate the test plot. Irrigation was continuing until the farmers' thought that enough amount of water is applied to the field. When the irrigator completed irrigating the test plot, the average depth of irrigation water passing through the flume and the respective discharge were read for the sizes of test plot being irrigated. The discharge and the depth of water applied were recorded automatically.

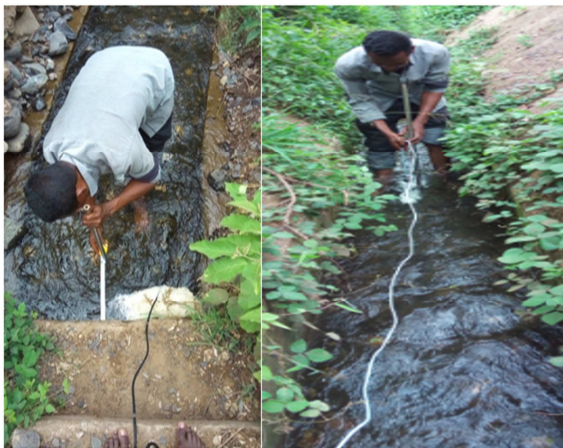
Figure 5. Flow Measurement at Main Canal by using current meter.

The discharges were calculated from the velocities of the water flowing in the main canal using automatic reading Current meter (Osk 1041 prices' electric Current meter) (Figure 5). The first control point measurement of discharge was conducted 40cm far from the intake and the other measurements have been taken 100m interval consecutively. In this location, the cross-section of the canal was lined, uniform and rectangular in shape as seen in Figure 5.

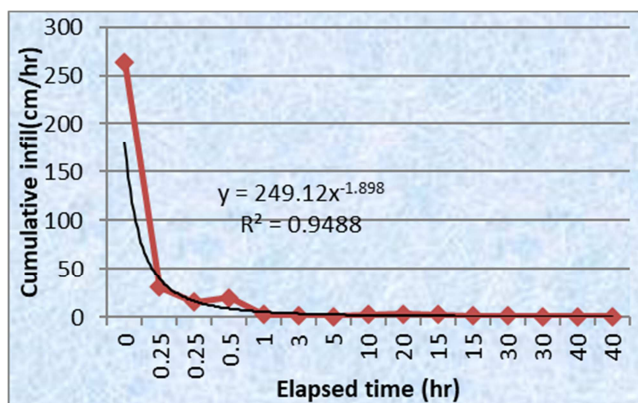
Figure 6. Typical infiltration characteristic of the soil of the study area.

To estimate infiltration characteristics of the soils, field experiment for the measurement of soil infiltration rate was conducted using three sets of infiltration rings for each selected farms at head, middle and tail. The scheme average basic infiltration rate was 4.5mm/hr. A typical infiltration characteristic curve of the soil is shown in Figure 6. According to [12] corporative document repository, soils having the basic infiltration rate between 1-5 mm/hr are categorized as clay. The result is used for an input data for CROPWAT model.

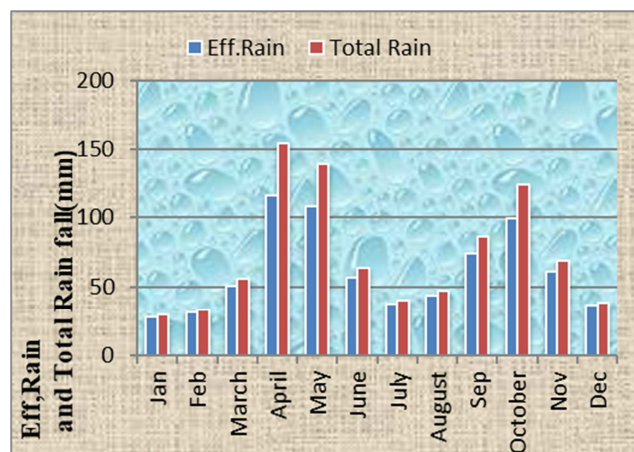
Figure 7. Effective rain falls and Total rainfall (mm).

Twenty-nine years of Rainfall data were collected from Arguba metrological station near to the scheme and it has the same Agro-climatic condition with the study area, hence; there is no any meteorological station in the schemes. The average total annual rainfall of the study area is 878.1 mm and the average total annual effective rainfall amount of the study areas is 742.6 mm.

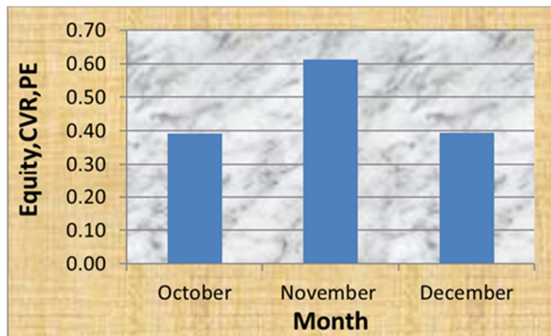
**Figure 10.** Average Equity of water distribution in the irrigation system during the month.

As illustrated the result in *Figure 10* equity of water distribution during October November and December was Fair, Poor and poor its value found to be 0.14, 0.33 and 0.48. According to water delivery performance standards given by [18] the spatial distribution of water in the canal during the month of October was fair. Therefore, it decided that, in these months, the spatial coefficient of variation of adequacy

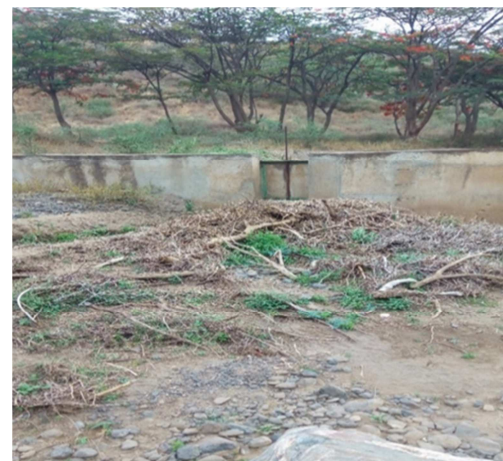
**Figure 15.** Malfunctioned structure in the scheme.

The effective of infrastructure stands for the ratio of the number of functioning structures to the total number of structures initially installed. Accordingly, in Gatto, the total numbers of different structure constructed were 14 but only 8 of them are functional. As a result, the value of Effective of Infrastructures is reckoned to be 57.2 percent. Many of the

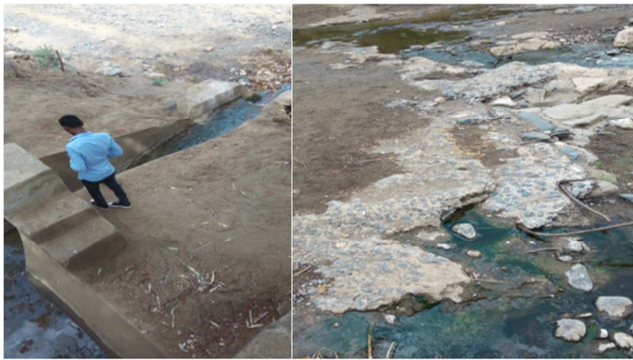
Figure 16. The flood erodes fertile land around bank of the canal.

In Gatto irrigation scheme, the potential net irrigable area was 200 ha, and the actual irrigated area during the study season was only 176 ha. This gives sustainability of irrigation scheme as 88% percent and the original irrigated land was reduced by 12% percent. These were happening due to flooding, natural drainage, and water shortage and soil fertility degradation. In the irrigation schemes flooding were happen and damages the farmer's field by loading stones on the field and affects the soil fertility. The flood erodes the fertile soil of the field and also it causes valleys that are not important for irrigation. This leads to reduction of irrigation area.

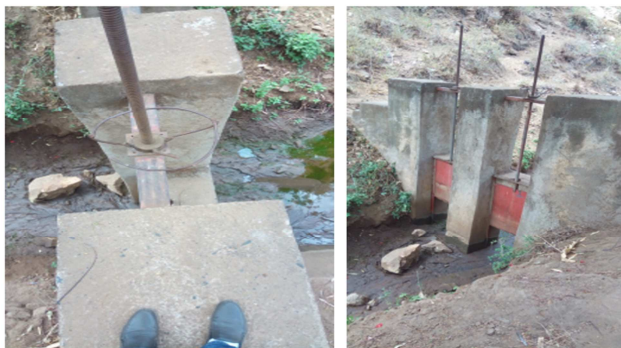
Figure 17. Malfunctioned flow regulator and present condition of the scheme.

Based on field observation and inventory data of physical structures, there was significant default on the weir crest, wing wall and the intake gate had a problem during the operation time i.e. the gate rod had not easily movable during the closing and opening of the intake gate due to lack of oil grease and malfunctioned of the structure.

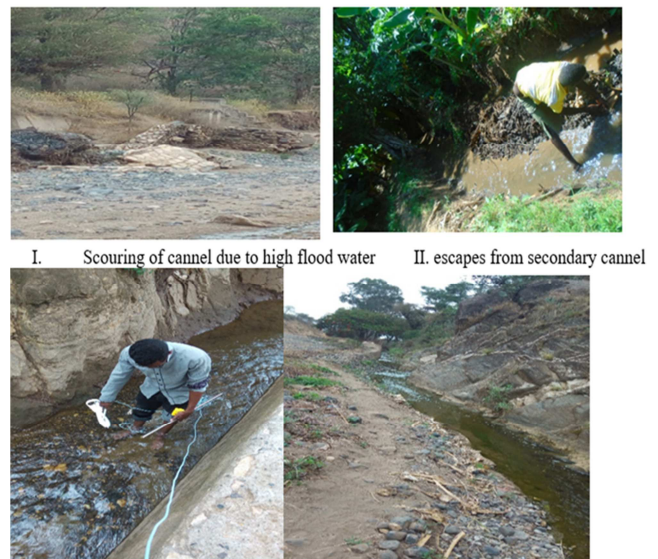
Figure 18. The present existence of canal condition in the scheme.

Main canal is a structure, which conveys water from the river to different parts of the scheme. The canal was Lined canal and its capacity decreased due to silting and sedimentation. At some part of the main canal, during the rainy season there was a great problem of scouring and siltation at the lower part of the canal. The secondary canals in Gatto irrigation scheme were unlined and mostly the water escapes by leaving its original direction during rainy season.

Generally, a deviation of some structures would signal the need for maintenance or rehabilitation for flow control structures [5] The reason for this deviation may be due to canal siltation and sedimentation. In Gatto irrigation scheme practically the distribution was rotational implying that completing irrigation at one part of the system or individual farmers' field then the turn will be the next system or farmers.

From the major problems of canal system observed during this study, seepages through earthen canals, leakages through lined canals and structures, siltation of canals, weed grow in the canal and on the branches, illegally broken canal for additional offtake and low water levels due to canal erosion are the main problems need attention by users, government and nongovernmental body.
