# The Dynamic Development of the Sebou Valley and Its Impact on the River Domain Between Oued Inaouene and Oued Bouchabel (Pre-Rif) Morocco

Yazami Ztait Mohammed. The Dynamic Development of the Sebou Valley and Its Impact on the River Domain Between Oued Inaouene and Oued Bouchabel (Pre-Rif) Morocco. *Journal of Water Resources and Ocean Science*. Vol. 11, No. 2, 2022, pp. 30-37.  
doi: 10.11648/j.wros.20221102.11

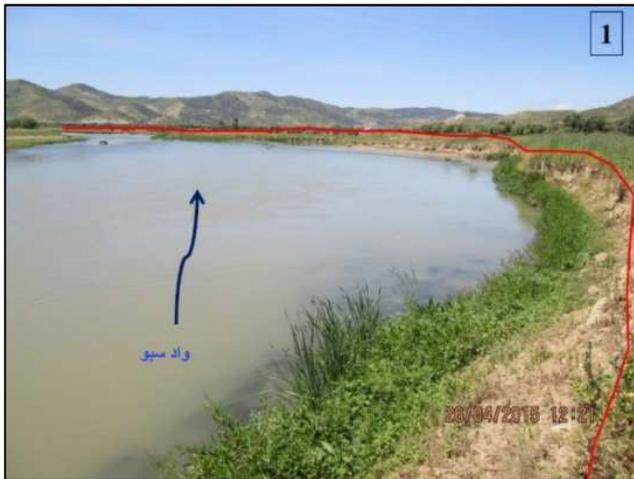
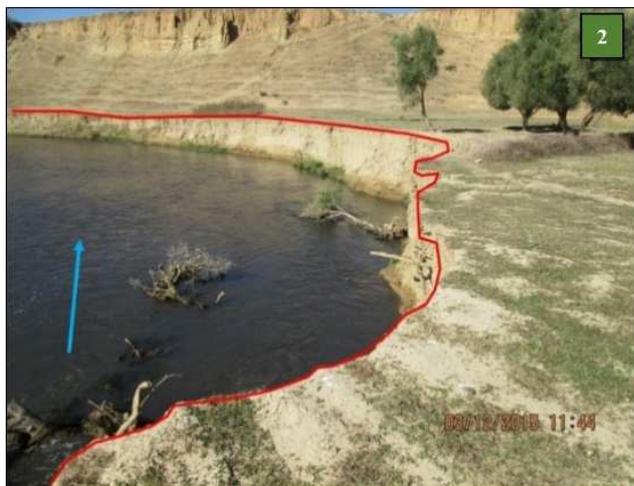
1) - Bank erosion east of Zkara

2) - Bank erosion southwest of Ouled Zen

**Figure 6.** Examples of lateral erosion in some banks of the Sebou River stream.

River banks are subject to strong lateral erosion due to the water current during eruptions, making the course of the stream in a continuous development, especially at the bottom of the curves, as shown in Figure 6, this provides examples of cases of bank erosion [2, 3, 6, 13, 14], as they are located in places faced with the water current, especially in the high flow stages, due to the fragility of the bank components and their low resistance to erosion, despite the presence of vegetation cover in some places.

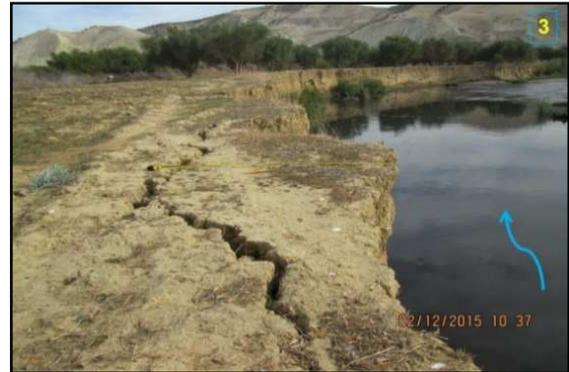
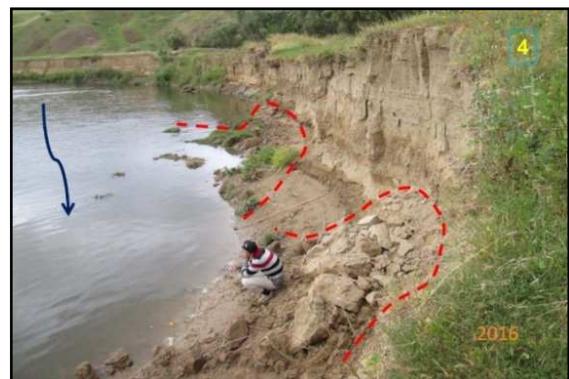
3) - The collapse of the banks, South of Douar Ouled El Yamani

4) - North of the Megra douar (view from the northeast)

**Figure 7.** Some models of bank collapse in the studied course.

The strength and danger of fluvial erosion increases as we move from top to bottom, as a result, most of the banks are subject to collapse, as shown in the images of panel 2 in image 1 on the north right bank, northeast of Douar Ouled El Yamani area, at the beginning of the concavity, This entire bank collapsed, following the digging at its feet, and Figure 7 west of Douar Megra area shows that the bank collapsed for about 2.5 km on the north right bank, it appears that the latter is constantly collapsing, despite being parallel to the water current and despite its plant cover availability.

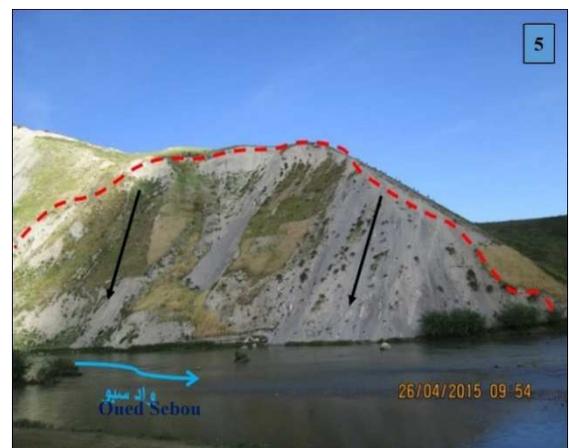
5)- The eastern slope of Kodya Ghaouti, southeast of Dowar Korbash (view from the east)

6)- South slope to the south of Douar Ouled Baligh (view from the west)

Figure 8. Models of some of the valley slopes slides.

When the stream reaches the valley slopes overlooking the stream, the stream is exposed to erosion at its feet [1, 5, 8], causing sliding of its marinade rocks, as we show in several

points in image panel 3. Through image 1, we see an example of a landslide at the foot of Kodya Ghaouti, southeast of Douar Korbash area in the western slope overlooking the right side of the stream, where the bottom of this slope has been exposed to the excavation, which leads to its sliding always, whether the flow is normal or strong and fast. In Figure 8, we present an example of the sliding of the northern slope of the South slope to the south of Douar Ouled Baligh from the left side of the concave bank, as an effect of the force and speed of the water current.
