# Analysis and Solution of Flooding Water Problem for EV Passenger Compartment

Li Zhongkui\*, Xu Zebin, Shu Peichao

Dongfeng Motor Corporation Technical Center, Wuhan, China

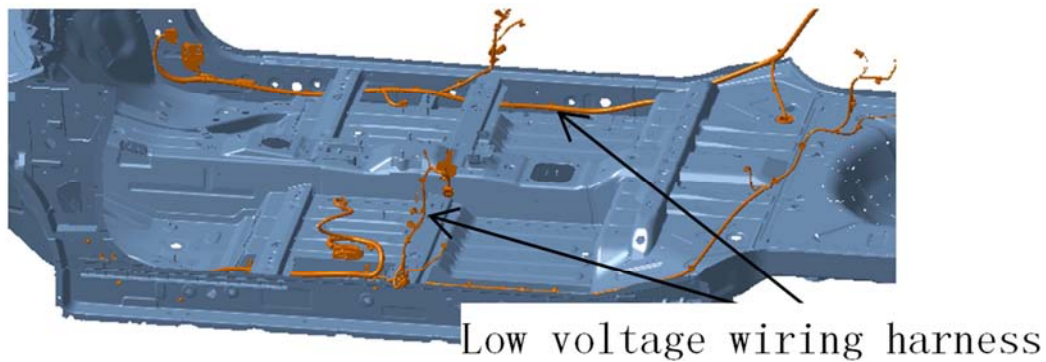
Figure 14. Low pressure cabling arrangement in passenger cabin.

The low-voltage wiring harness layout of passenger cabin is shown in figure 14. The wiring harness is positioned on both sides of the floor and is fixed to the inner plate of the side longitudinal beam by clamping.

(3) In order to solve the problem of water inlet at the wire harness buckle on the inner plate of the body longitudinal beam, the solution is to change all the wire harness buckle holes into welded studs, as shown in figure 25.

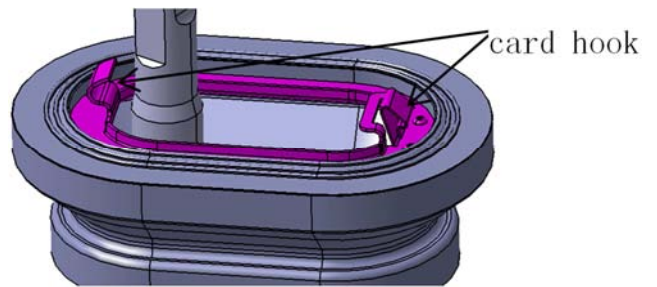
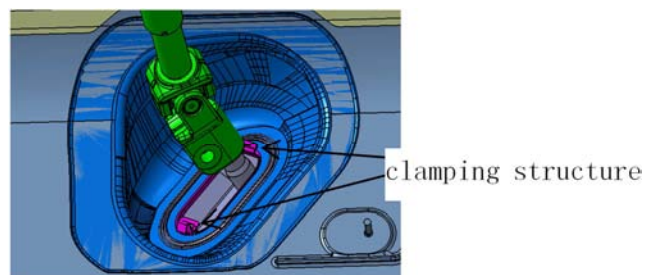
Figure 27. The hook structure is set in the sheath.

Figure 28. The buckle buckling body.

(5) To solve the problem of water inlet at the through-hole of the steering column on the dash panel, solutions are within the steering column sheath set card hook structure, will cover the collection on car body, as shown in figure 27 and figure 28, through the card hook card tight sheath, keep sheet metal sheath and body moment in the compression state.

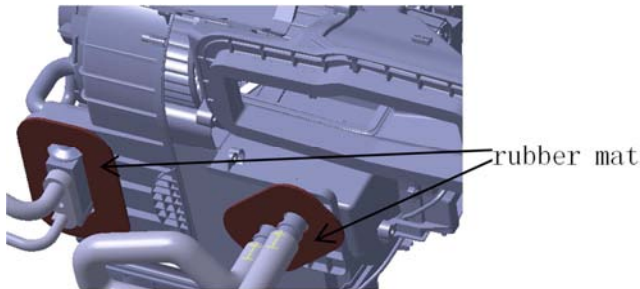
Figure 29. Add rubber gasket seal structure.

When the air conditioning pipeline passes through the front fender, it does not effectively seal the through-hole, resulting in a small amount of water from the air conditioning pipe passing through the through-hole into the cabin. Figure 20 shows the air conditioning inlet and outlet pipeline structure. Figure 21 shows the hole in the enclosure spacer, only one hole is added with the cushion block, but it is a sponge cushion, which has no waterproof effect.

(6) For the air conditioning pipe passing on the small hole water problem, the solution is to cancel the small sound insulation mat cushions, rubber mat in air conditioning body side, at the same time the air conditioning on ontology local reinforcement plate to plane, to increase the contact area, the maximum possible to stop the water flow into the car, as shown in figure 29.

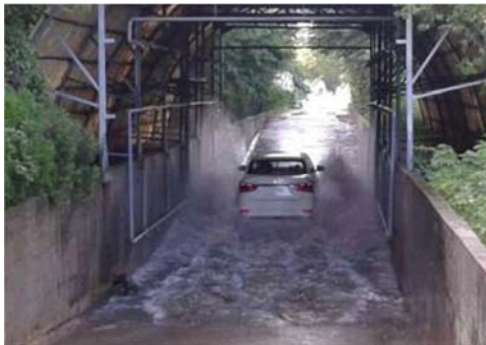
Figure 30. 15cm deep water tank wading test vehicle.

Figure 31. 30cm deep water tank wading test vehicle.

The above solution is applied to the real car, again wading test, respectively into 15 cm deep pools and 30 cm deep pool, as shown in figure 30, 31, running back and forth 10 min, has not found inside the passenger compartment with clear water, show that passenger compartment seal get larger ascension.
