Diagnostic Investigation of Hydro Electric Project Made Easy with Remote Operated Vehicle

3.1. Underwater Scanning of Hirakud Dam Using ROV

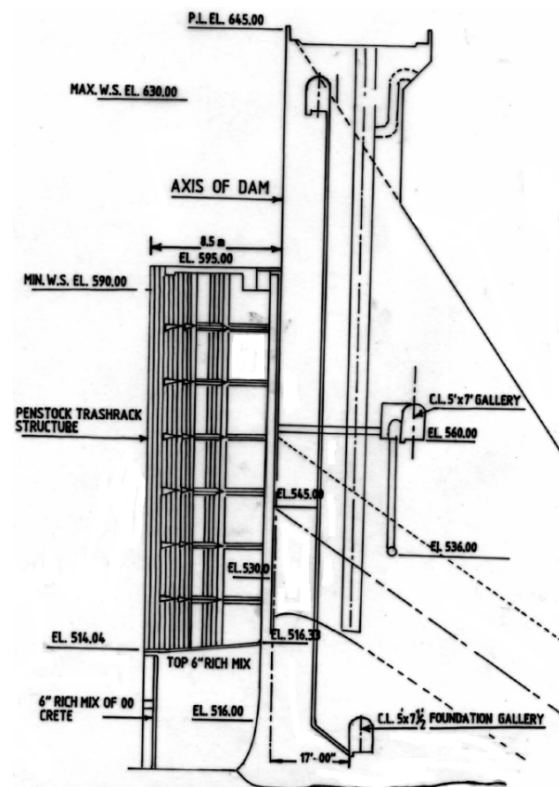
Figure 2. The Cross Section of the Power Intake of Hirakud Dam.

In Hirakud Dam Type –I Trashracks [8] were installed in the intake of Power House area (Figure 2).
