# Analysis of the Power Plant Breakwater Failure Subjected to Typhoon Mangkhut Based on Model Experiment

**Abstract:** Growing social concern regarding the environmental and visual impacts associated with coastal structures due to climatic change is leading to a reduction in breakwater failures. After Typhoon Mangkhut passed through the southeastern coast of China on September 16 in 2018, the breakwater of a Power Plant was serious failure. As a case study based on model test, the failure process and causes of breakwater were explored in this paper. The wave height and water level were used as the wave parameters, which were accurately extracted by the GOHS system when the typhoon transits, and the breakwater failure process was reproduced based on the typhoon wave forces action at that time. By the experimental result investigating, it was found that the joint of the caisson breakwater and the mound breakwater was firstly failure, then the armor blocks and stones near the seawalls became to be unstable, the seawall was collapsed finally. Based on the analysis of the experiment, the distribution in time and space of the damage of the protective blocks are obtained and divided into

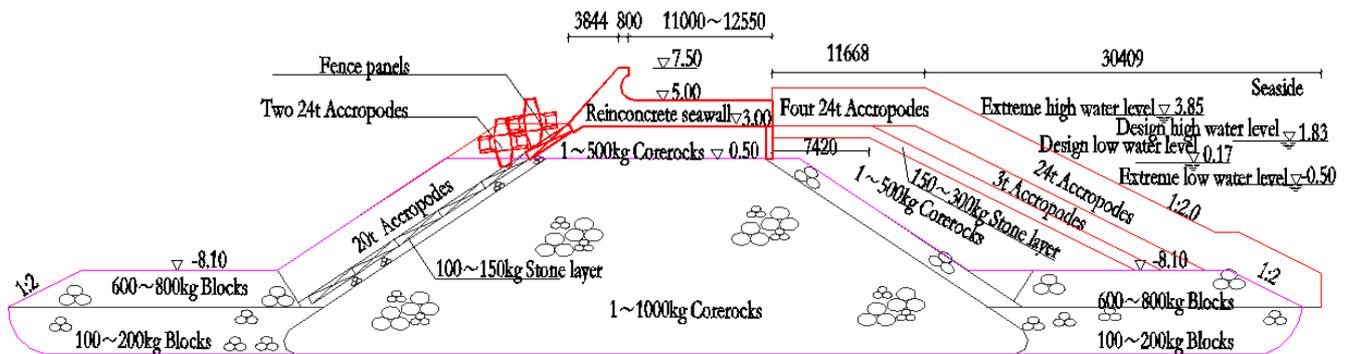
Figure 1. Cross section drawing of the breakwater.

The breakwater consists of a caisson breakwater and a mound breakwater, of which the caisson breakwater with a length of 56M was arranged at the head part of whole structure. The cross section drawing is shown in Figure 1. The model is designed according to the gravitational similarity criterion. The structural section size is designed according to the geometric similarity criterion. The model similarity scale is 1:43.

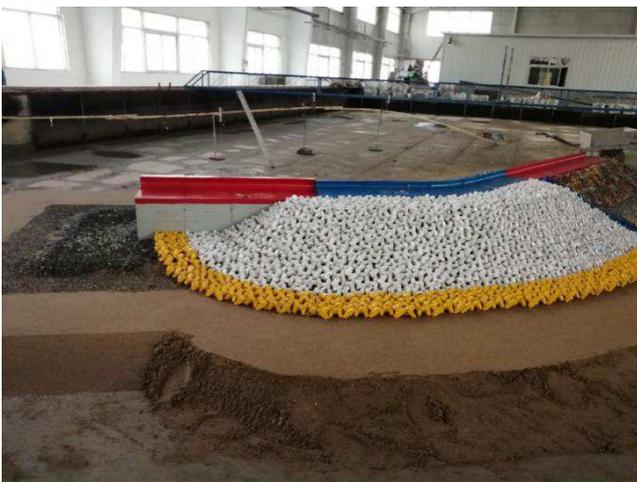
Figure 2. The layout of breakwater model (seaside).

The model is arranged as shown in Figure 2.
