Failure Analysis Report on Fractured Torsion Bar in Suspension of a Vehicle

Nan Nan, Jijun Feng. Failure Analysis Report on Fractured Torsion Bar in Suspension of a Vehicle. *International Journal of Materials Science and Applications*. Vol. 11, No. 2, 2022, pp. 55-61. doi: 10.11648/j.ijmsa.20221102.13

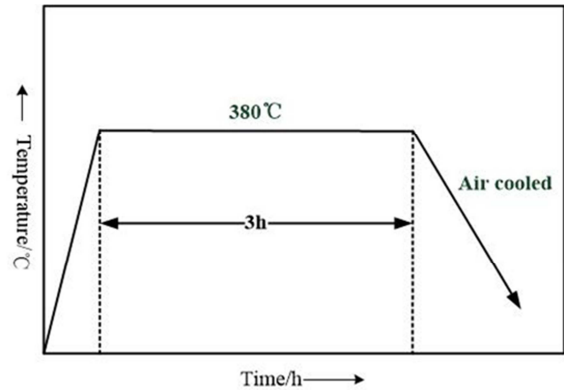
shown in Figure 10 without changing any other conditions: (1) Heat the sample to 380°C and maintain it at that temperature for 3 h; (2) rapidly cool the sample in the air to room temperature.

Figure 10. Process of tempering simulation experiment.

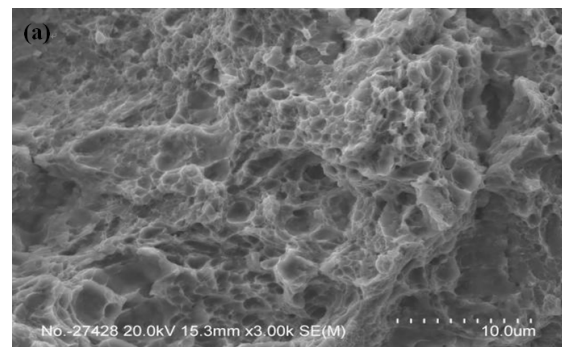
The tempering simulation experiment was performed on the spline coupons of S1 and S2; then, a hammer was used to make their artificial struck-fractures under normal stress, and an SEM analysis was performed to check the fracture property. A metallographic specimen of the retempered part was also prepared to check the metallographic structure. The results are shown in Figure 11. The brittle feature of the spline root area totally disappeared, since the artificial fractures of S1 and S2 are 100% large dimple ones as shown in Figures 11(a)-(b) instead of intergranular-dominant fractures. Furthermore, as shown in Figures 11(c)-(d), the microstructures of S1 and S2 after the tempering simulation experiment are still tempered troostite, which implies that our tempering simulation experiment did not induce a fundamental change in type of metallographic structure.

Figure 11. SEM images of artificial-struck fractures and metallographic structure of spline part of S1 and S2 after tempering simulation experiment: (a) SEM image of struck fracture of S1, (b) SEM image of struck fracture of S2, (c) Metallographic structure of S1, (d) Metallographic structure of S2.

The prevention of such problems depends on sufficient tempering to uniform the structure and eliminate large residual stress. From the view of this investigation, extending tempering time is recommended as an option to solve this problem.
