Supervisor-Field Engineering Approach (S-FEA) of Determining Tyre Failures in the Haul Trucks at Newmont Ahafo Mine

Department of Mining Engineering, University of Mines and Technology, Tarkwa, Ghana

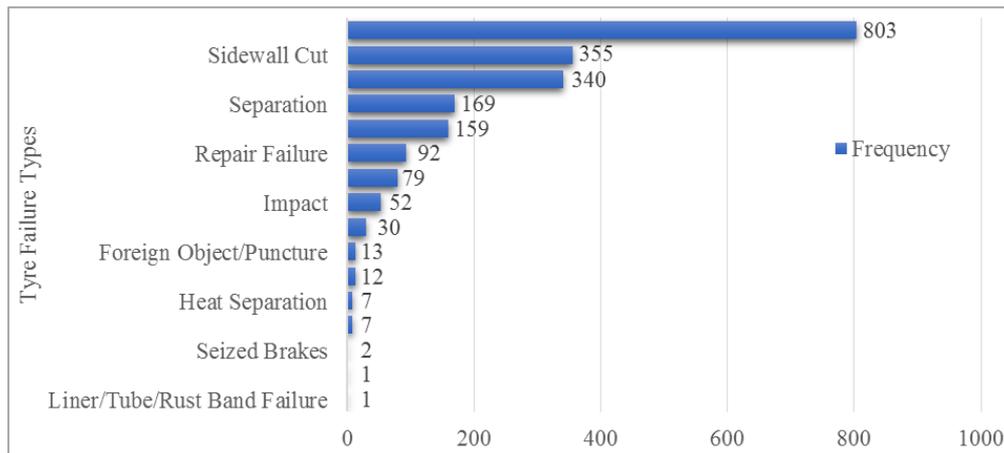
Figure 4. Tyre Failure Mode.

tyre size on the mine. Figure 3 shows tyre downtime against failure events. The mode of tyre failures and their frequencies were obtained as presented in Table 1 and graphically illustrated in Figure 3. It is worth noting that all these tyres failed during the period under review without achieving the mine’s 7 000 operational hours.

Tyre Failure Type	Frequency	Tyre Failure Type	Frequency
Liner/Tube/Rust Band Failure	1	Impact	52
Radial Cracks	1	Shoulder Cut	79
Seized Brakes	2	Repair Failure	92
Accidental Damage	7	Worn	159
Heat Separation	7	Separation	169
Bead Damage	12	Tread Cut	340
Foreign Object/Puncture	13	Sidewall Cut	355
Tread Cut Separation	30	Tread Chunking	803

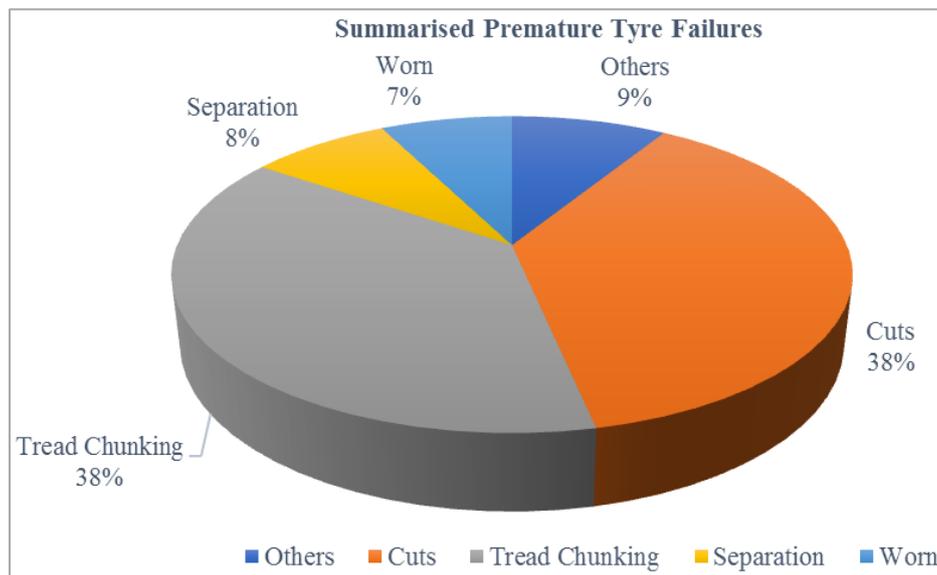
Figure 5. Major Premature Tyre Failure Types at NAM.

From Figure 4, the premature tyre failures were further grouped into five to undertake qualitative research through field surveys/tours, haul truck tyre observations, and interviews with junior staff, supervisors, general foremen, and superintendents from both mine operations unit and maintenance department. This research is to aid in identifying the major causes of each of the premature tyre failure modes, which have been summarised and presented in Figure 5.

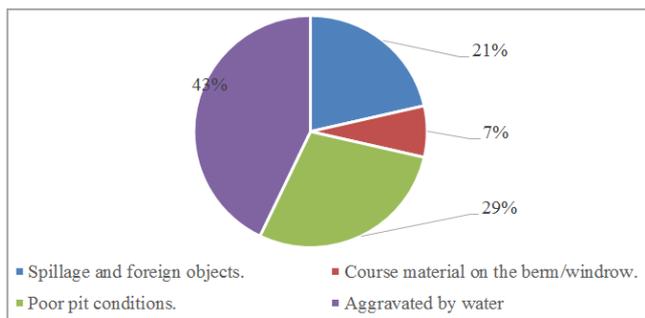
Figure 9. Causes of Haul Truck Tyre Shoulder Cut.

In interviews with field workers, supervisors and superintendents from the mine operation and tyre maintenance departments, the following were identified as contributing factors: Spillage and foreign objects; Course material on the berm/windrow; Poor pit conditions; and aggravated by water. Following the identified causes of shoulder cuts, a field study was conducted in the Subika and Awonsu pits of NAM, Ghana. The data collected recorded 8 cases over the period of 12 months. The breakdown is presented in Figure 9. It was clear that the major causes of premature tyre failure by shoulder cut are aggravations by water and poor pit conditions. Figure 8 below shows a cut in the shoulder area but no casing damage.

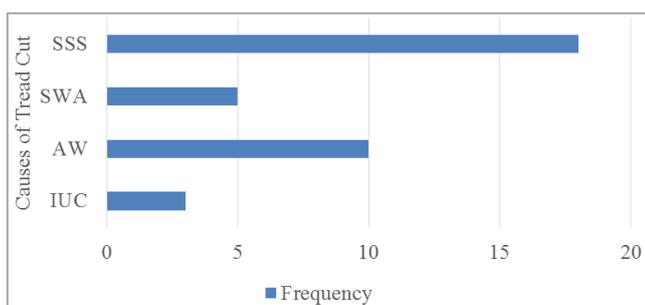
Figure 11. Category of the Major Causes of Haul Truck Tyre Tread Cut.

A typical example of a cut in the tread crown but not penetrating the casing is presented in Figure 10. The causative factors of the tread cut include Improper inflation or underfoot conditions (IUC); Aggravated by water (AW); Sharp objects in the work area (SWA); and spinning, skidding or sliding (SSS). The number of cases recorded for the factors that cause tread cut was taken and analysed in Figure 11.

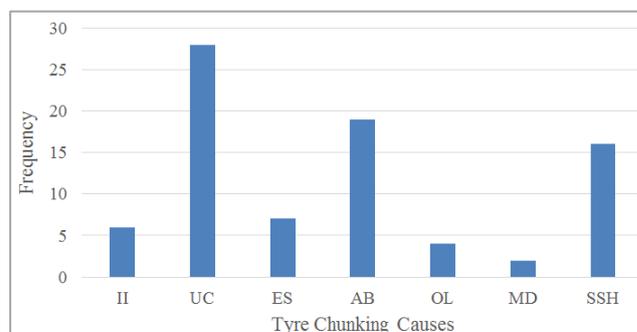
Figure 13. Causes of Tread Chunking of Haul Truck Tyres at NAM, Ghana.

Chunking refers to the phenomenon of missing tyre tread sections, as depicted in Figure 12. It appears the tread has been removed in pieces or ripped away from arbitrary locations on the tyre. In interviews with relevant workforces, contributing factors revealed the following: Improper infla-

tion (II); Underfoot conditions (UC); Excessive speeding (ES); Aggressive braking (AB); Overloading (OL); Mismatched diameters on dual tyre machines (MD); and spinning, skidding or high torque (SSH). Data collected over a period of 12 months, from January 2020 to December 2020, on Haul truck tyre premature failure resulting from tread chunking has been analysed and presented in Figure 13.

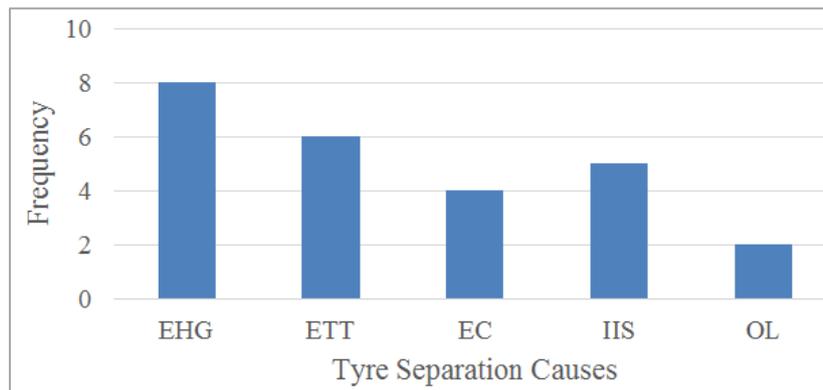
Figure 15. Causes of Haul Truck Tyre Separation.

Tyre tread separation is a dangerous condition wherein the tyre’s tread separates itself from the casing or body of the tyre. Thus, it is the deformation of the tread area due to the tread band separating from the casing ply, as shown in Figure 14. The contributing factors are excessive heat generation (EHG), exceeding the TKPH for the tyres (ETT), excessive cornering (EC), incorrect inflation or speed (IIS), and overloading (OL). Having identified the major causes of the haul truck tyre failure by separation, fieldwork was done over 12 months – January 2020 to December 2020, to obtain data regarding the most applicable causes of tyre separation at NAM, Ghana. The result obtained has been summarised in Figure 15.

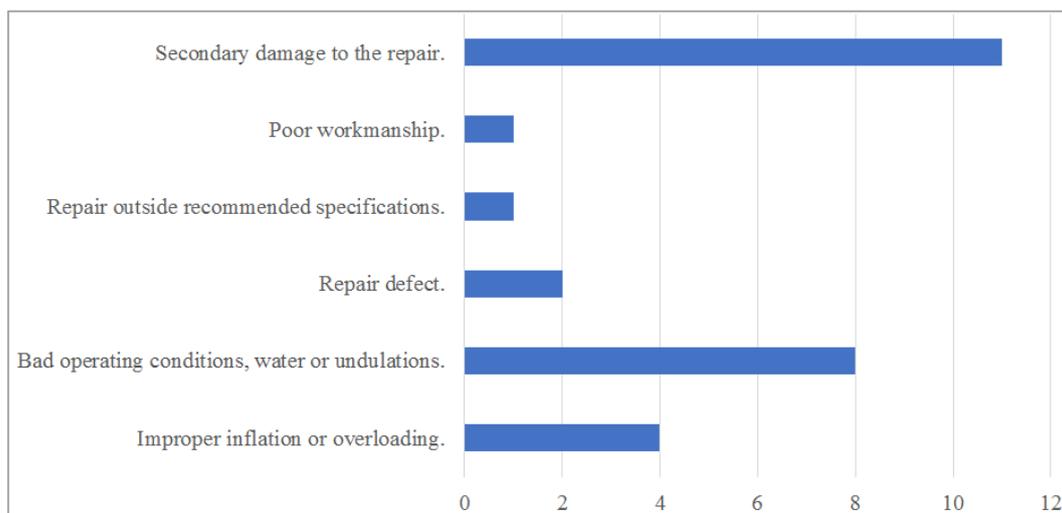
Figure 17. Major Causes of Tyre Worn at NAM.

According to the tyre damage report acquired from the maintenance department, factors contributing to the wear of haul truck tyres include i) improper inflation or overloading, ii) unfavourable operating conditions such as water or undulations, iii) defects in repairs, iv) repairs conducted outside recommended specifications, v) subpar workmanship, and vi)

secondary damage caused by the repair process. A field study on the causes of haul truck tyres worn out at NAM, Ghana, was carried out by recording the various factors that contributed to tyre worn out from January 2020 to December 2020. The result is presented in [Figure 17](#).

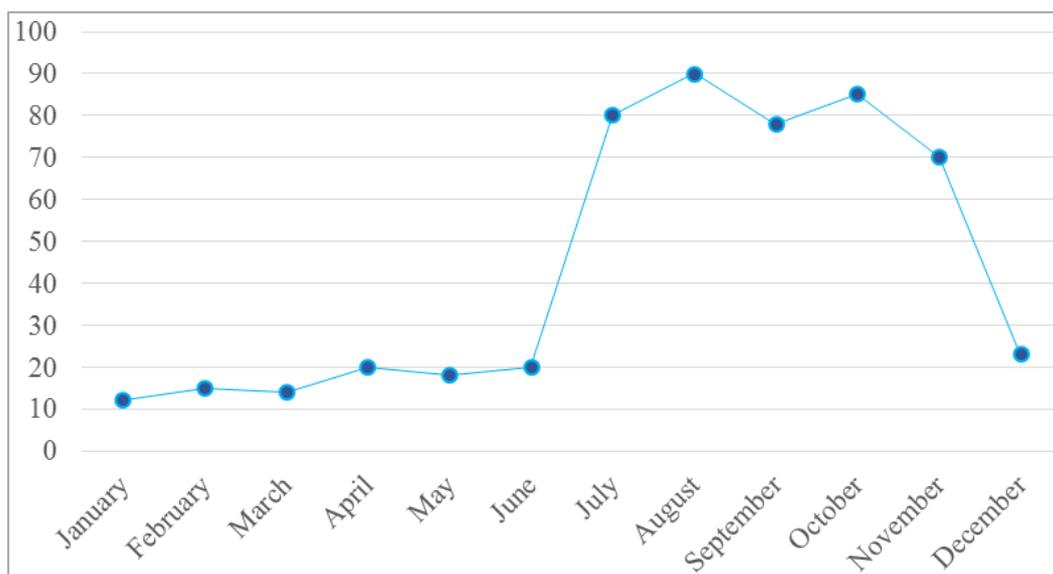
Figure 18. Premature Tyre Failure Trend in NAM, Ghana.

During the data collection and observation, it was noticed that more cases were recorded in certain months. This necessitated tallying the total tyre failures recorded for each month during the study to identify any hidden trend in premature tyre failures within the year. The study was conducted from January 2020 to December 2020. The summary is presented in Figure 18.

With the Ahafo region being part of the forest belt of Ghana, it records its wet season from July to November, while the dry season starts from December to April. The trend indicates that most of the premature tyre failures were recorded during the wet seasons as compared to the dry seasons.
