# Fault Analysis of 600MW Generator Stator Bars in a Power Station

The manufacturer of the generator for Unit 5 at a certain power station is Toshiba Hydro Power Equipment (Hangzhou) Co., Ltd. The generator model is SF600-66/17150, and it was commissioned for power generation on May 27, 2016. It has a rated capacity of 666,670 kVA, a rated power factor of 0.9 (lagging), a rated voltage of 20,000 V, and a rated current of 19,246 A. The stator winding is a 3-phase, 6-branch Y-connection with 35 slots per branch, totaling 630 slots.

At 00:56:16 on June 13, 2024, while Unit 5 generator at the power station was operating with a load of 600 MW, the stator grounding protection of both Sets A and B of the generator protection activated, followed by the shutdown and decoupling of the generator. Based on the comprehensive analysis of the protective action report and fault waveform recording, it is determined that a single-phase ground fault occurred in the unit, with Phase A being the faulted phase.

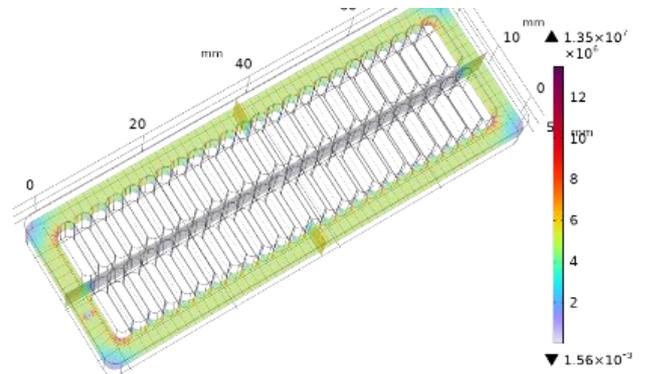
Figure 14. Distortion of electric field distribution caused by metal defects.

By setting a copper particle with a radius of 0.1mm in the main insulation to simulate metal impurities entering during the production process, with other parameter settings the same as in Section 4.1. When metal impurities are mixed into the main insulation material due to production processes, the corresponding electric field distribution is shown in Figure 14. At this time, the maximum electric field intensity is  $1.35 \times 10^7$  V/m, and the metal impurities are at a floating potential in the main insulation material. Similar to the bubble defect, the presence of metal particles leads to an expansion of the high electric field intensity area in the main insulation, and the area of electric field distortion almost spans the main
