Analysis of Correlation Among Partial Discharges, Ozone Emission, and Ultraviolet Radiation in High Voltage Motor Stator Windings

Abstract: In this research, a normal winding and simulated defective winding were created to examine the correlation between partial discharges, ozone concentration, and ultraviolet radiation in high-voltage motor stator windings. In the simulated defective winding, the semiconductor layer was removed so that discharges could occur easily between the winding surface and the iron core. A high voltage was applied to both normal and defective windings to measure the partial discharge magnitude, ozone concentration, and ultraviolet radiation. Subsequently, the results were compared and analyzed. The electrical partial discharge magnitude, ozone emission, and ultraviolet radiation measurement methods and properties were explained, and all test results and correlations were analyzed.

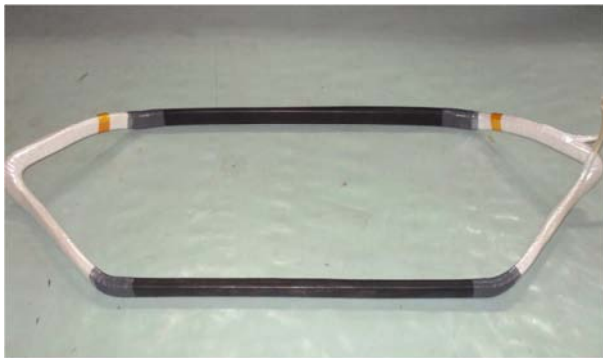
To examine the characteristics of the ozone, ultraviolet emission, and partial discharge according to defects when applying a high voltage, a 6.6-kV high voltage-motor stator winding with artificial defects and a normal winding were tested and analyzed. Figure 1 shows the normal winding,

which has the semiconductor layer to reduce the potential difference between the stator winding and the iron core, and Figure 2 shows the defective winding whose semiconductor layer was removed from the winding surface so that discharges could occur easily inside the slot, between the winding and iron core [8].

Figure 1. Normal winding.

The normal winding was inserted in the A phase, and the defective winding that simulated the slot discharge was inserted in the B and C phases. Windings of the same type were connected and no neutral point connection was made to separate the different phases. Independent tests were performed for each phase, ensuring that no voltage would reach the B and C phases while a high voltage was being applied to the A phase.

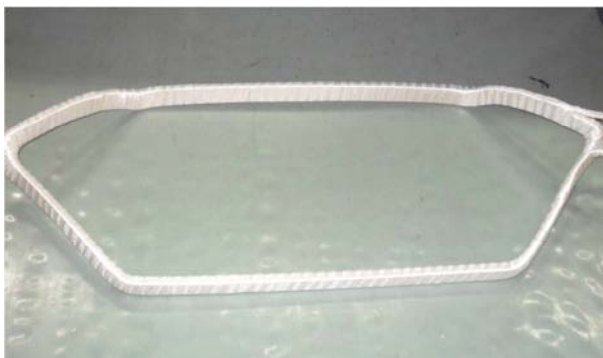
Figure 2. Winding without semiconductor layer.

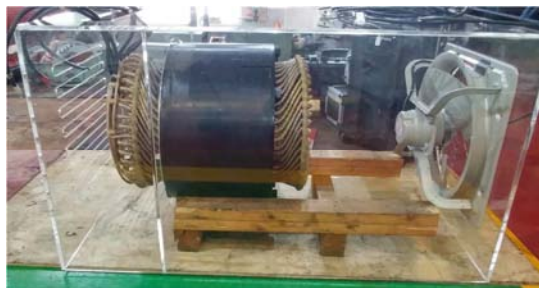
Figure 3. High voltage motor sample and enclosure.

fan on the rotor shaft, and then is drained out. Therefore, to achieve a constant flow of cooling air, an enclosure that covers the entire high voltage motor sample was constructed, as shown in Figure 3. A vent was put on one side, and a fan on the other so that external air would be sucked inside, passing through the high voltage motor, and then expelled outside.

Ozone is generated when partial discharge occurs is heavier than air and goes down to the bottom. However, in actual high voltage motors, external cooling air enters, cools the stator winding at a constant flow rate by the action of a

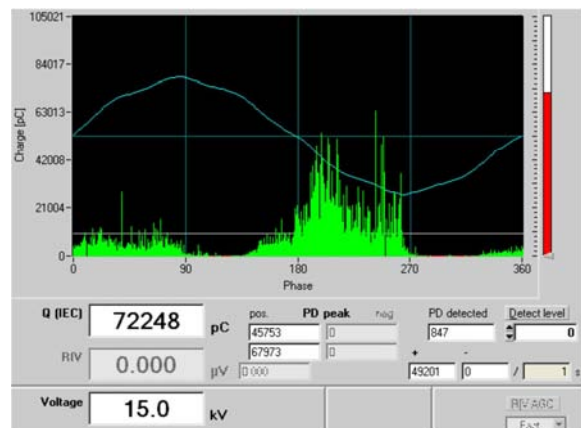
Figure 5. B-phase partial discharge measuring screen.

As shown in Figure 4, the A phase (normal winding) shows an internal discharge pattern in which the magnitude of the partial discharge pulse that occurs when phase angle of the voltage is 0° – 90° is almost the same as when it is 180° – 270° . This is what happens when discharges occur in gaps inside primary insulators, and represents the most common pattern. In Figure 5 and 6, it can be observed that the magnitude of the partial discharge pulse that occurs in the B and C phases without the semiconductor layer when the phase angle of the voltage is 180° – 270° is greater than when it is 0° – 90° , representing a typical slot discharge pattern. This occurs when discharges take place between the winding surface and the iron core [9]. Thus, the results of the pattern

analysis that show the discharge pulse location in accordance with the test voltage phase revealed that while internal discharge is observed in the normal winding, slot discharge is observed in the winding without the semiconductor layer. Accordingly, it was verified that the sample was appropriately prepared.

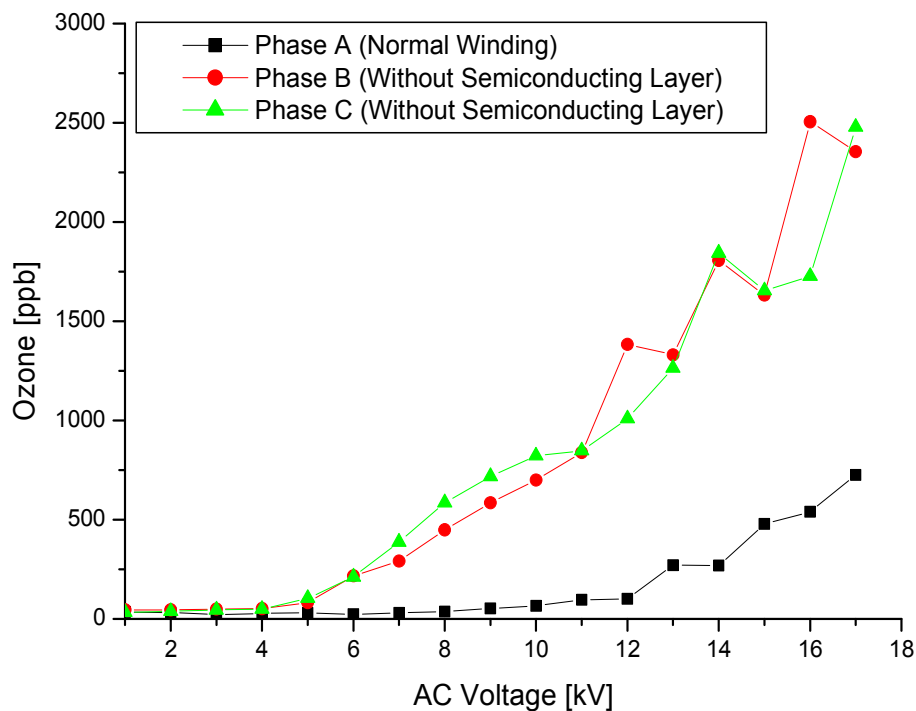
To compare the partial discharge magnitude and ozone generation in the normal and defective windings, Figure 7 and 8 show a graph between the applied voltage-partial discharge and applied voltage-ozone amount measured at 17 kV, which is before the occurrence of dielectric breakdown. As shown in the graph of Figure 7 and 8, in both the normal winding and the winding without the semiconductor layer, the partial discharge magnitude and ozone concentration increased with increasing test voltage. When the same voltage was applied to both samples, the partial discharge magnitude and ozone concentration were found higher in the B and C phases (no semiconductor layer) than in the normal winding.

Figure 7. Voltage-ozone generation characteristics.

The increasing trends of the partial discharge magnitude and ozone concentration depending on the applied test voltage were similar and it was verified that the ozone concentration was directly proportional to the partial discharge magnitude. Thus, the ozone concentration measurement can be used as a good indicator of partial discharge magnitude, which is a main cause of deterioration in stator windings.

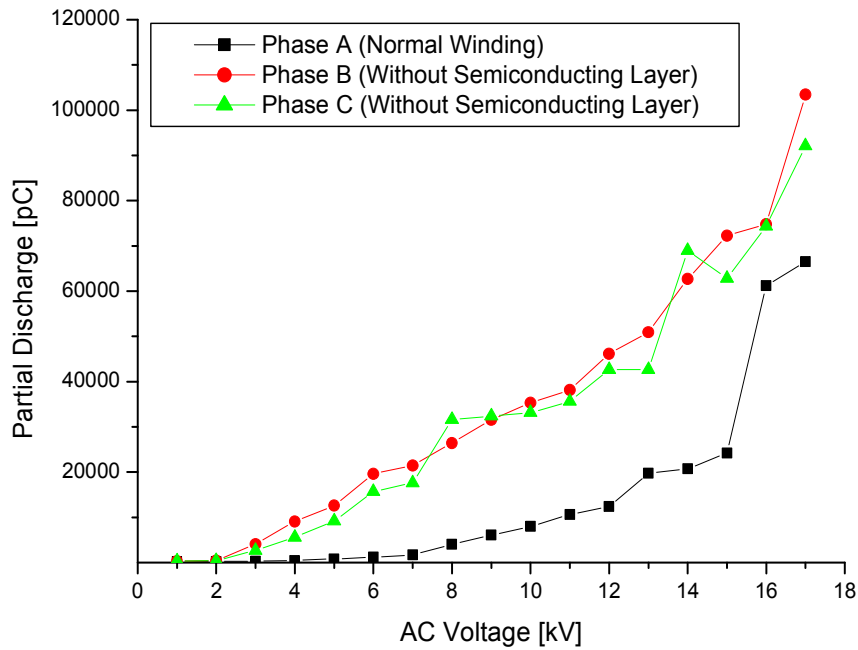
Figure 8. Voltage-partial discharge characteristics.

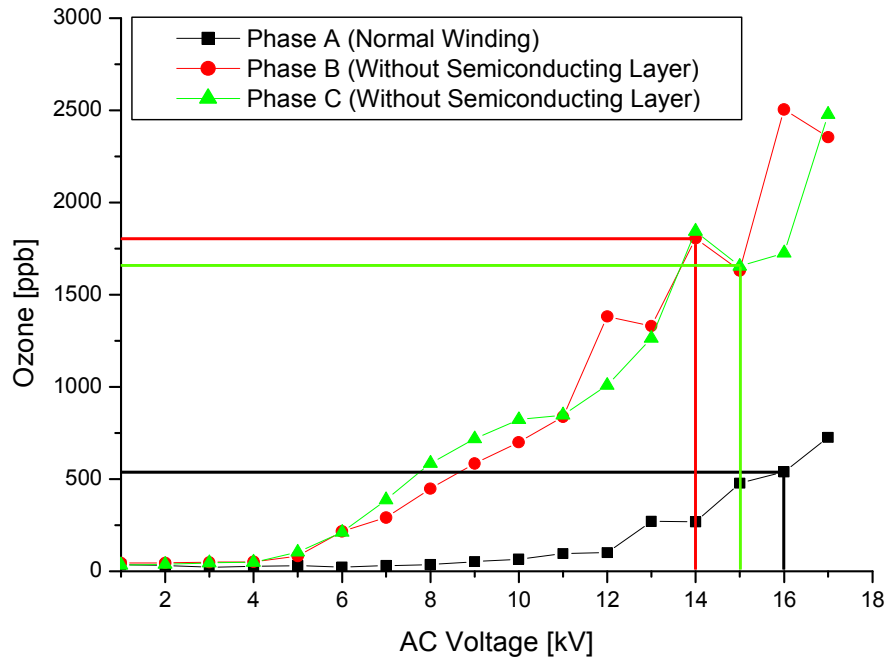
As given in Table 1 and from Figure 9 and 10, when the partial discharge magnitude of each phase was approximately 62,000pC, the ozone concentration is higher in the B and C phases, in which slot discharge is observed, than in the A phase, in which internal discharge is observed. When the stator winding rubs against the iron core due to vibrations causing damage to the semiconductor layer, partial discharge occurs between the winding surface and the iron core. Such slot discharge defects were verified to be more effective as a method of measuring the ozone concentration than discharges that occurred in the internal gaps of primary insulators [10]

Figure 10. Ozone emission at the same partial discharge magnitude (62,000pC) (A phase: 539.6ppb, B phase: 1,806 ppb, C phase: 1,654 ppb).
