Analysis of Correlation Among Partial Discharges, Ozone Emission, and Ultraviolet Radiation in High Voltage Motor Stator Windings

Abstract: In this research, a normal winding and simulated defective winding were created to examine the correlation between partial discharges, ozone concentration, and ultraviolet radiation in high-voltage motor stator windings. In the simulated defective winding, the semiconductor layer was removed so that discharges could occur easily between the winding surface and the iron core. A high voltage was applied to both normal and defective windings to measure the partial discharge magnitude, ozone concentration, and ultraviolet radiation. Subsequently, the results were compared and analyzed. The electrical partial discharge magnitude, ozone emission, and ultraviolet radiation measurement methods and properties were explained, and all test results and correlations were analyzed.

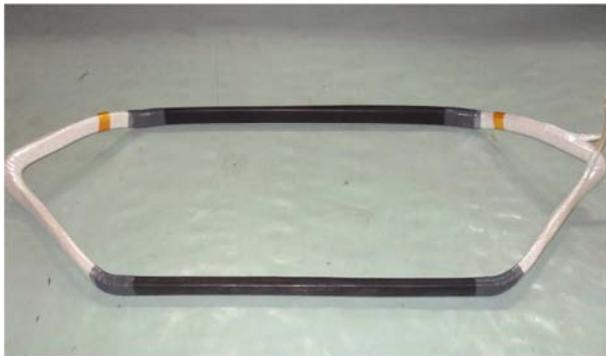
Figure 1. Normal winding.

To examine the characteristics of the ozone, ultraviolet emission, and partial discharge according to defects when applying a high voltage, a 6.6-kV high voltage-motor stator winding with artificial defects and a normal winding were tested and analyzed. Figure 1 shows the normal winding,

which has the semiconductor layer to reduce the potential difference between the stator winding and the iron core, and Figure 2 shows the defective winding whose semiconductor layer was removed from the winding surface so that discharges could occur easily inside the slot, between the winding and iron core [8].

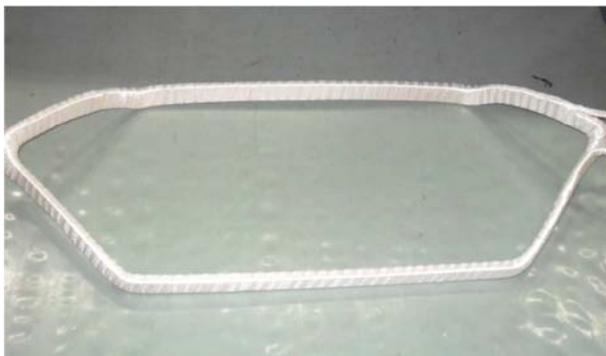
Figure 2. Winding without semiconductor layer.

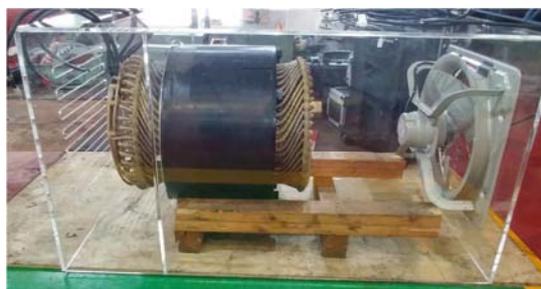
Figure 3. High voltage motor sample and enclosure.

fan on the rotor shaft, and then is drained out. Therefore, to achieve a constant flow of cooling air, an enclosure that covers the entire high voltage motor sample was constructed, as shown in Figure 3. A vent was put on one side, and a fan on the other so that external air would be sucked inside, passing through the high voltage motor, and then expelled outside.
