# Performance of damage detection methods used in bridge structures through dynamic tests in steel beams

Rolando Salgado, Gustavo Ayala, Paulo J. S. Cruz, Sergio A. Zamora. Performance of Damage Detection Methods used in Bridge Structures through Dynamic Tests in Steel Beams. *American Journal of Civil Engineering*. Vol. 2, No. 2, 2014, pp. 18-26. doi: 10.11648/j.ajce.20140202.12

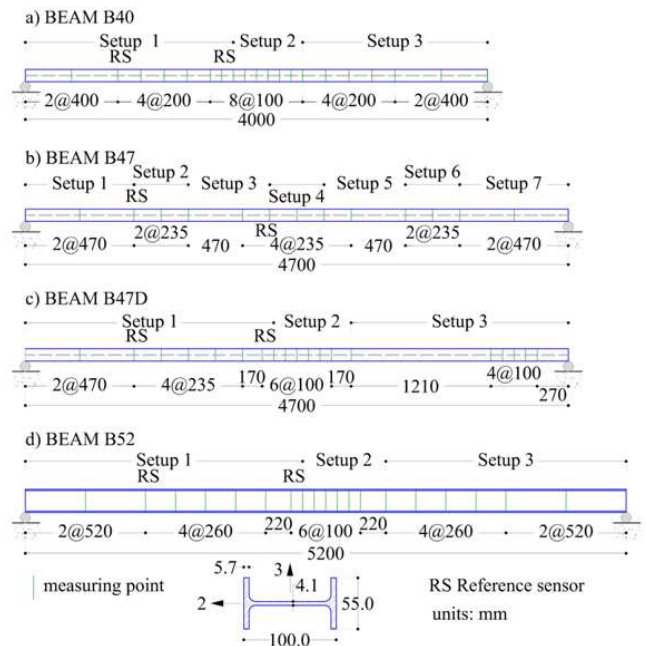
**Figure 1.** Geometry of the steel beams and location of the measuring points for the dynamic tests.

The beams considered for the damage detection analyses were made from steel and their geometric properties were: Young's Modulus,  $E=210$  MPa, mass density,  $\rho=7.85$  ton/m<sup>3</sup>, with area,  $A=1.03\times 10^{-3}$  m<sup>2</sup> and second moments of area,  $I_2=1.59\times 10^{-7}$  m<sup>4</sup> and  $I_3=1.71\times 10^{-6}$  m<sup>4</sup> in the weak (2) and strong direction (3), respectively. Considering that all the beams were simply supported, three geometrical cases were considered. For the first two cases, beams with 4.0 and 4.7 m span lengths were located with their weak axis (2) in the horizontal direction. In the third case, the beam with 5.2m long span was located with its strong axis (3) in the horizontal direction. These beams were referred as B40 B47 and B52 according to their span lengths. In the case of the beam B47, dynamic tests were performed with two different sensor layouts and damage distribution along the beam. As a result, different modal parameters for the same case study were obtained. Therefore, it was defined an additional case referred as B47D. The geometry of the described beams used for the experimental dynamic tests is shown in Fig. 1.

In the dynamic tests, 21 measuring points were located in the beams as shown in Fig. 1. To cover the total number of points with seven roving accelerometers and two reference sensors for each beam (referred to as RS in Fig. 1), three sensor setups were required. The use of seven roving accelerometers in the beams may alter the total mass of the beam and subsequently its modal parameters. To avoid that, 12 wood cubes with the same mass than the accelerometers (253 grams) were located, for each setup, in the measuring points free of sensors. Exception was the beam B47 where the acceleration response was acquired with only three accelerometers requiring seven sensor setups to cover the 15 measuring points. In beam B47 the mass of the three accelerometers did not represent an important part of the total mass of the beam; therefore, the additional masses were not necessary. The procedure used for performing the dynamic tests is shown in Fig. 3.

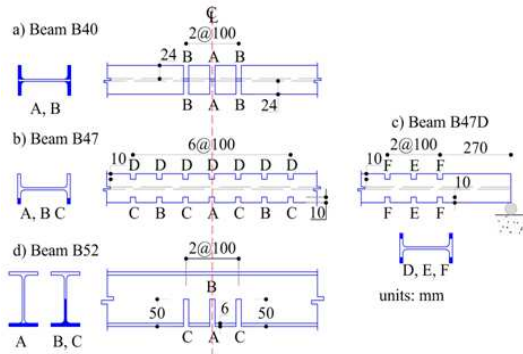
Figure 2. Damage scenarios.

In Fig. 2, letters A to F indicate the sequence that notches appeared on the beams. For instance, for beam B40 damage pattern A is a double-edge notch 24 mm deep located in the middle length of the beam.

Damage pattern B is three notches, 24 mm deep separated 100 mm each one which involve the damage pattern A and the two notches defined as B. The same criterion above described was followed for the damage scenarios of the other beams. Damage scenarios in beam B40 represented severe damage caused by double-edge cracks. Regarding beam B47, damage scenarios A to C evaluated moderate damage caused by single-edge cracks. Damage scenario D is a severe damage caused by double-edge cracks. In damage scenarios E and F, the ability of the damage detection methods to detect damage caused by double-edge cracks near the right support was evaluated. In beam B52, the first damage scenario A represented a light damage caused by a single-edge crack. Damage scenarios B and C represented severe damage caused by single-edge cracks.

Different damage scenarios were evaluated in the steel I beams. According to their position, notches were located in the mid-span zone of the beams. Only the beam B47D presented three additional notches near its right support. Notches were separately 100 mm. Only 200 mm separation was used for the beam B47 case C. Depths, locations and separations of notches in the beams for the considered damage scenarios are shown in Fig. 2.

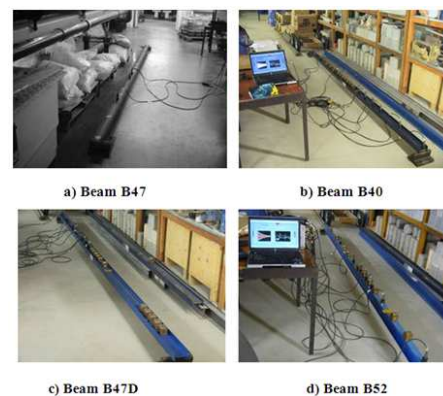
Figure 3. Procedure followed for performing the dynamic tests.

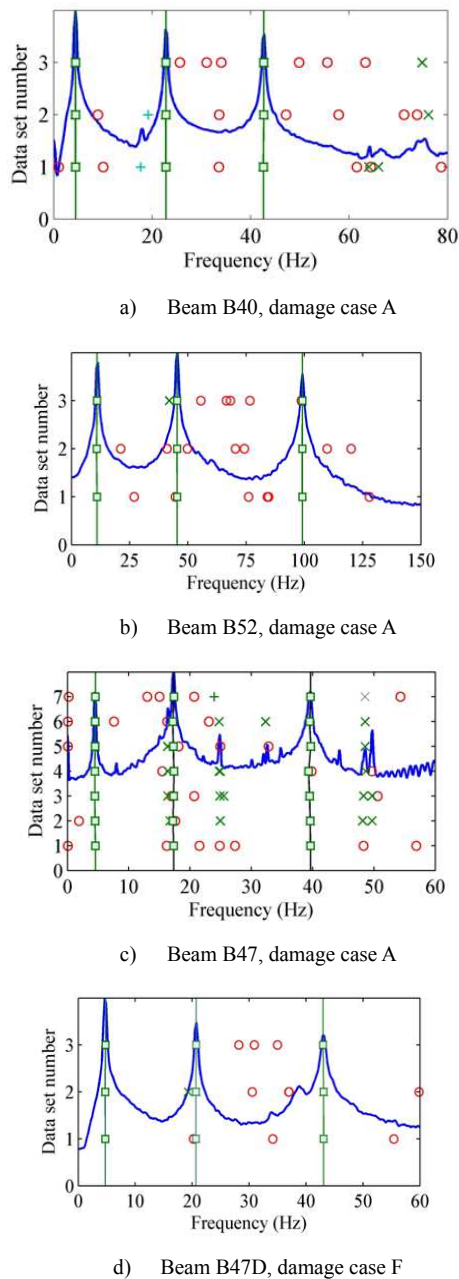
Keys: ■ selected mode; + unstable mode; ○ noise mode; × stable mode

**Figure 4.** Typical example of the selection mode graphs.

In total, fourteen modal identifications were done. The maximum state space in all modal identifications was set to 120. Models were estimated with state space dimensions from 0 to 60. The first three natural frequencies and their corresponding mode shapes and damping ratios were identified for each damage scenario as shown in the selection mode graphs of Fig. 4.

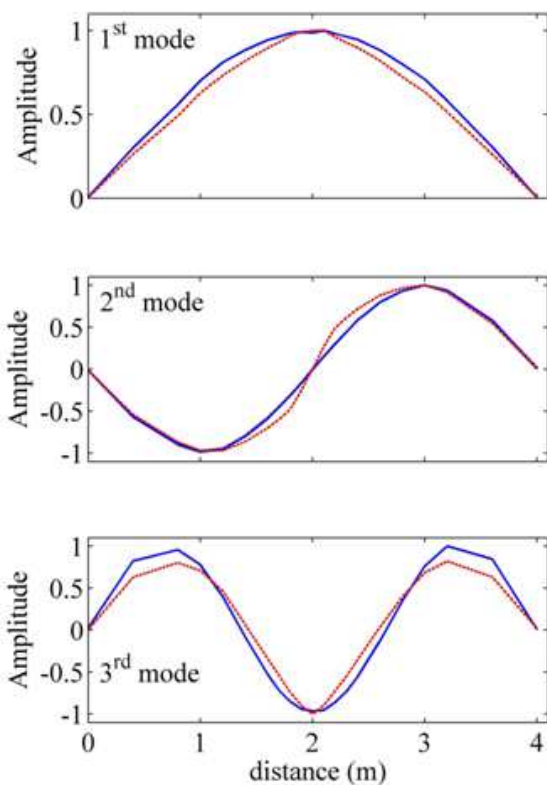
Keys: — the undamaged case; ..... the damage case C

**Figure 5.** Mode shape comparison in beams B52.

Modal parameters determined from the selected graphs are given in Tables 1 to 4 for beams B40, B52, B47 and B47D, respectively. They indicated that the natural frequencies ( $f$ ) from all the evaluated cases were determined with high confidence, i.e., low covariance values (COV) with an average of 1.13, 0.62 and 0.17 % for the beams B40, B52, B47 and B47D, respectively. In contrast, damping ratios  $\xi$  were calculated with a high variability, resulted in an average of the covariance values of 43.67, 40.30, 44.92 and 39.24 % for the beams B40, B52, B47 and B47D, respectively. Example of the obtained mode shapes of the beams, before and after damage, is shown in Fig. 5.

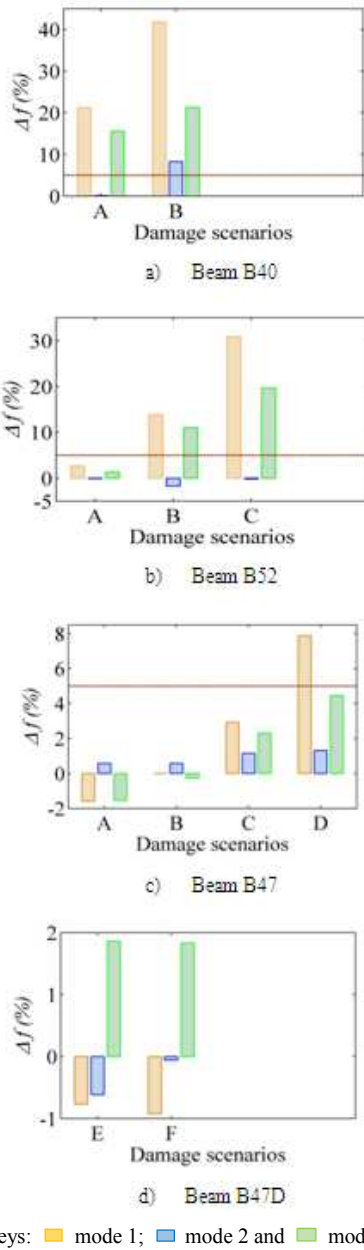
Figure 6. Frequency change comparison.  $\Delta f = (f_0 - f_d) / f_0$

Successful damage detection was defined when the frequency change (rate of undamaged  $f_0$  and damaged frequencies  $f_D$ ;  $(\Delta f = (f_0 - f_D)/f_0)$  is larger than 5%. In fact, ambient factors, errors during data acquisition and precision of the instrumentation can give variability of the frequencies around 5%, [15]. The frequency change comparison between the undamaged and damaged cases for the considered steel I beams is shown in Fig. 6.

As it was expected, the frequency change was larger than 5% for the severe damage introduced to beams B40 and B52.

Except the damage case A for the beam 52 which represented a light damage. In the case of the beam B47, it can be pointed out that the frequency change was larger than 5% only for the damage case D of the first mode shape. Damage introduced in the zone near the support of the beam B47D did not alter significantly the frequency change of the damage case D (taken as baseline for beam B47D).

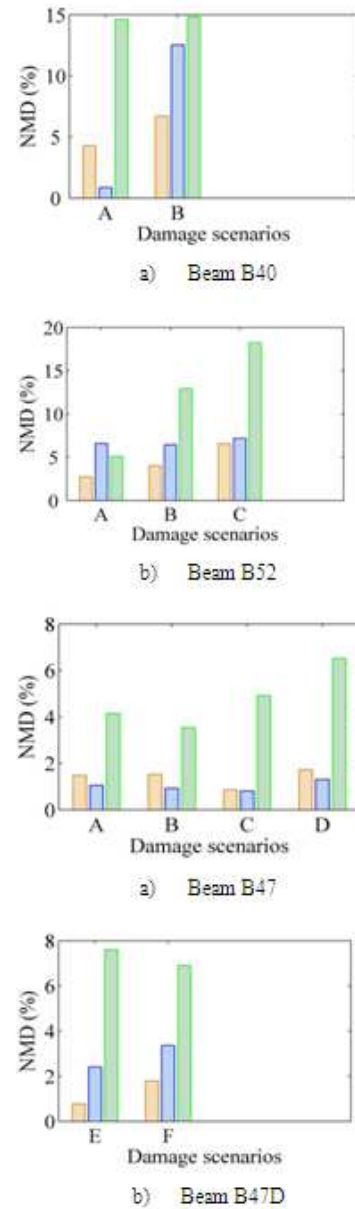
Figure 7. Modal comparison using NMD method.

Regarding the mode shape comparison, the NMD method gives more rational scale when the differences between two modes are small compared with Modal Assurance Criterion (MAC) method. For instance, NMD values of 20, 15 and 8 % correspond to MAC values of 0.9615, 0.9780 and 0.9936, respectively. For damage detection purposes, a MAC value less than 0.80, equivalent to a NMD larger than 50%, would indicate the existence of damage in the structure. This criterion try to rule out mode shape differences caused by ambient factors, like gradient of temperature and humidity, noise present in the dynamic response and inaccuracies during the modal identification process. The application of the NMD method to the mode shapes obtained from the different damage scenarios in the steel I beams is shown in Fig. 7.

In the mode shape comparison of Fig. 7 no successful damage detection was found for any damage case (any damage scenario had NMD larger than 50 %). In fact, the MAC and the NMD method average the differences between the coordinates of the two compared mode shapes. Even when big differences happen in some particular points of the modes, the resulted NMD value does not change in the same rate. As it was expected, the NMD values were larger for the most severe damage cases (beam B40 all cases and B52 cases B and C). It was also noticed that the third mode was the most sensitive to damage in all the damage cases.

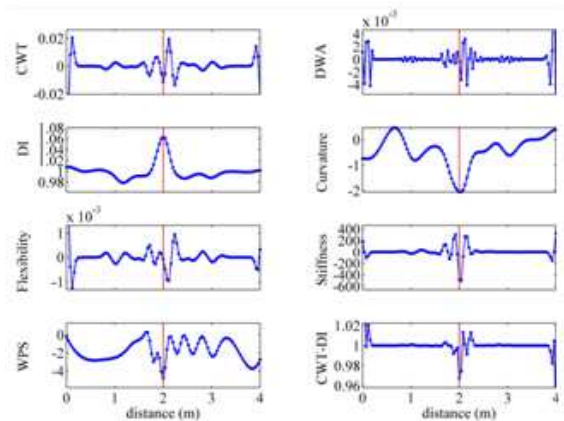
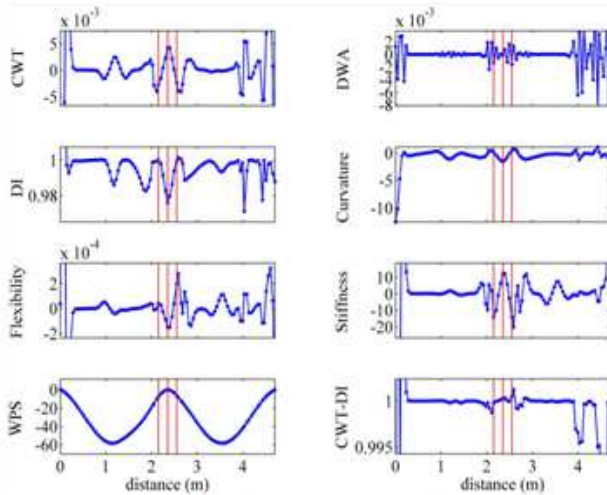
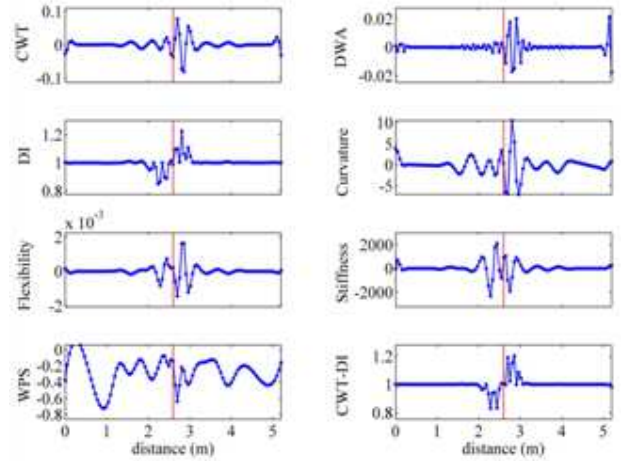
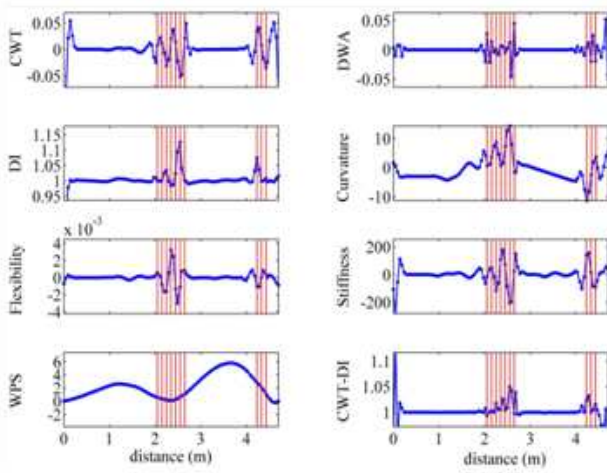
a) Beam B40, damage scenario A, mode 1;

b) Beam B47, damage scenario B, mode 1.

d) Beam B52 damage scenario A, mode 1.

Key: \*\*\* location of damage.

Figure 8. Examples of the evaluation of damage detection methods.

c) Beam B47D, damage scenario F, mode 3.

Successful damage detection was considered when a sharp peak and/or disturbance zone with coefficient values clearly above those of its neighborhood was found in the graph. Exceptions are the zones near the ends where high disturbance caused by the singularities of the supports is always present. Results of applying the damage detection methods to the most sensitive mode shapes and energy shapes are shown in Fig. 8.

From Fig. 8 damage detection methods could detect damage in most of the cases. They only presented difficulties to detect the damage scenarios of beam B47 (Fig. 10). The light damage introduced to beam B47 and its reduced number of measuring points may be the reason for this behavior. The performance of the evaluated methods for different damage scenarios are summarized in Tables 5 to 7 for the modes 1, 2 and 3, respectively.

In Tables 5 to 7, *V* refers to clear detection of damage, i.e., the graph of the applied method presents a clear disturbance in the location of damage as shown in Fig. 8; *G* refers to clearer disturbance present in the damage zone. In this case, the graph of the applied method presents several peaks outside the damage zone with smaller amplitudes than those located within the damage zone. When damage was not detected at all, i.e., no clear disturbance is located in the damage zone (see Fig. 10 for the CWT-DI method), the evaluated methods were classified as no damage identification (-). For beam 47D cases E and F, damage detection was evaluated for damage present in the mid-span region as well as near the right support (see Fig. 8).
