Study on Landslide Mechanism and Treatment Technology in Tunnel of Sandy Cobble Stratum

Figure 1. Tunnel sandy pebble distributions.

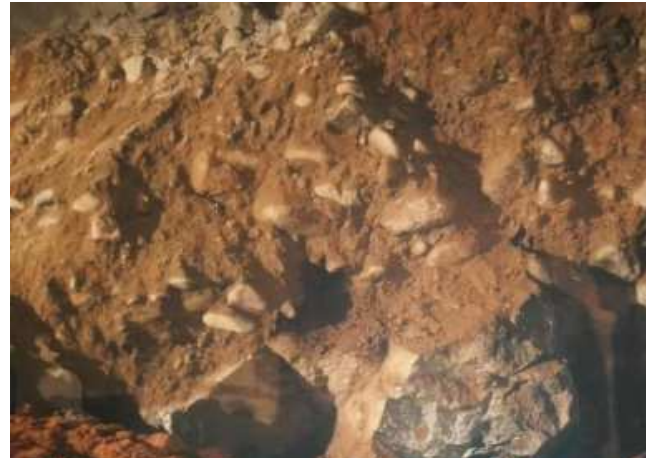
Gongboxia tunnel is located in the XunHua basin, no fault structure is adopted, and strata are monoclinic. strata occurrence in between $150-165^\circ \angle 5-10^\circ$. The import section belongs to the river erosion accumulation landform, micro landform belongs to the the Yellow River River impact accumulation terrace, terrain is relatively slow and round. In addition, the bedrock rock in silty mudstone with sandstone and conglomerate, silty mudstone, strong weathering rock, soft rock is very thin, ~ thick layered structure, fracture, interlayer cataclastic structure rock was poor, poor integrity. The formation water is almost zero pebble gravel as main component of gneiss and granite gneiss, sandstone, the egg stone hard, not weathering, and the presence of large boulders, the silt and sand filling, filling the local enrichment.

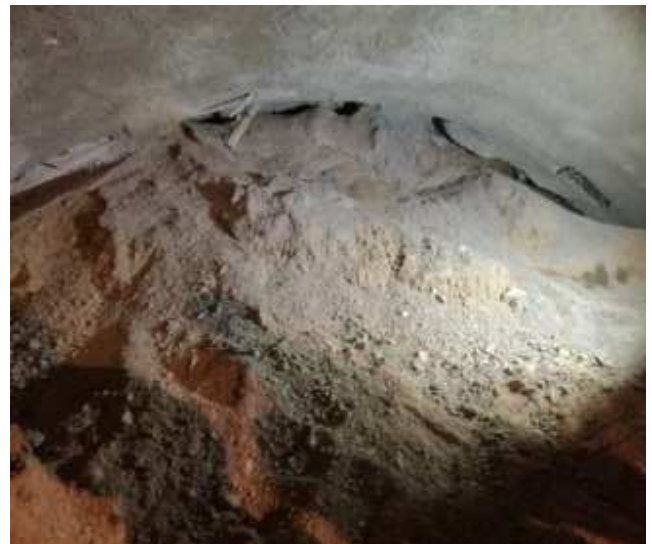
(a). Arch collapsed.

Figure 2. Landslides during tunnel construction

Because of the unique engineering characteristics, the landslides occur frequently in tunnel during construction. Through the statistics of the Gongboxia tunnel during the construction of many landslides accident analysis, landslides occurred arch and side wall in the tunnel roof, the displacement of large sometimes wear to the surface collapse. Landslides can be divided into following categories: vault collapse, collapse, collapse, side wall cracking, the initial support of initial support and serious invasion of the ground collapse.

Landslide case description: tunneling to ZK76+965, in the original advance ductule, under the support of excavation section, vault above has a small amount of residue in drop, backward evacuated, construction personnel found the situation changes, falling after half an hour and then dome. Like sand flow landslides happened, 2 minutes duration. Landslide section height to the surface, about 30 m, the collapse of the long time, directly affected to the surface, causing the three constraints in front surface roof caving, the biggest one is to form a diameter of 4.5 m, 1.5 m deep funnel-shaped cavity collapse.

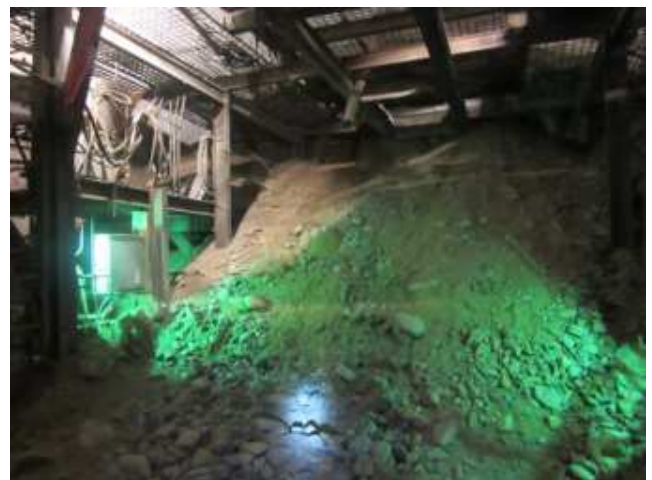
(b). Constraints collapsed

With the development of tunnel tunneling, arch excavation, due to mechanical disturbance, face slip, core soil sudden instability, outward extrusion, lead to the collapse of the tunnel face soil inside tunnel face was completely collapsed covered collapse with gravel loose fine sand, amount of landslide is about 45 m³. In addition, the tunnel will occur landslides on both sides, serious a landslide occurred in the tunnel on the left side of the wall, on the left side of the wall location steel arch bending deformation, steel mesh, spray at the beginning of C25 concrete floor crack, crack width is 5 ~ 35 cm, toroidal length is 1.2 ~ 1.5 m, collapse of the tunnel section with a third space. As a result, the initial support showed a sharp deformation and penetrated the clearance of the secondary lining.

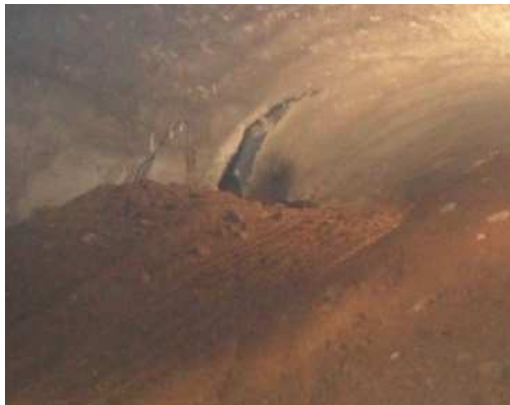
(d). The initial supporting cracking.

The distribution of pebble particles in the formation is uneven, and the specific gravity of each area varies. In the construction of roof and tunnel face surrounding rock loose, poor stability, low shear strength if break the stability of surrounding rock will collapse. On both sides of the tunnel excavation because before and after different degree disturbance, can also cause the arch waist or side wall collapse, collapse in the form of direct action of gravity of primary support structure, the role of the primary support deformation of surrounding rock pressure and loose rock pressure increases, causing the initial support of cracking and invasion.

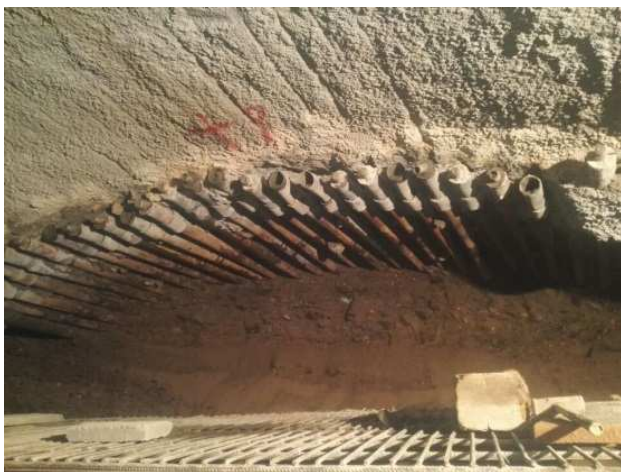
Figure 4. Close the short pipe roof supporting effect on site.

The original design of the advanced small pipe support basically can't solve the problem of arch collapse. Then, turning to pipe roof support. Due to large proportion of sand pebbles, loose and good grading, prone to collapse when drilling holes, drilling difficulties and other issues. Conventional design parameters of pipe roof cannot apply to sandy pebble stratum, will be the end of pipe roof problem such as the offset is too large. Through field test, finally decided to adopt close short pipe roof support. "Close" refers to the ring between the pipe roof to the relatively small spacing, arrangement more closely. "Short" refers to a short length of pipe roof. The supporting parameters are shown in table 1.

Close short pipe roof at a certain distance, into a fan-shaped arrangement in the tunnel arch department, not only beam arch effect, and improves the cohesive force, improve the surrounding strata. Close short pipe roof formed toroidal reinforcement ring radial well constraints surrounding strata and prevent its pressure relief and relaxation, ensure the safety of the excavation process. Basically contain arch above the tunnel flow sand and collapse phenomenon, the supporting effect is shown in figure 4.

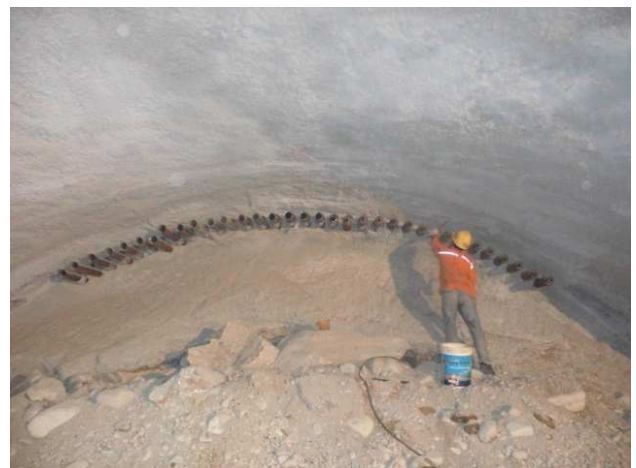
Figure 5. Core soil constraints set aside.

The original design of the construction method for single side heading method, but found in site construction, the feasibility of this method to implement more bad, the landslide problem is serious. Finally, changed to be three steps aside core construction method.

surrounding soil, circular excavation steps again, and obligate core soil, timely support after excavation, and then, steps and down the steps in the excavation, excavation and supporting, form a line production. Step method is proposed, which can conduct multiple working face, rapid construction, timely closed loop, play together the bearing capacity of the surrounding rock and lining. Among them, the reserved core soil (figure 5) can enhance the stability of the constraints, the constraints to prevent collapse of instability.

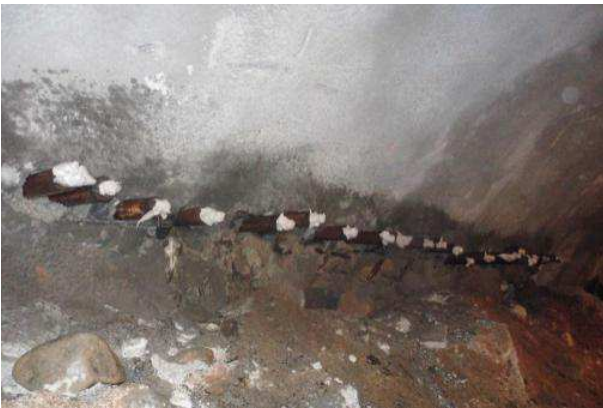
Figure 6. Lock foot anchor pipe.

Because there is no middle-board in the three step excavation method, the vertical displacement is larger, and the vertical deformation control mainly depends on both sides of the arch foot. This shows that the stability of the arch foot is critical. During the construction of the anchor pipe inserted by two feet (material specifications and close short pipe roof), close to the level into the surrounding rock, in 4 ~ 6 m in length, average arrangement in two common steel arch frame (50cm), connected by transverse reinforcing steel bar and steel arch in the middle. Thus, to improve the bearing capacity of the arch foot. Moreover, through the lock foot anchor pipe grouting (figure 6), also can have improve on both sides of the cohesive force and the stability of surrounding rock.

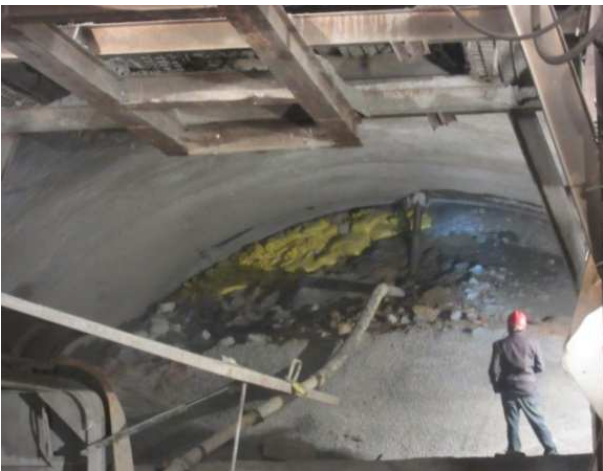
Figure 7. Sandbag plugging and backfill of the grouting.

Beginning in the vault for pipe shed advance support, drilling process, can cause disturbance to the surrounding rock is too large, broke the formation of equilibrium state, part of the surrounding rock instability, the phenomenon of sand flow and landslides. In order to prevent further landslides, the scene processing measures are generally use sandbag first block, then turn landslides in pumping cement mortar, backfill (figure 7). In addition, if the wall of rock mass is poorer, more loose. Sometimes occur landslides, processing measures are to walk the perimeter of the cavity collapse residue, to put 2-3 m of cement mortar, backfill, fill the cavity collapse in time (figure 8).

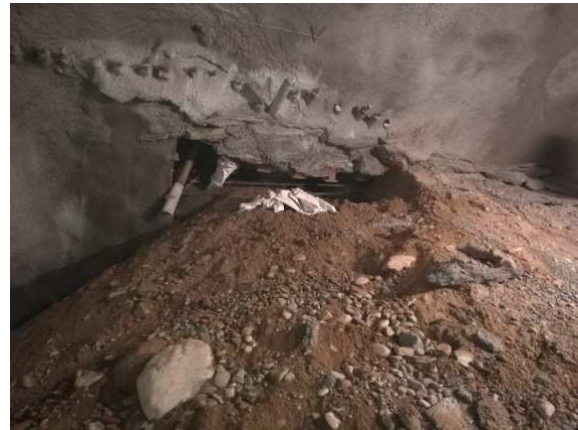
Figure 8. Cavity backfill grouting.

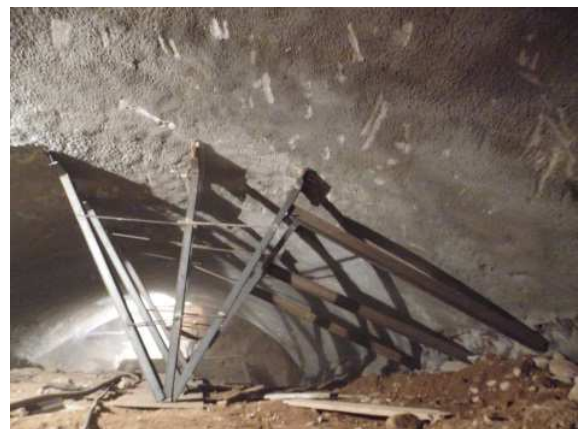
Figure 9. Temporary support in the hole.

Through sand gravel stratum, the stratum is loose, the arching sex is bad. Jiang Y C et al think that loose surrounding rock pressure in surrounding rock pressure is given priority to [9-10]. in the surrounding rock loose collapsing the gravity or the weight of direct effects on the tunnel lining, can lead to deformation of primary support, serious when primary support cause craze. Primary support to prevent further deformation, deformation of serious parts inside the hole, using I20a type i-beam for temporary support, in order to change the stress of surrounding rock and initial support, improve the stability of surrounding rock, prevent collapse of surrounding rock and secondary collapse (figure 9).
