Investigation of Fire Protection Certification for Aircraft Engine Components

Wu Jingfeng, Song Jianyu. Investigation of Fire Protection Certification for Aircraft Engine Components. *International Journal of Energy and Power Engineering*. Vol. 8, No. 6, 2019, pp. 73-78. doi: 10.11648/j.ijjepe.20190806.11

Abstract: Fire protection performance is one of the most important capabilities for aircraft engine, since the result may be hazardous in the case of a fire condition. According to fire protection regulation CCAR 33.17 of China Civil Aviation Regulations, fire-proof tests of a specific pipeline, a fuel tank and a fuel filter assembly were carried out. Test conditions include inlet fluid temperature, fluid pressure, fluid volume flow, fire temperature and heat flux density. The average flame temperature during the fire tests is 2000 degrees Fahrenheit, the heat flux density is $116\text{kW/m}^2 \pm 10\text{kW/m}^2$ and the distance from burner exhaust to the test area is 100mm in these fire tests. Fire test of pipe passed, but the fire test of oil tank failed because of the failure of the oil circulation system and the melting of plastic pipe material in the ventilation pipe sepa

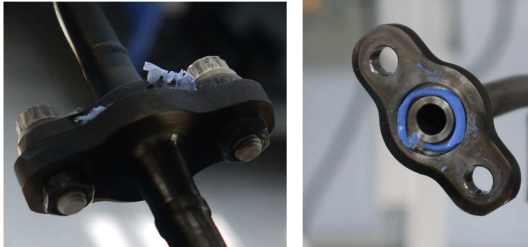
Figure 4. Structure of B-end after test.

Figure 4 shows that the B-end joint is free of deformation, the sealing structure is complete, but the O-ring is carbonized and damaged;

After the test, the decomposition inspection of A and B end joints are shown in Figure 3 and Figure 4, respectively.

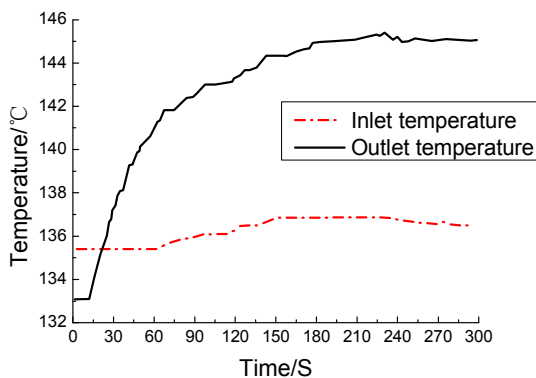
(a) Fire resistant test of A-joint

The temperature changes at the inlet and outlet of the pipeline test pieces are shown in Figure 5. Figure 5 (a) shows that the inlet temperature of the pipeline has been maintained between 135°C and 137°C during the 5-minute fire-resistant test on the A-joint, and the outlet temperature has risen from 133°C to 145.5°C and tends to be stable. During the test, the temperature difference between the inlet and outlet of the pipeline reaches 9.5°C.

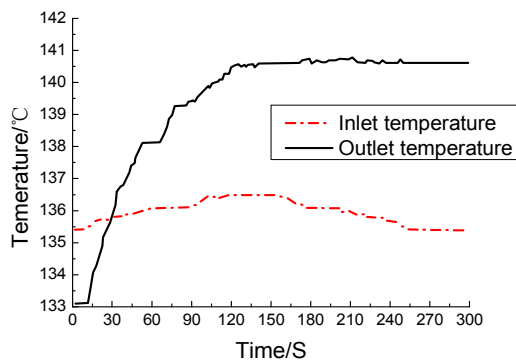
(b) Fire resistant test of B-joint

Figure 5 (b) shows that the inlet temperature of the pipeline has been maintained between 135°C and 137°C during the

5-minute fire-resistant test on the B-joint, and the outlet temperature has risen from 133°C to 140.5°C and tends to be stable. During the test, the temperature difference between the inlet and outlet of the pipeline reaches 5.0°C.

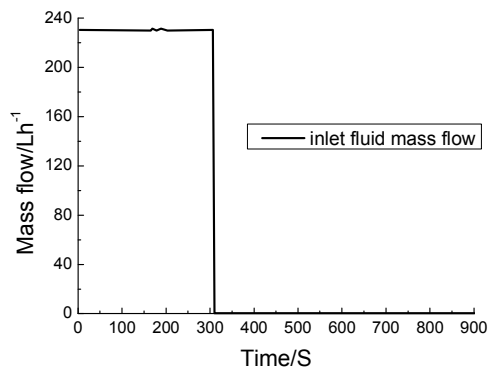
Figure 8. Fluid mass flow.

Figure 8 shows that the flow rate of fluid keeps 227 L/h in the first 5 minutes, and no flow of fluid in the last 10 minutes. The flow condition meets the test requirements.

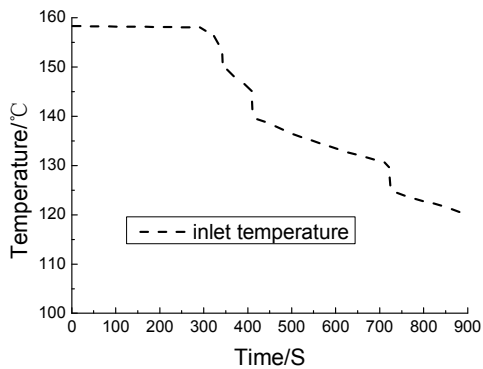
Figure 9. Inlet fluid temperature.

Figure 9 shows that the inlet fluid temperature is kept at 158°C for the first 5 minutes, and the flow stops after 5 minutes. The fluid naturally decreases with the cooling of air, and the inlet oil temperature meets the test requirements.

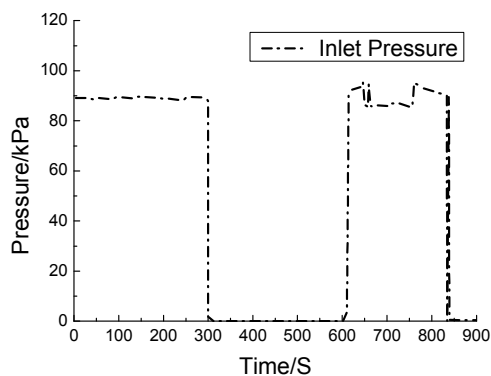
Figure 10. Inlet fluid pressure (gauge pressure).

Figure 10 shows that the gauge pressure of the oil tank is 89.4kPa in the first five minutes, which meets the set pressure range. Then the outtake pipe is opened and the gauge pressure is 0 kPa. During the period from 600 seconds to 840 seconds, there is a sustained and fluctuating increase of about 92kPa. During the period from 840 seconds to 900 seconds, the gauge pressure returns to 0 kPa.

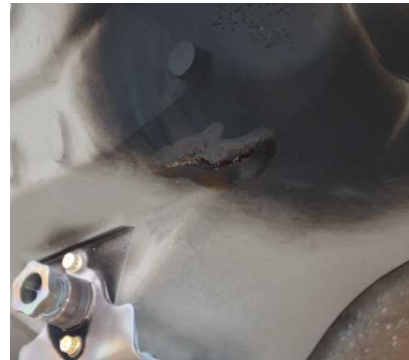
Figure 11. Inspection after test.

Figure 11 shows that after decomposition inspection, a crack of about 70 mm appears in the lower right side of the tank. The widest crack is about 5 mm.

Except above, there is no leakage of liquid oil or steam in other parts. The valve at the bottom of the tank is in good condition, and the remaining oil in the tank is 220 ml. The O-ring on the drain valve, oil level indicator and oil return pipe have been carbonized, but there is no oil leakage in each position, and the clearance meets the design requirements.

After cutting off the ventilation pipe, it was found that there was a melting defect in the inner plastic structure of the pipeline. It is due to the melting of plastic pipe material in the ventilation pipe, the blockage of the ventilation tank, and the continuous and oscillating pressurization in the tank, which results in the intermittent ejection of liquid lubricant and oil vapor from the tank through the ventilation pipe in the test, thus greatly reduces the lubricant in the chamber of the test piece. The position uncovered by the fluid cannot withstand the high flame temperature and the rupture occurs.

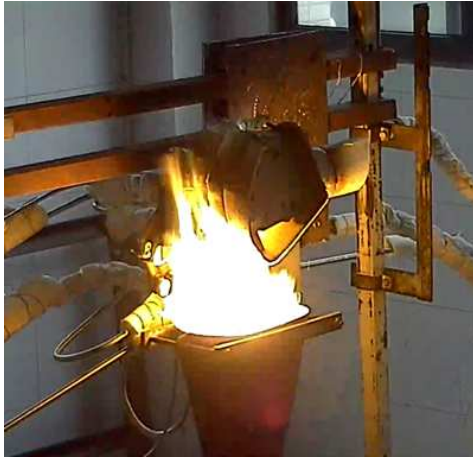
Figure 12. Fire test of a fuel filter assembly.

A 15 minutes fire-proof test of fuel filter assembly was carried out.

The first test failed and a residual flame appeared after the test. The reason is that one of the oil drainage paths is blind pipe design, causing oil accumulation in the fire test process, and it has not been involved in the flow and heat transfer, which leads to the increase of oil temperature and seal failure at high flame temperature.

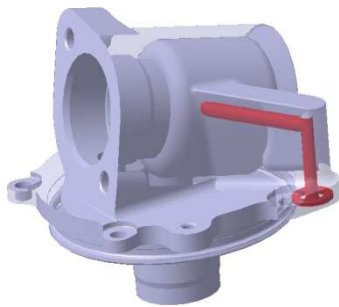
Figure 13. Design change of blind pipe.

Later, aiming at this problem, the unreasonable redundant drainage circuit in the test sample is deleted, as shown in the red oil circuit in Figure 13. The second fire test was successful.

can absorb and take away heat. The fire protection performance will be better with larger flow of working substance. And the blind pipe design should be forbidden.
